Dr
Austin, TX 7875	50
04/08/2019

Report Type: Foundation Assessment and Relative Height Survey Property Lead Inspector: A. Jordan #9458

## Foundation: Measurement of Relative Heights

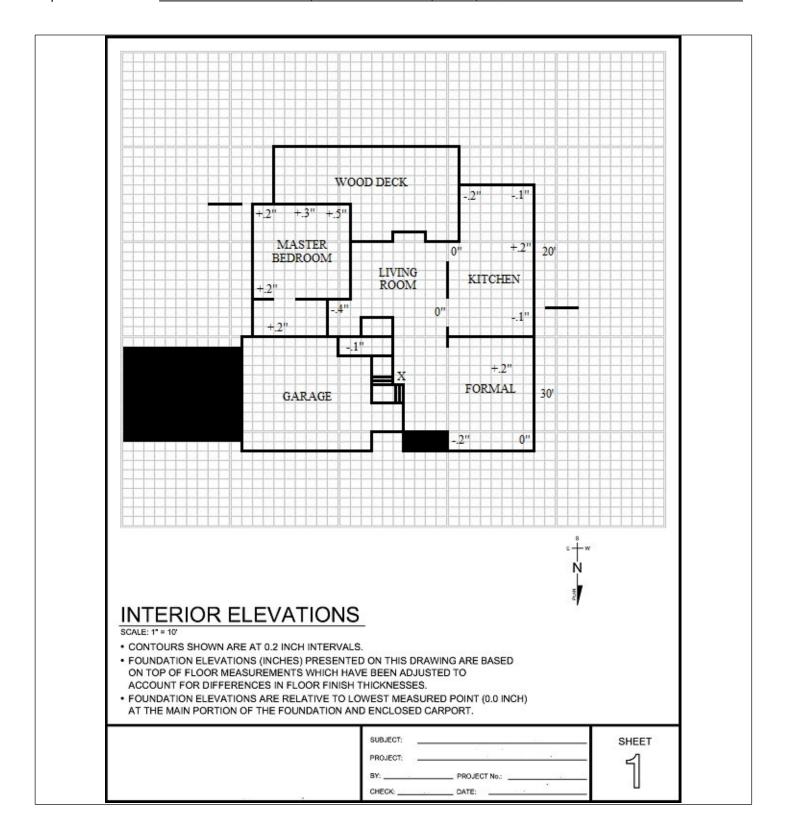
The following drawing shows the raw measurement data taken during the inspection of the property. The measurements are shown on an engineering scale in tenths of an inch. All readings indicate a difference in elevation relative to the reference point, which is indicated by the 'B' symbol. The exterior numbers represent approximate linear footage. The drawing is not to scale, but is a reasonable facsimile. The drawing should only be used as a reference tool:

The visual analysis of the structure and foundation did not reveal indicators associated with excessive foundation movement and failure. Evidence of minor-moderate phenomena (structural damaged caused by settlement) was noted. Relative height differences recorded by foundation surveying equipment (ZipLevel Pro) indicate that settlement common to the structure's location, type, and age has occurred. The survey information correlates with visual indicators. In this inspector's professional opinion, the structure is currently supported by the foundation to an adequate degree. Noted evidence of structural damage caused by settlement appears to be minimal and, for the most part, cosmetic in nature. Ensure that the home is properly maintained and updated as needed. Any recommendation or concerns noted in associated reports should be addressed by skilled professionals. If further evaluation or verification of these findings are required, a structural engineer should be contacted.
