THE AUSTIN HOME INSPECTOR

On 08MAY2019, a site visit to the above mentioned property was made in order to perform a property assessment. A partial and limited assessment of the foundation and crawlspace was conducted at that time. Areas of concern and recommendations have been provided herein.

CRAWLSPACE ASSESSMENT

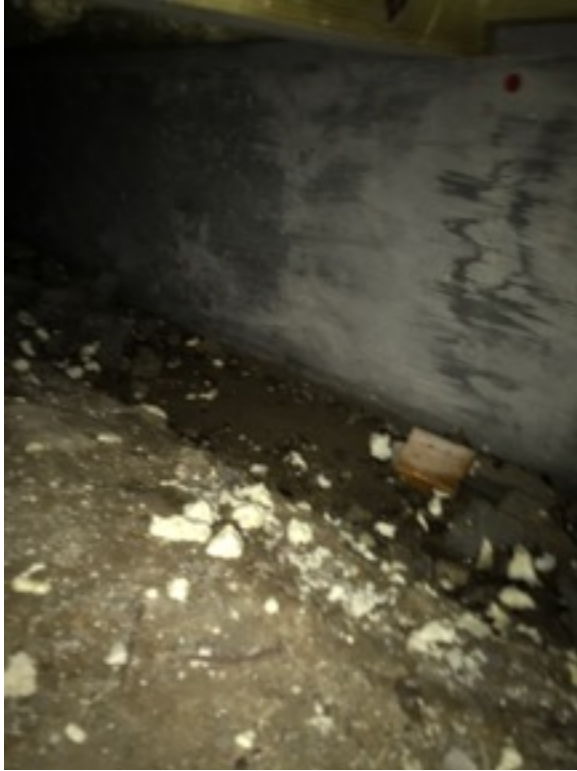
The crawlspaces have not been provided adequate ventilation or encapsulation. Additionally, excess moisture has accumulated at various areas indicating that an improper below grade moisture barrier may be present (particularly at the right side stem wall). The lack of proper ventilation and airflow coupled with excess moisture intrusion has resulted in damage to moisture susceptible materials, conditions conducive to the growth and proliferation of mold, problematic air quality and environmental conditions, and humidity conditions which increase the likelihood of vapor drive and/or diffusion into the floor assembly. Additionally, the presence of open cell foam insulation in an un-encapsulated, high moisture environment presents an installation and material condition concern. Open cell foam is considered to be a permeable to semi-permeable material and, although not specifically prohibited from use in crawlspaces, the installation of this material in high moisture, ambient environments is typically excluded in manufacturer recommendations. Commonly observed installation practices call for open cell foam to be placed in encapsulated/sealed environments. Open cell foam exposed to unfavorable, high moisture conditions increase the likelihood of moisture entrapment, vapor diffusion, vapor drive, and various associated issues which may cause continued damage to the structure.

EXCESS MOISTURE AT STEM WALL

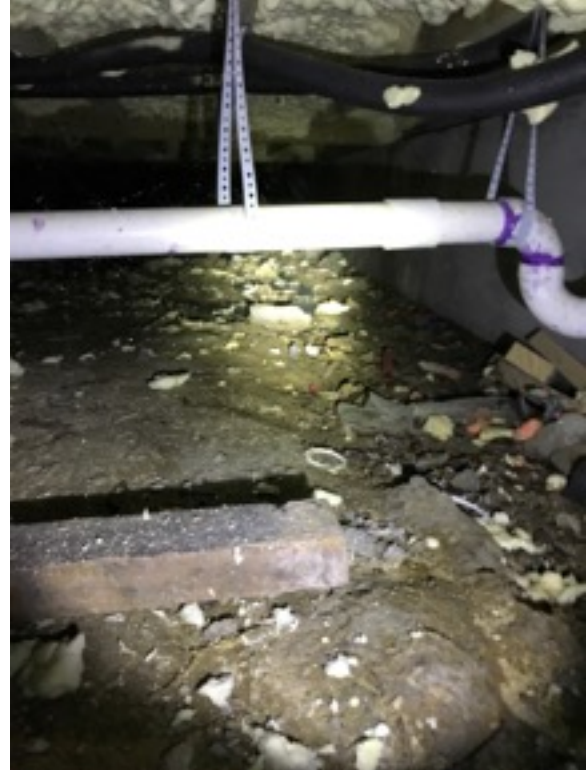
EXCESS MOISTURE AT STEM WALL
