GREENBELT STRUCTURAL SERVICES  
A DIVISION OF TAHI LLC

## **I: MOLD ASSESSMENT - GENERAL INFORMATION AND SITE OBSERVATIONS**

## ADDENDUM I: FOUNDATION/CRAWLSPACE ASSESSMENT

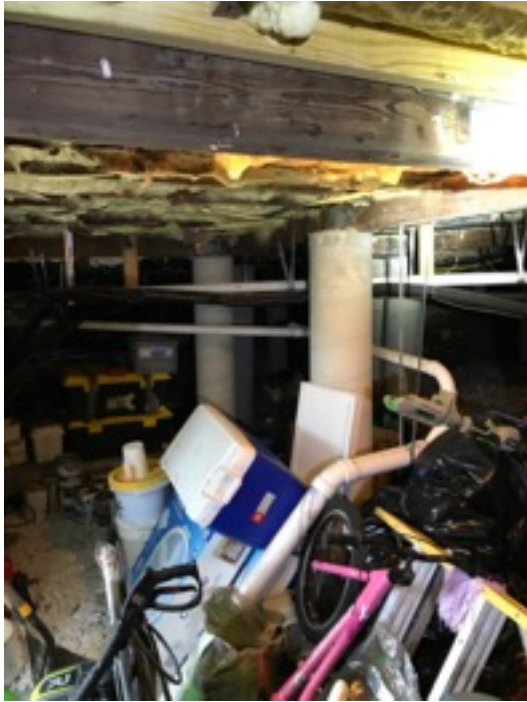
LEFT CRAWL SPACE

At the time of inspection, wood rot, suspect surface mold, and fungal growth was visually discovered within the crawlspaces (mainly at stored material, wood products, and soil surfaces). Excessive moisture accumulation was discovered at areas under the back deck, at the back corner (near center stem wall and plumbing) and at isolated portions of the perimeter stem wall (throughout). A visual assessment and equipment readings indicated that humidity levels were well over recommended levels.

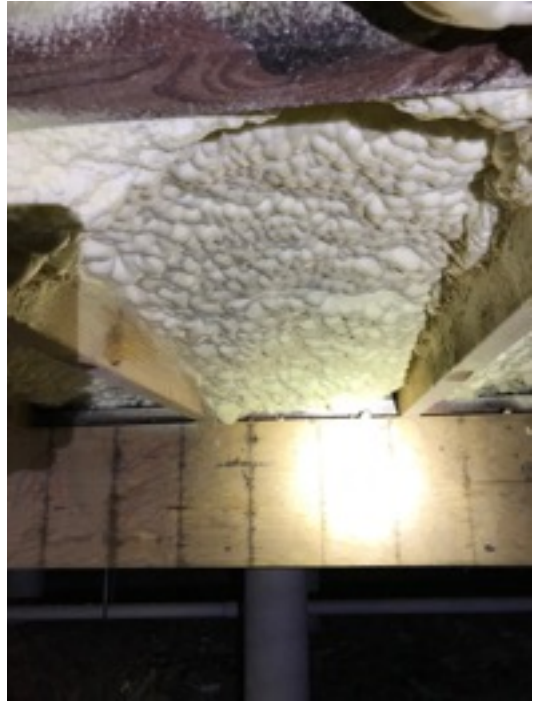
Further investigation of the current condition of foam insulation located in the crawlspaces should be conducted by a subject matter expert to determine if removal is required. Updates to insulation should be conducted per the guidance of the contracted subject matter expert.

OPEN CELL FOAM INSULATION

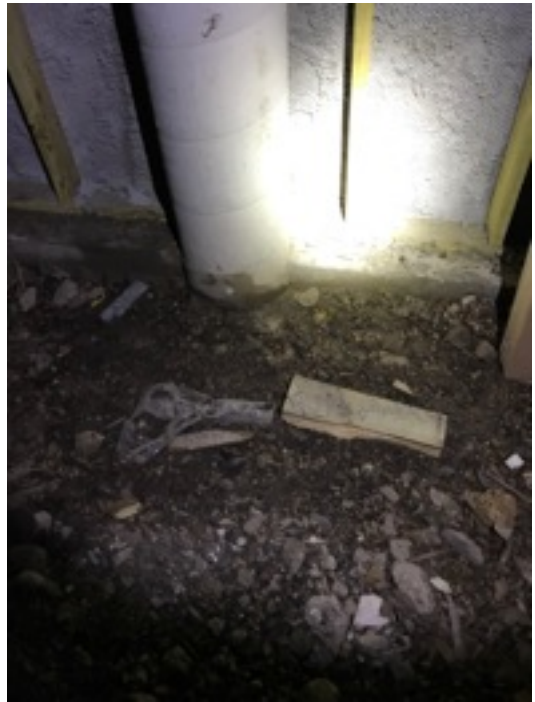
MOISTURE PENETRATION

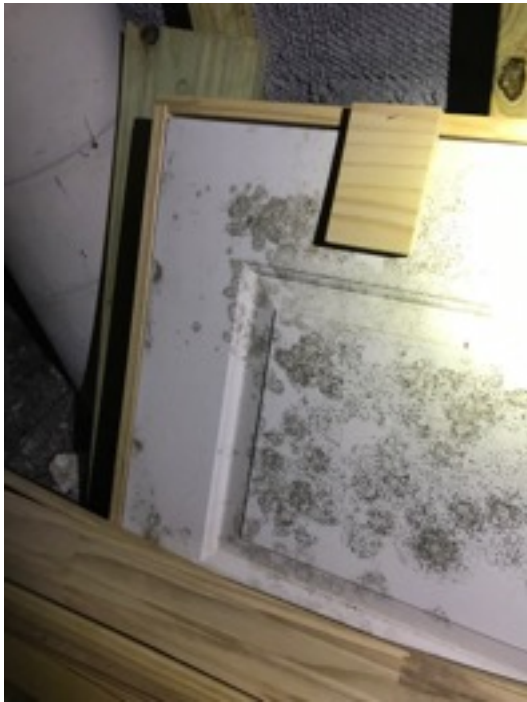
VISUALLY DISCOVERED MOLD

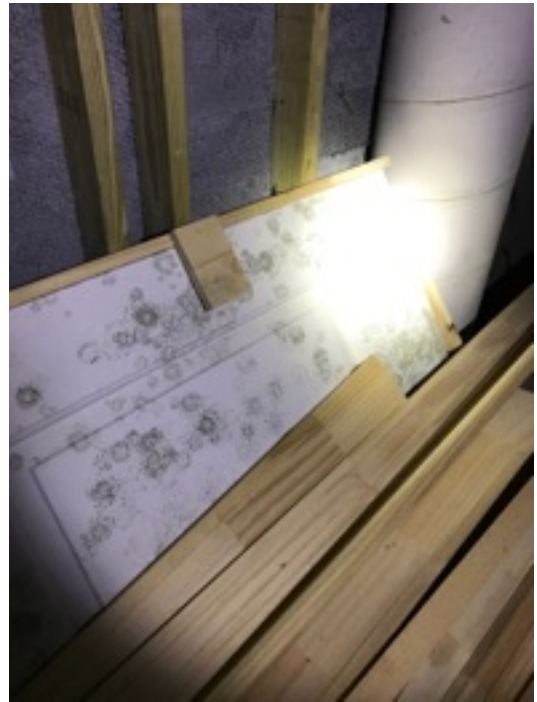
VISUALLY DISCOVERED MOLD

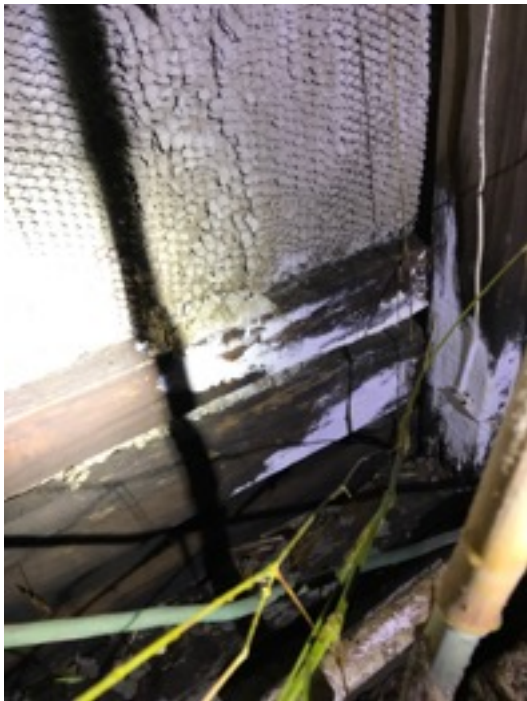
SUSPECT MOLD/FUNGAL GROWTH

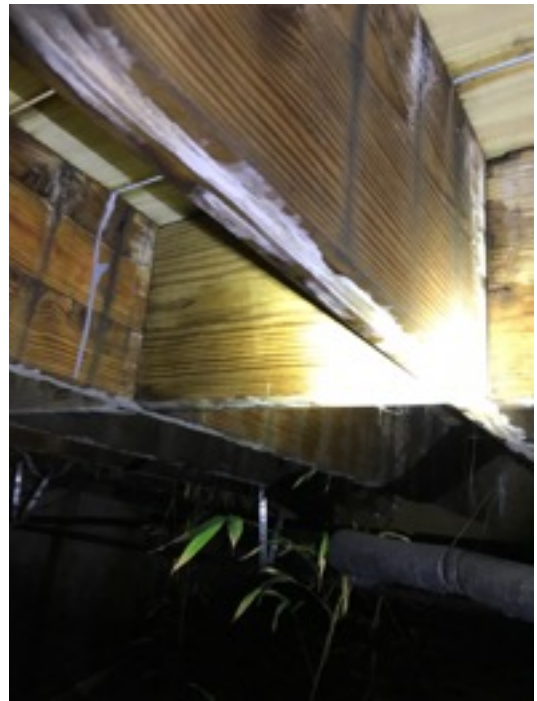
SUSPECT MOLD/FUNGAL GROWTH

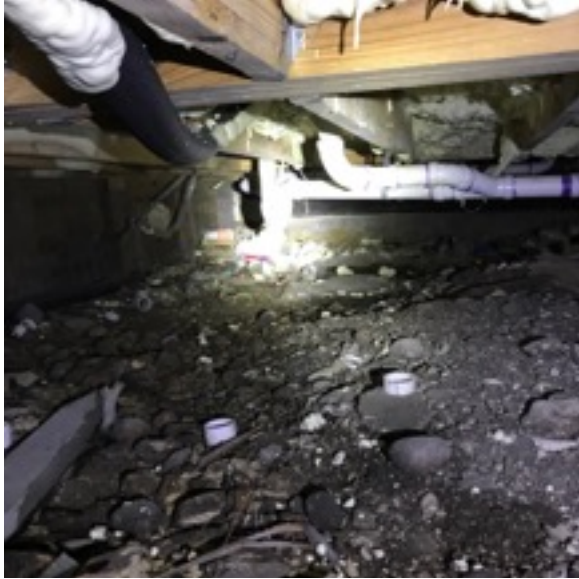
EXCESS MOISTURE AT BACK CORNER

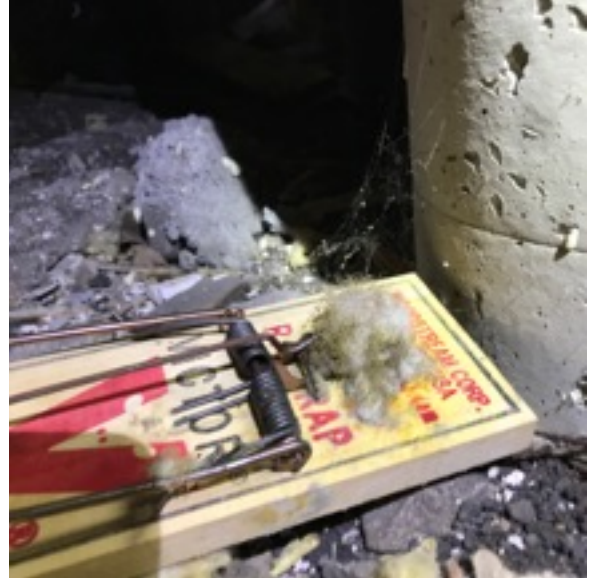
MOLD/FUNGAL GROWTH AT TRAPS

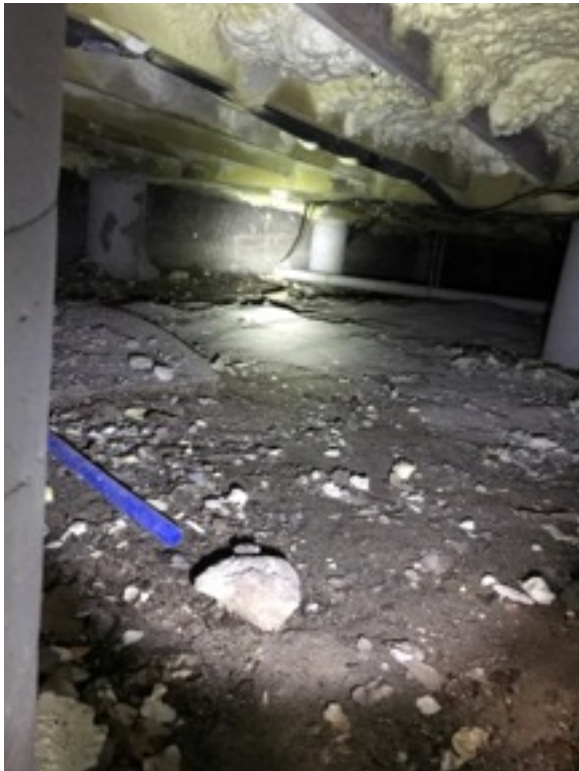
RIGHT SIDE CRAWL SPACE

At the time of inspection, suspect mold was visually discovered within the crawlspaces (mainly at wood products, and the surfaces of open cell foam insulation). Excessive moisture accumulation was discovered at various portions of the perimeter stem walls and throughout. A visual assessment and equipment readings indicated that humidity levels were well over recommended levels.

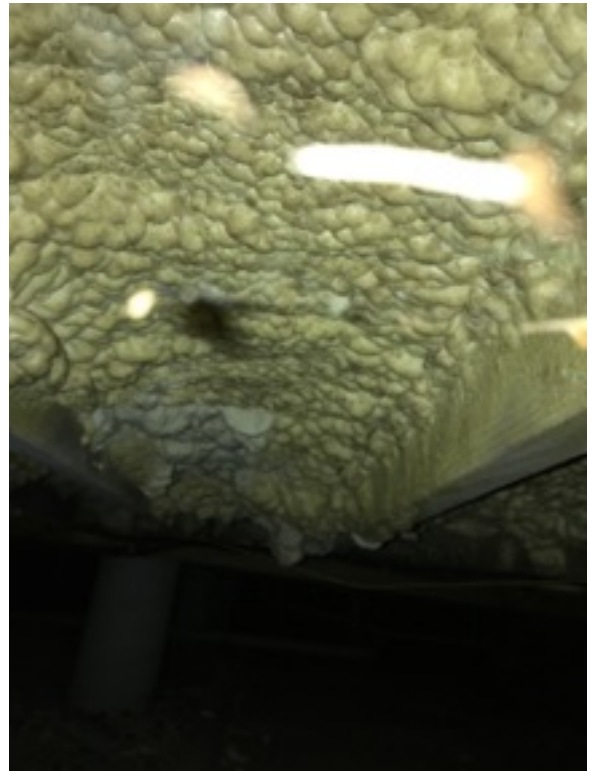
SUSPECT SURFACE MOLD

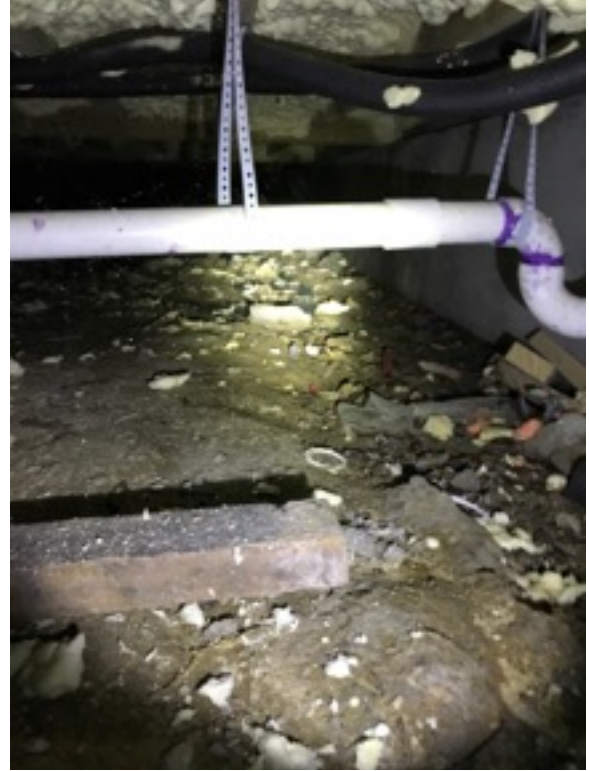
EXCESS MOISTURE AT STEM WALL
