THE AUSTIN HOME INSPECTOR

Property Address:  
Prepared For:  
Assessment Type: Limited Plumbing Camera Assessment  
Report Type: Limited Assessment Report  
Date: 08MAY2019

## **LIMITED PLUMBING CAMERA ASSESSMENT**

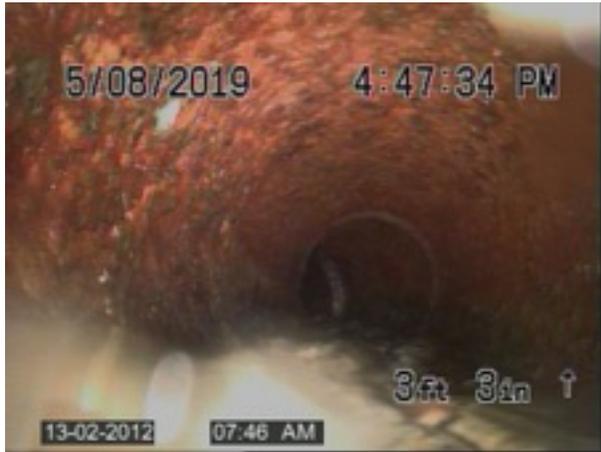
- Dated or problematic plumbing material observed (cast iron)

CAST IRON AT BURIED SEWER LINE

Indicators of sewage functionality issues and/or material damage was discovered during the limited assessment of the plumbing drainage system. Additional investigation by a plumbing specialist (to include static testing) is recommended to verify the noted concerns and determine what update/repair options are available and warranted. Conditions noted at the time of inspection which prompted this recommendation include, but are not limited to:

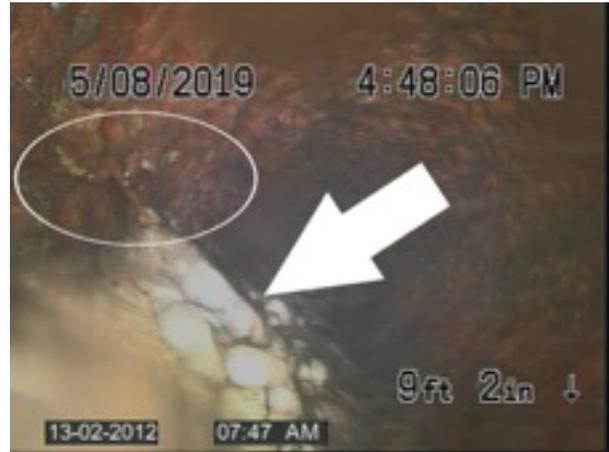
SUSPECT FRACTURE/DEBRIS AT PIPE

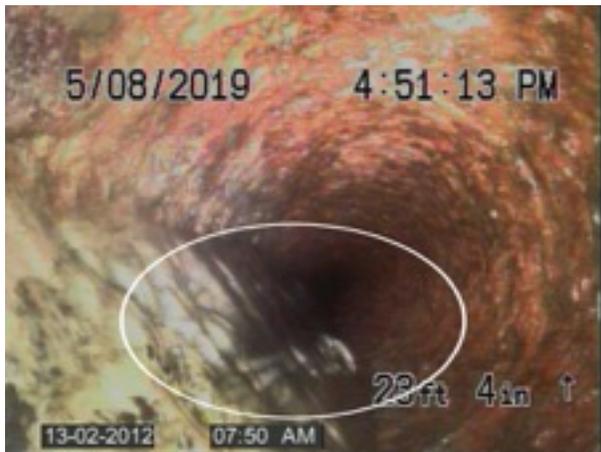
- Tree roots, soil, and/or other material discovered which indicate damage/separation of pipe material

ROOT ENTRY POINT #1

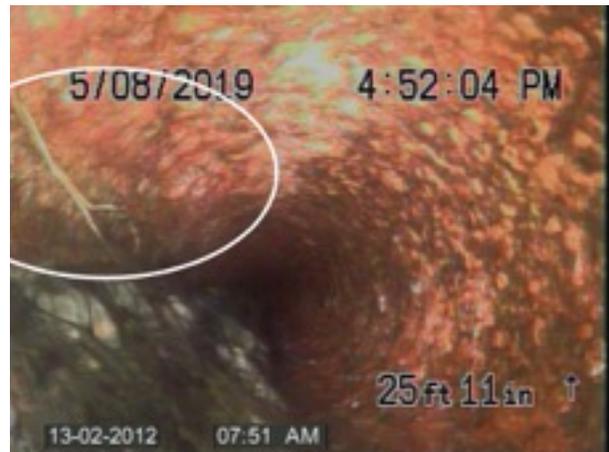
ROOT ENTRY POINT #2

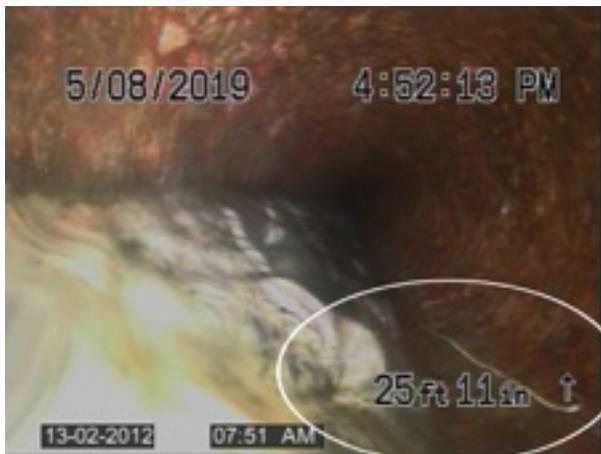
ROOT ENTRY POINT #3

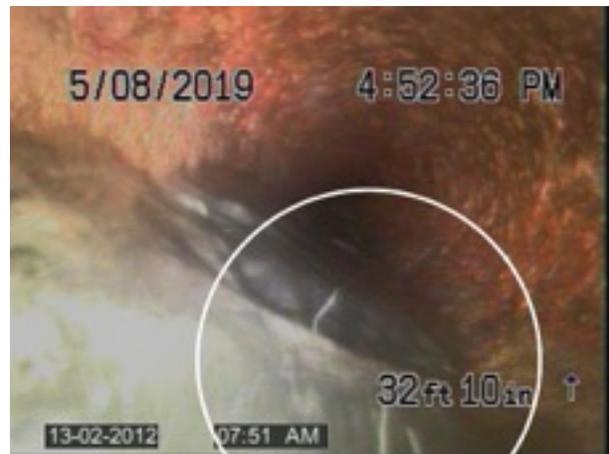
ROOT ENTRY POINT #4

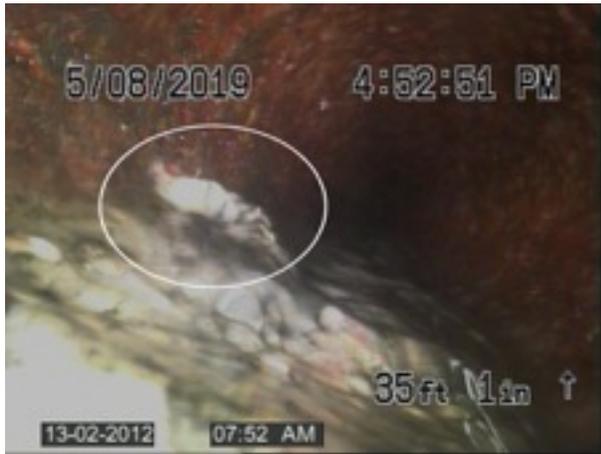
SUSPECT PIPE DAMAGE/FRACTURE

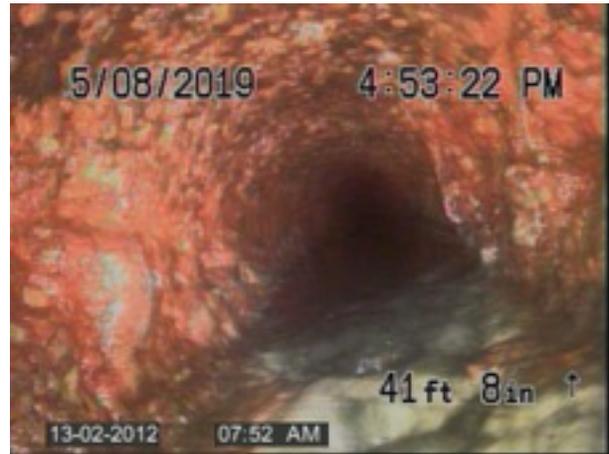
PIPE DEFORMATION/COMPRESSION

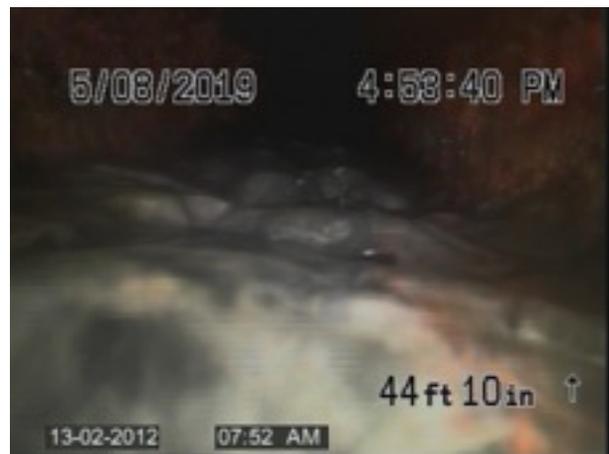
Pooling, static water most likely caused by a sewer line belly (sag or low area) was discovered during the camera assessment. A 'belly' is defined as a pipe holding water due to inadequate slope percentages at one or more sections of the lateral drain. A belly in a sewer line is often caused by geological events (soil movement/erosion), foundation settlement, inadequate soil compaction during installation, or a combination of various factors. Often, pipe bellies do not cause immediate or complete failure of the sewage system, however, bellies become problematic when/if debris collects and causes system blockage or backup. In most cases, it is not possible to determine if pipe settlement has stabilized or is ongoing. Due to this limitation, the possibility of increasing drainage flow disruption and future repair needs at seemingly inconsequential bellies/sags can not be ruled out. Professional opinion and repair/replacement recommendations to address pipe bellying will vary from one specialist to the next and is often decided on a case-by-case basis. Due to the inability of a home owner or maintenance specialist to regularly monitor portions of buried plumbing, a proactive approach to addressing sewage system issues is considered to be a best practice and proper preventative maintenance care. Based on the current degree of drainage disruption, the possibility of increasing issues, and various additional factors noted at the time of assessment, it is recommended that a plumbing specialist be contacted to

- Appx. 42-44' from clean out: Short span of belly (60-100% pipe)

42': START PIPE BELLY

44' 10": END PIPE BELLY

verify/eliminate all pipe bellies and/or any other issues affecting the gravitational drainage of sewage material. Specific issues and concerns discovered during the limited assessment process which have prompted this recommendation include, but are not limited to:

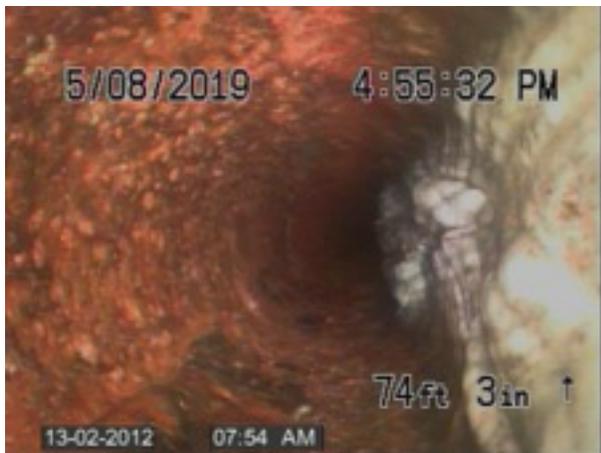
DETERIORATION, SUSPECT FRACTURE

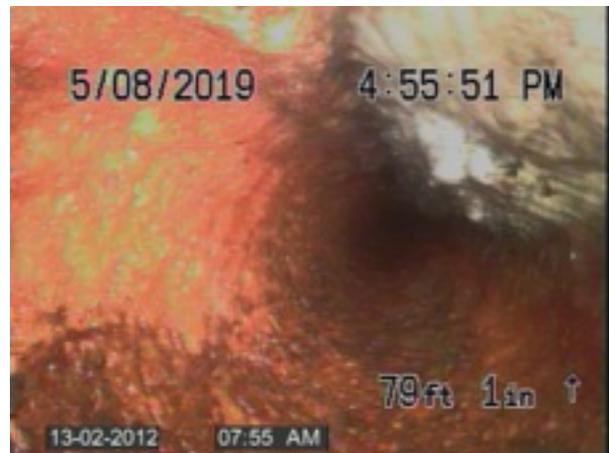
DETERIORATION, SUSPECT FRACTURE

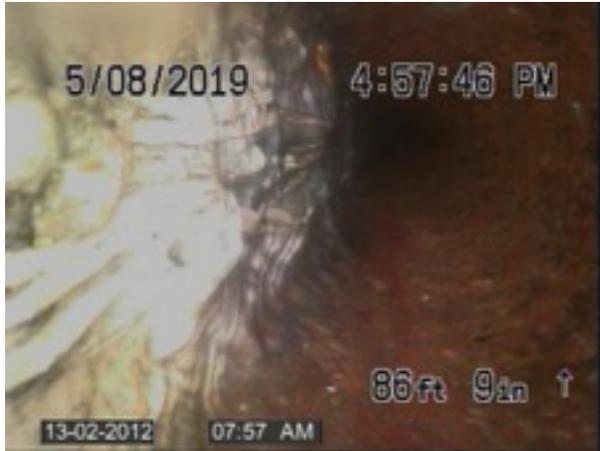
ROOT ENTRY #5

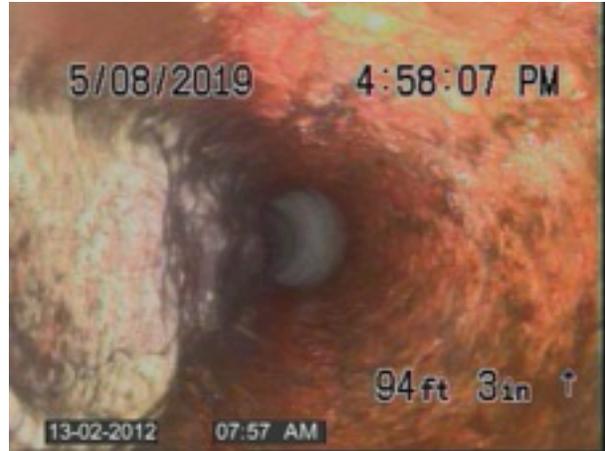
DEFORMATION NEAR CITY CONNECTION
