GREENBELT STRUCTURAL SERVICES
A DIVISION OF TAHI LLC

TAHI Inspections and Greenbelt Structural, in conjunction with Capital Building Inspections, performed a limited assessment at the above noted property. The purpose of the site visit was to assess the condition of the structure and aspects of the parcel to determine the feasibility options for future project planning.

STRUCTURAL DETAILS	
BUILDING USAGE	Commercial Building - General Retail and Office
DATE OF CONSTRUCTION	1979 (CAD)
CONSTRUCTION TYPE	Tilt Wall w/ Steel Framing (I-Beams, Columns, Engineered Truss)
FOUNDATION TYPE	Concrete Slab - Segmented or Similar Design
ROOF DESIGN	Flat Roof, TPO Covering Over Steel Roof Decking
PRIMARY WALL CLADDING	Concrete w/ Aggregate Facade
ADDITIONAL STRUCTURES	Building #9 (Cleaners) of Similar Design
STRUCTURAL ADDITIONS	Concrete Foundation w/ CMU Block Walls (Suite 6A)
DATE OF ADDITION	Exact Date Unknown, Constructed After 2003
DRAWINGS/PLANS REVIEWED	No - No Drawings/Plans Provided or Discovered

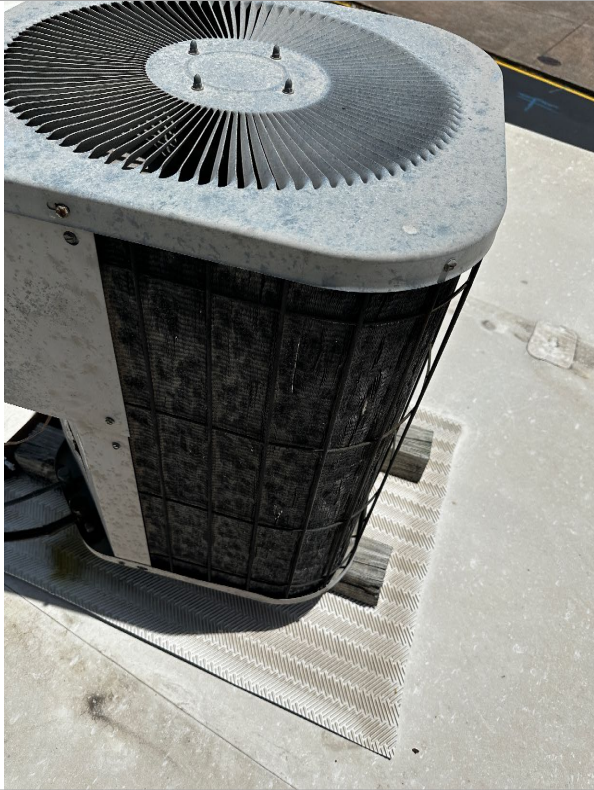
1X REMAINING HVAC: POOR CONDITION

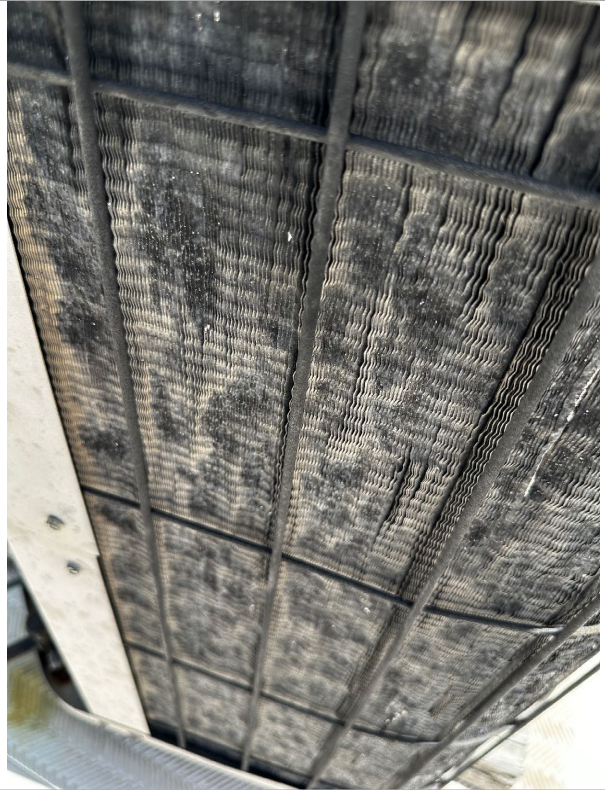
1X REMAINING HVAC: POOR CONDITION

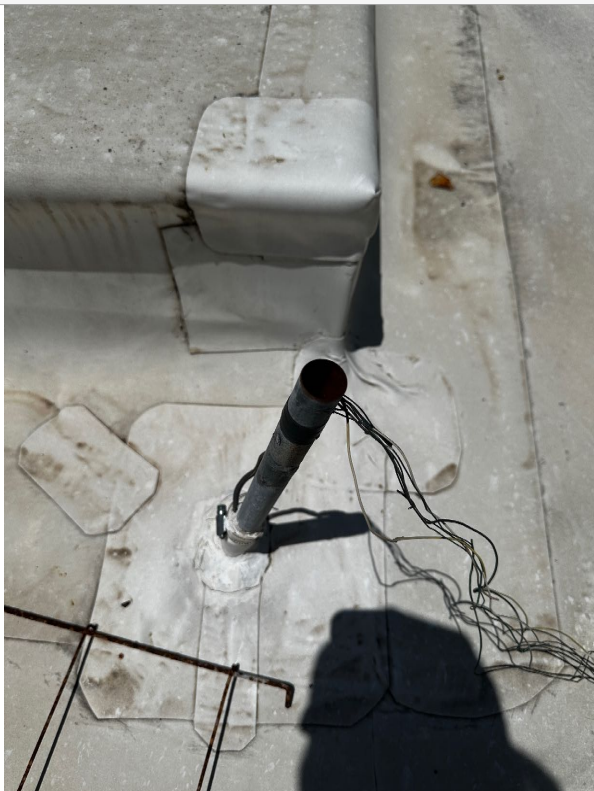
ROOF LEAK POINTS

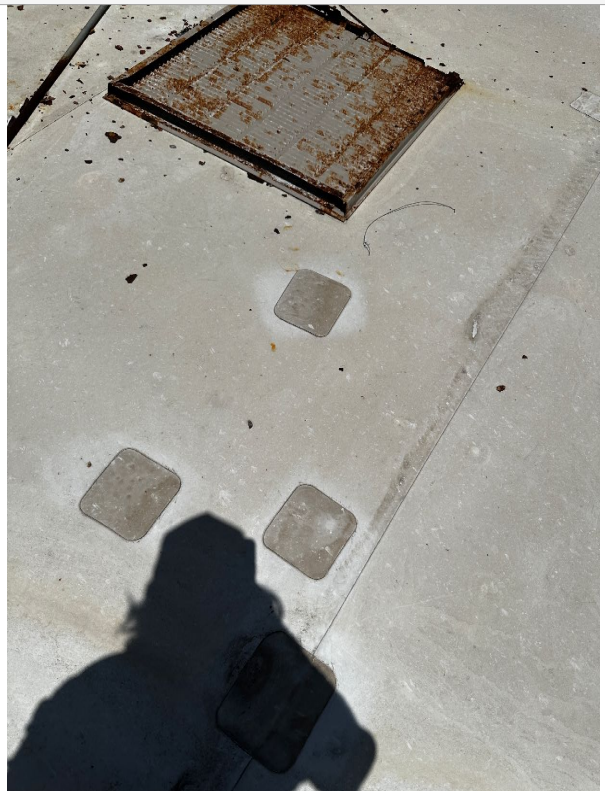
PREVIOUS ROOF PATCHES

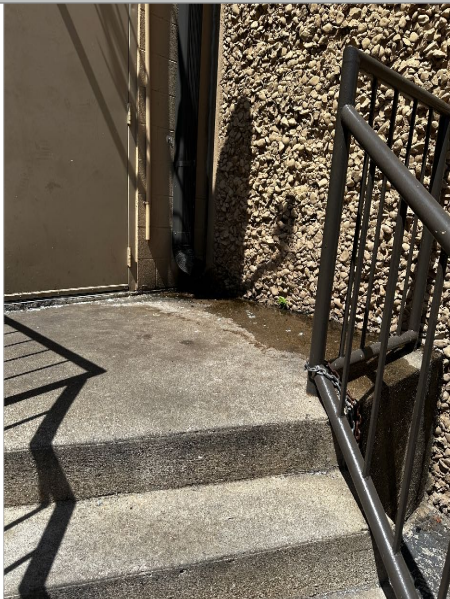
ACTION ITEM	DESCRIPTION / RECOMMENDATION	ADDITIONAL INFO
Gutters	Priority: Mid Service and updating of the roof gutter system is advised to address gutter leaks, roof run-off issues, and adjustments to downspout termination points (to better divert water away from the building).

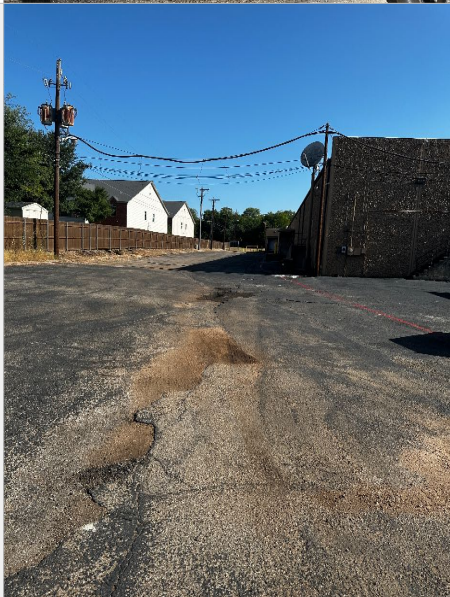
Driveway	Priority: Low-Mid Address pot holes, areas of pooling at back driveway area.

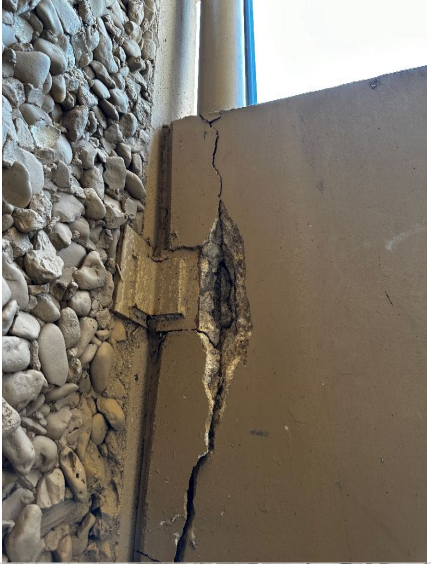
ACTION ITEM	DESCRIPTION / RECOMMENDATION	ADDITIONAL INFO
Porch Wall	<p>Priority: Mid</p> <p>Cracks/damage at the back porch area wall was noted (under the steel support column). Repairing/sealing the exposed rebar is advised. Ensure maintenance specialists monitor the area for worsening conditions.</p>

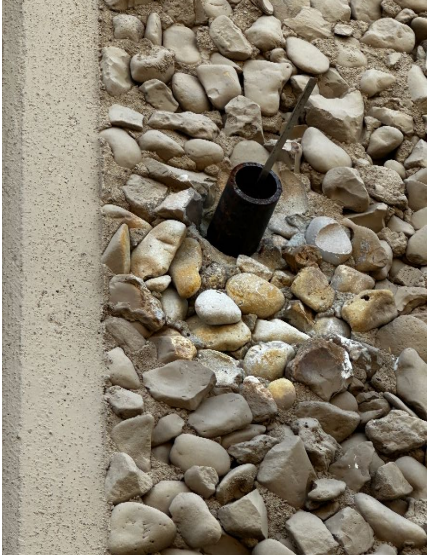
Ext. Walls	<p>Priority: Low-Mid</p> <p>Caulk/seal penetration points at exterior walls (pipes, conduit penetrations).</p>

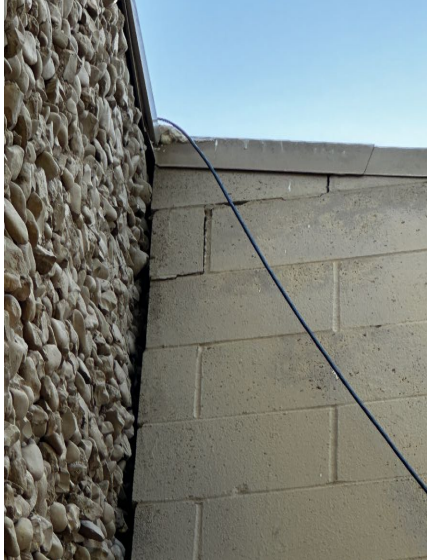
ACTION ITEM	DESCRIPTION / RECOMMENDATION	ADDITIONAL INFO
Ext. Walls	<p>Priority: Low</p> <p>Method of connecting/sealing main building/addition structure (6A) could not be determined. Further assess and seal as needed.</p>

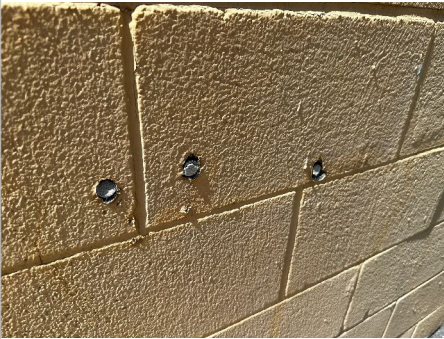
Ext. Walls	<p>Priority: Low</p> <p>Drill holes (similar to those created during insect treatments) and unusual paint stains/flaws were noted that the CMU block wall (6A building addition). No active issues discovered in these areas. Recommend requesting any additional information from the current owners.</p>

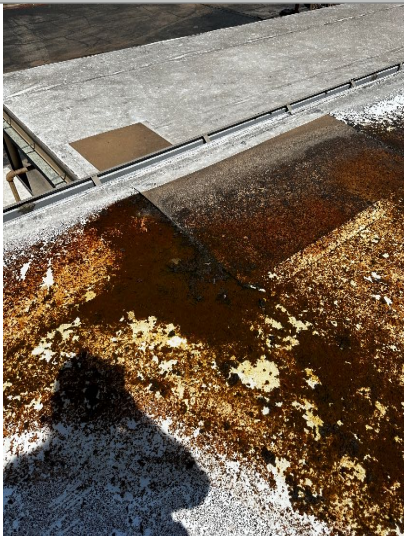
ACTION ITEM	DESCRIPTION / RECOMMENDATION	ADDITIONAL INFO
Pooling Water	<p>Priority: High</p> <p>Areas of pooling water (up to 1/2" in depth) was noted at the back side of the roof. areas of active pooling water issues correlated with signs of previous leaks observed within the building. Steps should be taken to reduce the amount of pooling water caused by HVAC issues (failed condensate drain issues). Consulting with a roofing specialist will aid in determining what additional improvement and update options are available.</p>

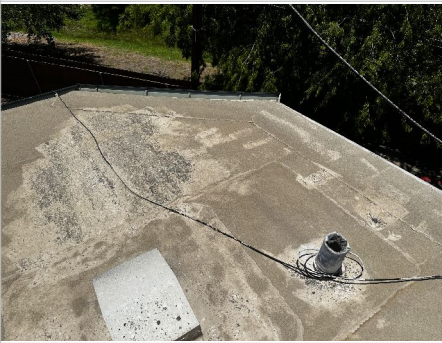
Open Conduit	<p>Priority: High</p> <p>An open/exposed conduit pipe penetrating the secondary building was noted. It is assumed that intermittent moisture entry into the building occurs at this location. Ensure the conduit is properly sealed or sealed. Address any leak damage as needed.</p>	
Addition Roof	<p>Priority: Mid</p> <p>Previous repairs and installation of a roll-on sealant has occurred at the roof over the addition (6A). Current servicing and planning for replacement needs within 5 years is advised.</p>

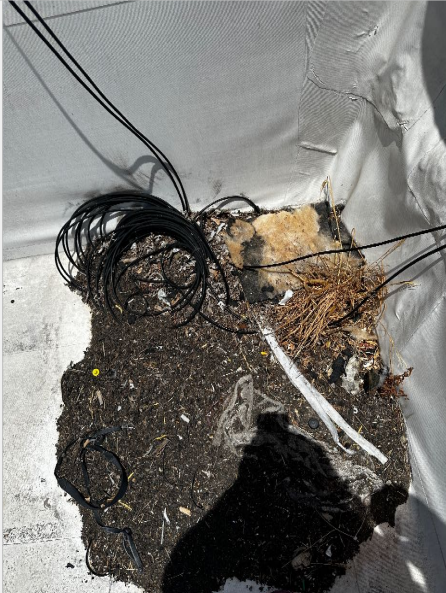
ACTION ITEM	DESCRIPTION / RECOMMENDATION	ADDITIONAL INFO
Walkway Pads	Priority: Low The addition of service walkway pads (providing routes to rooftop mechanical equipment) would improve long term protection of the roof covering.	
Roof Debris	Priority: Low Removal of roof level debris should take place in appx. 6-12 month intervals.

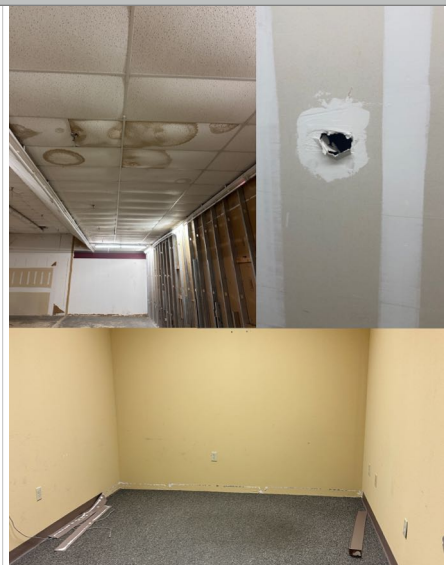
ACTION ITEM	DESCRIPTION / RECOMMENDATION	ADDITIONAL INFO
General	Priority: Low-Mid The overall condition of the accessible walls and features (cabinets, baseboards, trim work, etc.) appeared to be fair/normal when considering the age and type of the inspected structure. Regular maintenance needs, areas of architectural (cosmetic) damage, and/or various flaws were noted during the general inspection process. Isolated flaws should be professionally addressed as needed and/or in conjunction with ongoing maintenance schedules (links to various maintenance calendars provided above). Examples and site specific details noted during the property inspection may be listed below or included in the photo gallery.

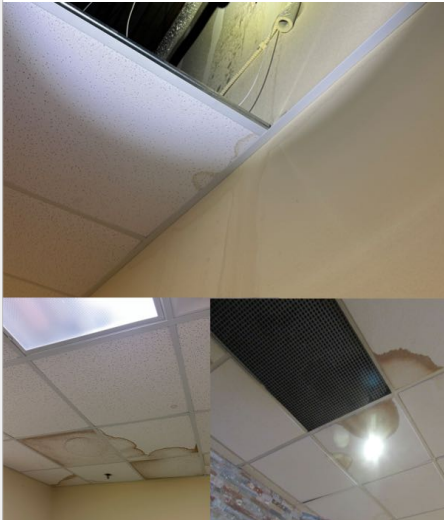
ACTION ITEM	DESCRIPTION / RECOMMENDATION	ADDITIONAL INFO
General - Water Stains	<p>Priority: Mid</p> <p>Isolated areas of water stained/damaged ceiling tiles and finishes were observed at various locations. Likely causes/sources of water damage included previous roof leaks, mechanical equipment leaks, and plumbing leaks. During our site assessment, no substantial, active leak issues were identified, however, the possibility of ongoing intermittent leak issues could not be ruled out. We recommend that all areas of visible, previous leak damage be further investigated and tenants and/or building owners be interviewed to determine if further information/repair documents are available. Ensure all previous or potential leak sources are eliminated. If the source of the leak damage is unknown, the area should be monitored by maintenance specialists. Repair and replacement of any leak damaged material within the building should take place as needed. Ensure all issues/concerns at the roof level (roof covering and mechanical) are professionally addressed as needed.</p>

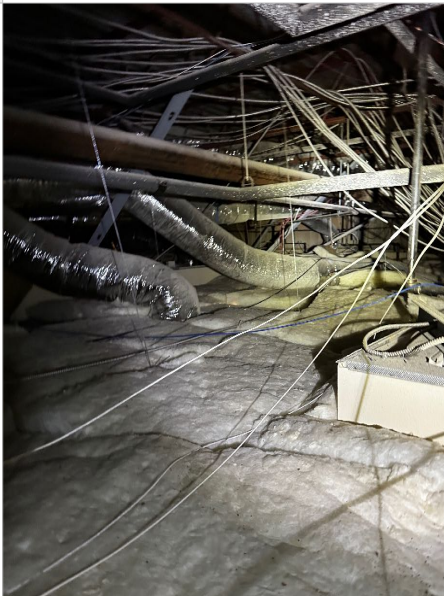
Fire Walls and Protection	<p>Priority: Mid</p> <p>Portions of the building has been provided firewalls/partitions (walls extending up to roof to separate individual suites/mechanical locations/etc.). Based on our limited observations over the drop ceilings, additional firewall protection may be required to meet current standards. Determination of specific firewall updating was not conducted during our site visit. In general, we advise that the building meet applicable firewall and general protection set forth in Chapter 7,9 of IBC (or other similar, applicable references).</p>

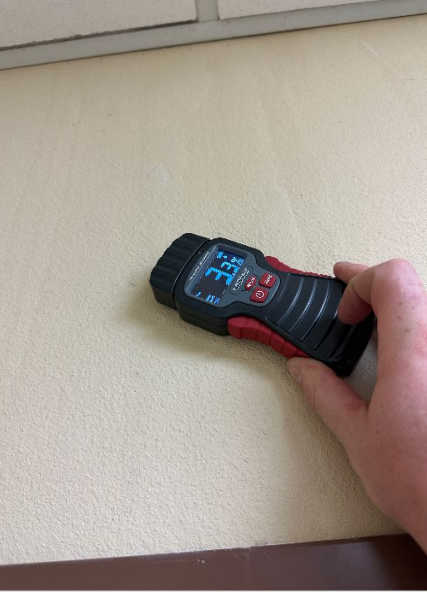
ACTION ITEM	DESCRIPTION / RECOMMENDATION	ADDITIONAL INFO
Suite 8A	<p>Priority: Mid</p> <p>Multiple areas of water damage caused by previous roof and mechanical leaks was discovered. As a result, drywall, insulation, and ceiling tiles were visibly damaged. At time time of inspection, no active leaks in these areas were discovered, however, the possibility of remaining, intermittent leak issues can not be ruled out. We recommend requesting any available repair information. Removal/replacement of moisture damaged finishes or soft surface material is recommended.</p>

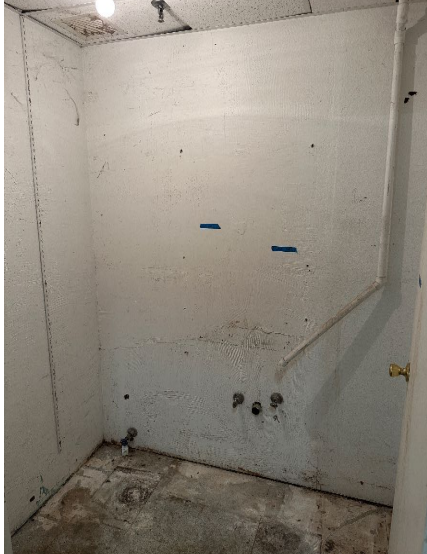
Suite 7	<p>Priority: Low</p> <p>Common drywall damage, portions of building partially demoed (finishes removed). Update as needed.</p>	
Suite 7	<p>Priority: Mid</p> <p>Areas of older floor tiles and exposed tile adhesive was noted at the back portion of the vacant store (former thrift shop). Based on the age of the building and observed material, it is possible that asbestos based products are present. Inspection and testing for asbestos is outside the scope of work our firm conducted. For further information, an asbestos specialist should be contacted.</p>

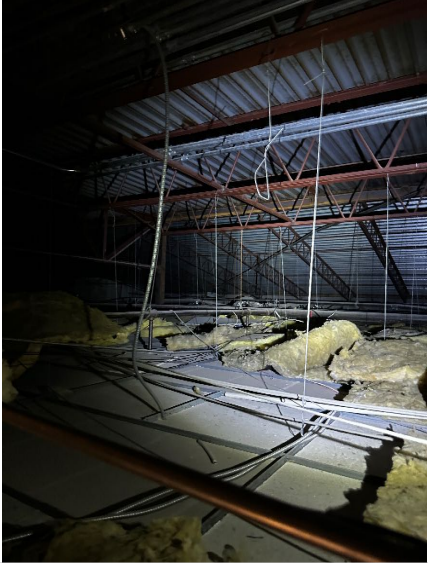
ACTION ITEM	DESCRIPTION / RECOMMENDATION	ADDITIONAL INFO
Insulation	<p>Priority: Mid</p> <p>Observations of batt insulation indicate various areas of low/missing insulation is present throughout. Updating the insulation (over drop ceiling) is recommended to improve overall energy efficiency of the building.</p>

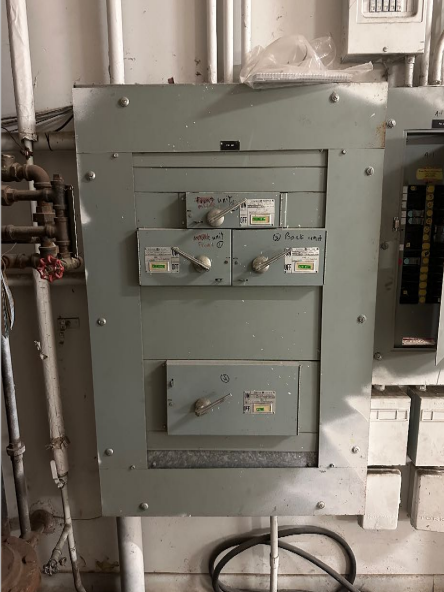
ACTION ITEM	DESCRIPTION / RECOMMENDATION	ADDITIONAL INFO
General	<p>Priority: Mid</p> <p>Information available during the assessment of the electrical system indicates that both original and updated equipment and features are present. Overall, the original portions of the system appear to generally meet standards observed at the time of installation. Although the electrical system is functional, safety and component updates are recommended to improve the overall protection of the building and occupants. In most cases, updating system features to today's standards is not be required unless renovations take place. Updates would be considered a safety and functionality improvement. Ensure all updates are conducted by a licensed professional.</p>

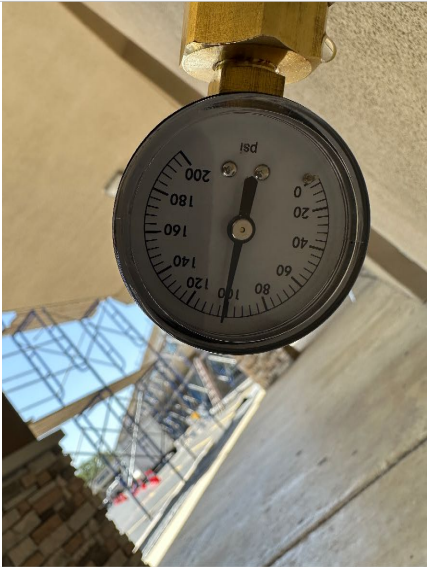
ACTION ITEM	DESCRIPTION / RECOMMENDATION	ADDITIONAL INFO
Floor Drains	<p>Priority: High</p> <p>Excess debris build up and damaged covers were noted at various floor drains. Recommend jetting of drains, particularly at restaurants and maintenance hall areas. NOTE: Observed lateral and branch drain material was PVC. Floor drains appeared to be cast iron. Cast iron piping has a higher likelihood of failure as it ages. Due to the high amount of debris within the floor drains, conducting a pipe scoping camera assessment in these areas was not possible.</p>	
Supply Pressure	<p>Priority: High</p> <p>Recorded incoming supply pressure was measured at 100PSI. Max pressure is recommended to be no more than 80PSI. Recommend addition of pressure regulating valve/s as needed.</p>

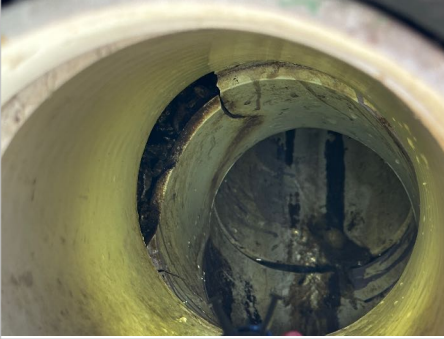
ACTION ITEM	DESCRIPTION / RECOMMENDATION	ADDITIONAL INFO
Riser Pipe	<p>Priority: Mid</p> <p>A cracked/damaged riser pipe was discovered during a pipe scoping camera assessment (back street riser near adjoining government building). If the cracking/damage worsens over time, replacement of the riser pipe will be required.</p>

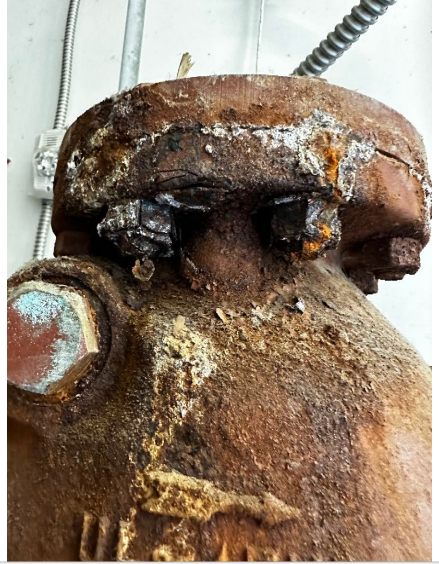
Clean Out Access	<p>Discovered clean out access points (to wastewater piping) was limited to areas at the back of the building. No clean out access points were discovered at side or front portions of the property. Current installation standards call for lateral wastewater pipe every 100' linear. Due to the presence of impervious coverage and other limitations, retroactive installation is not recommended at this time. If future repair need require excavation of sub-surface piping, additional clean out risers should be installed at that time.</p>	
Fire Sprinkler System	<p>Priority: Mid</p> <p>Pipe and fastener corrosion was observed at portions of the steel plumbing primarily serving the fire sprinkler system. Contacting a fire system service specialist is advised to further investigate the system and determine what repair/update options are available and warranted.</p>

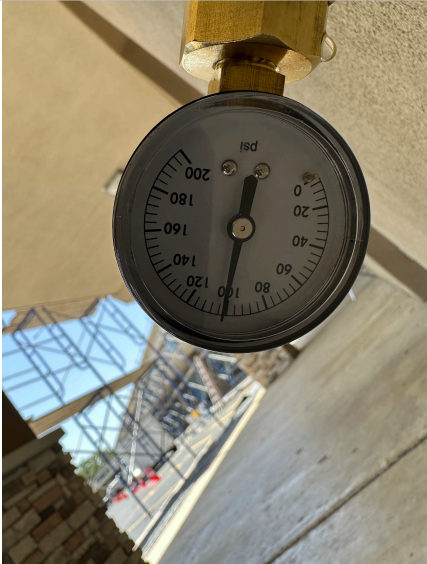
ACTION ITEM	DESCRIPTION / RECOMMENDATION	ADDITIONAL INFO
Floor Drains	Priority: High Excess debris build up and damaged covers were noted at various floor drains. Recommend jetting of drains, particularly at restaurants and maintenance hall areas. NOTE: Observed lateral and branch drain material was PVC. Floor drains appeared to be cast iron. Cast iron piping has a higher likelihood of failure as it ages. Due to the high amount of debris within the floor drains, conducting a pipe scoping camera assessment in these areas was not possible.	
Supply Pressure	Priority: High Recorded incoming supply pressure was measured at 100PSI. Max pressure is recommended to be no more than 80PSI. Recommend addition of pressure regulating valve/s as needed.

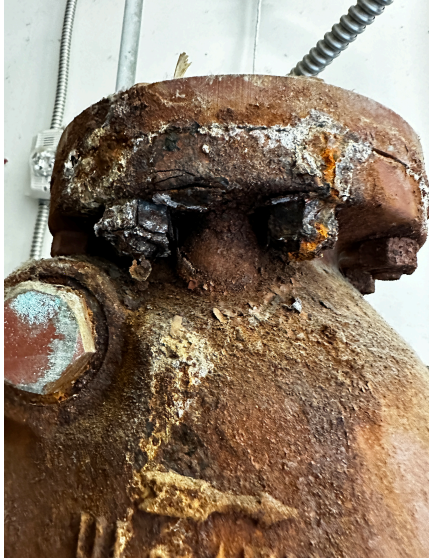
Fire Sprinkler System	<p>Priority: Mid</p> <p>Pipe and fastener corrosion was observed at portions of the steel plumbing primarily serving the fire sprinkler system. Contacting a fire system service specialist is advised to further investigate the system and determine what repair/update options are available and warranted.</p>

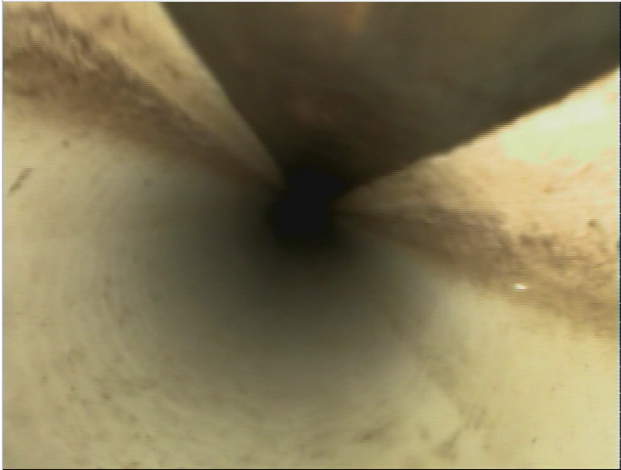
MAIN LATERAL - NORMAL CONDITIONS

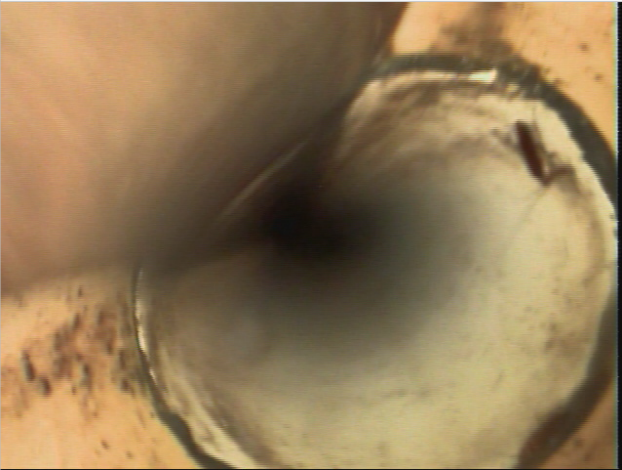
MAIN LATERAL - NORMAL CONDITIONS

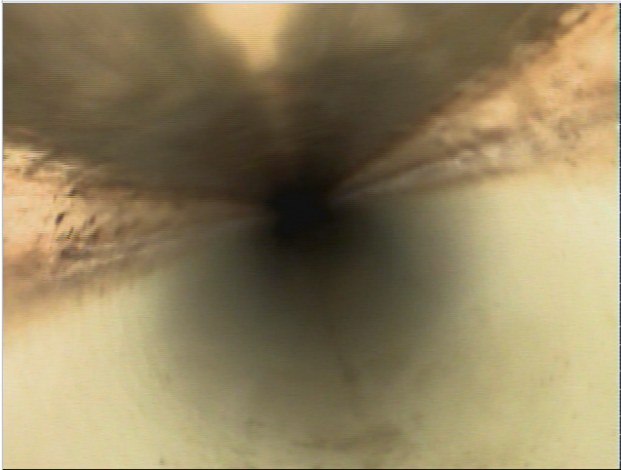
MAIN LATERAL - NORMAL CONDITIONS

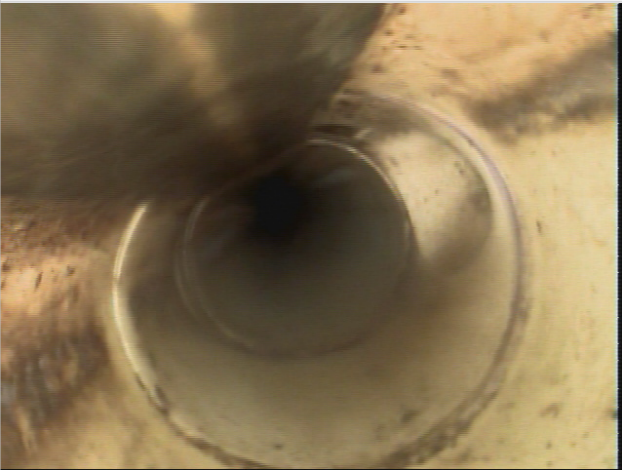
MAIN/BRANCH CONNECTIONS - NORMAL

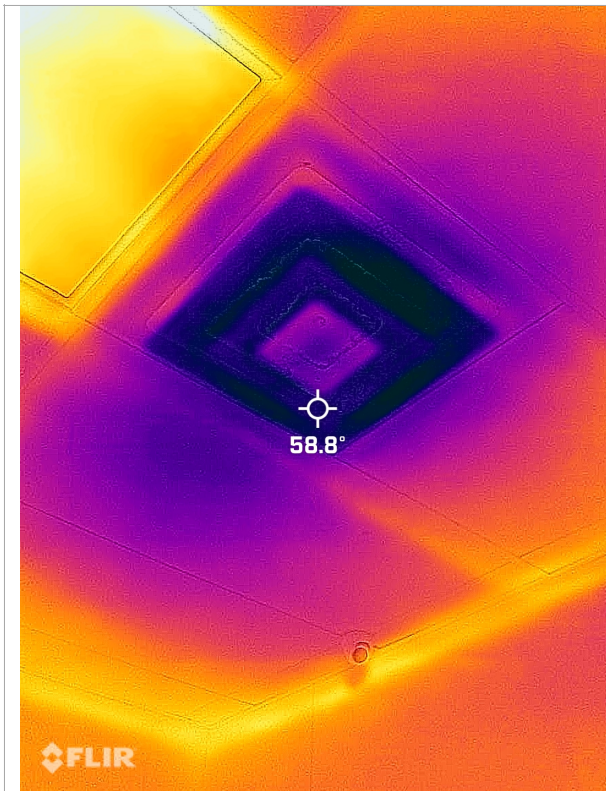
MOST HVAC UNITS FUNCTIONAL

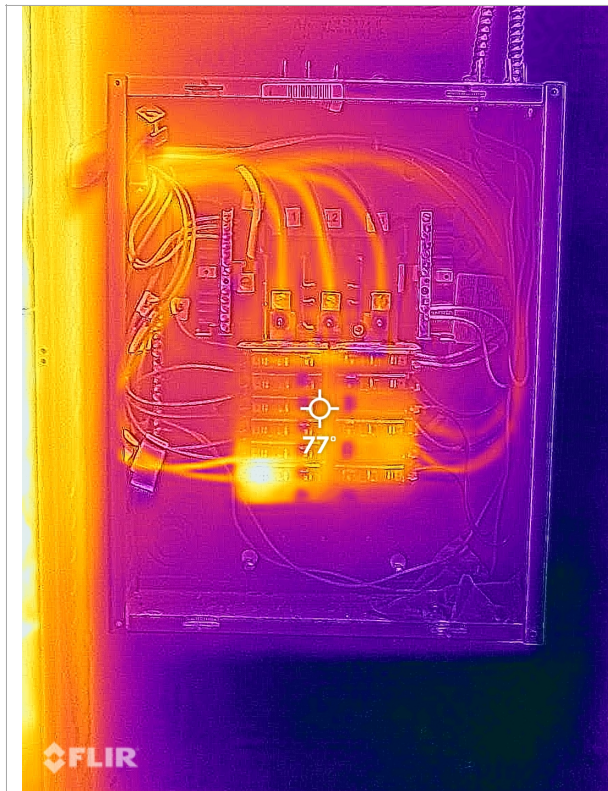
ELECTRICAL - NORMAL CONDITIONS

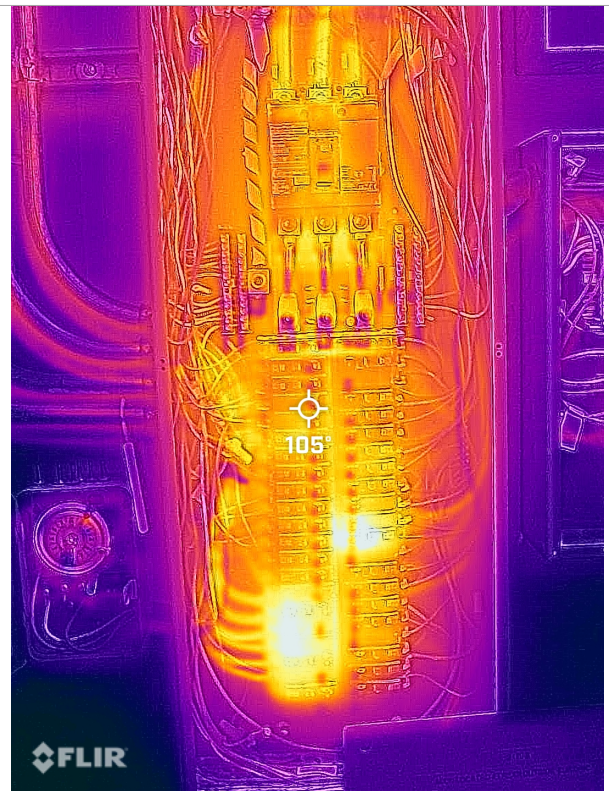
ELECTRICAL - NORMAL CONDITIONS

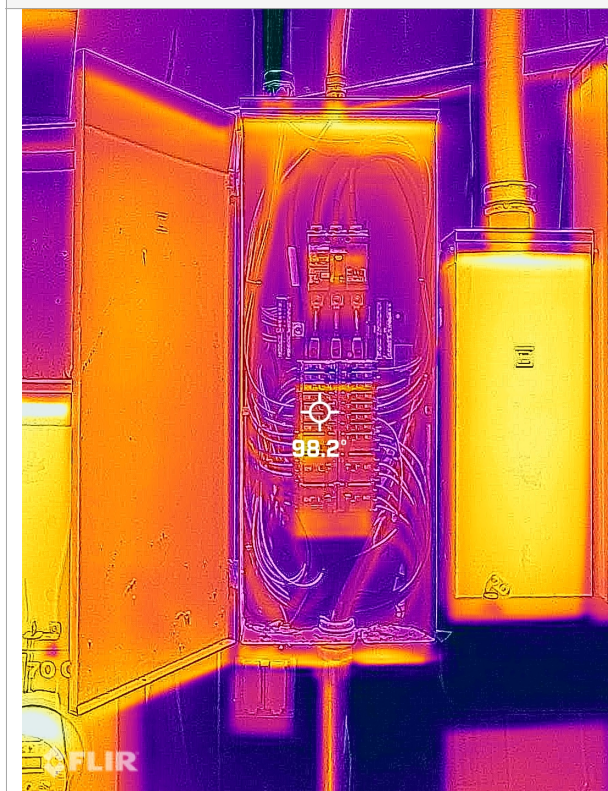
ELECTRICAL - NORMAL CONDITIONS

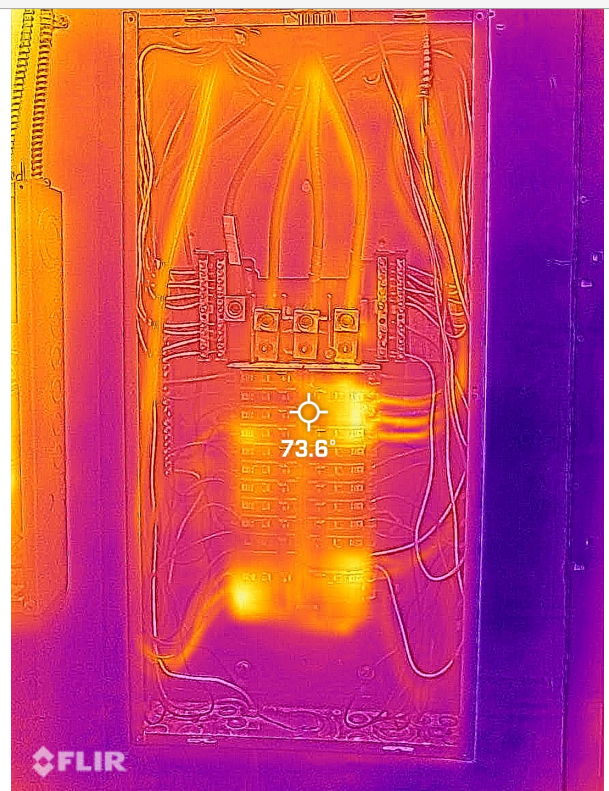
ELECTRICAL - NORMAL CONDITIONS

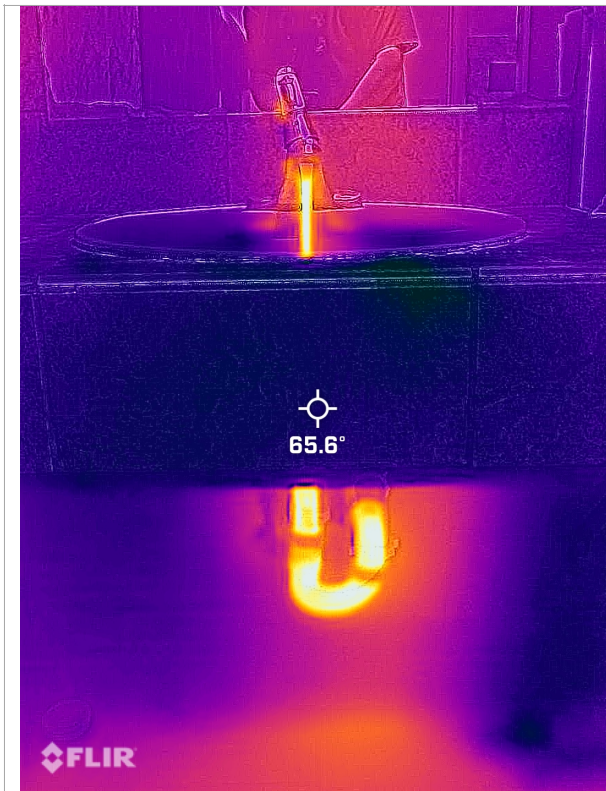
PLUMBING - NORMAL CONDITIONS

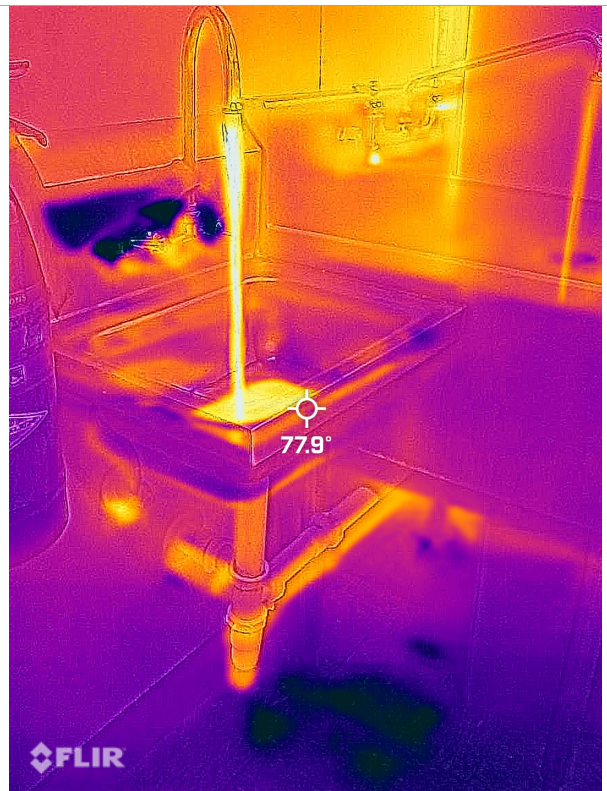
PLUMBING - NORMAL CONDITIONS

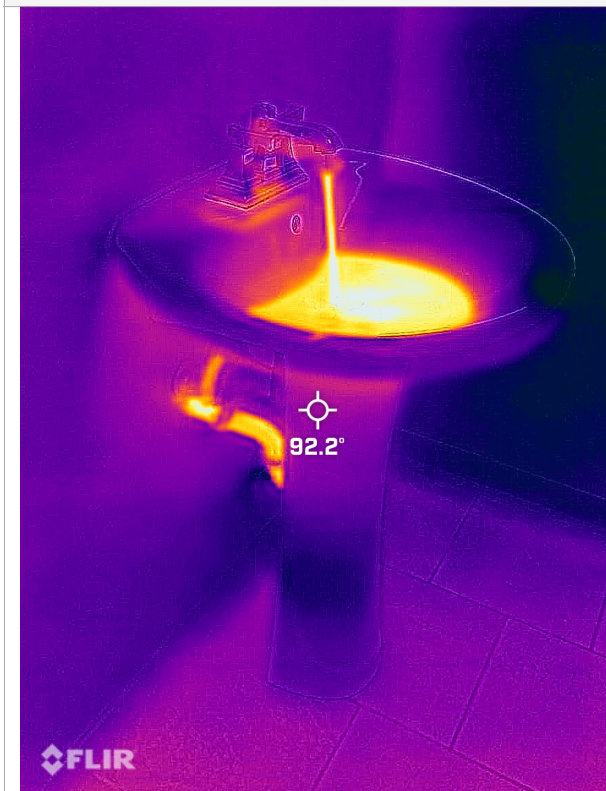
PLUMBING - NORMAL CONDITIONS

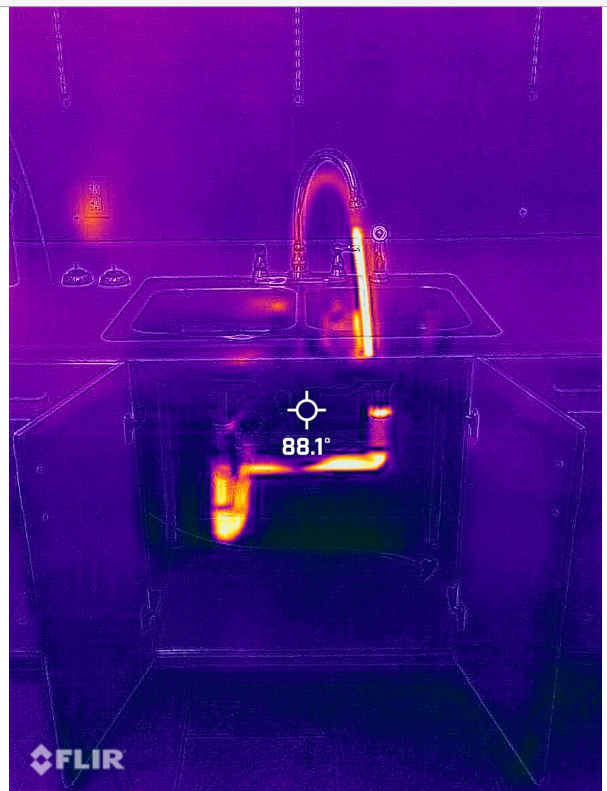
PLUMBING - NORMAL CONDITIONS
