GREENBELT STRUCTURAL SERVICES
A DIVISION OF TAHI LLC

TAHI Services and Greenbelt Structural performed a limited assessment at the above noted property. The purpose of the site visit was to conduct a structural investigation to determine current condition and provide additional recommendations with regards to foundation repairs.

PROJECT REVIEWER

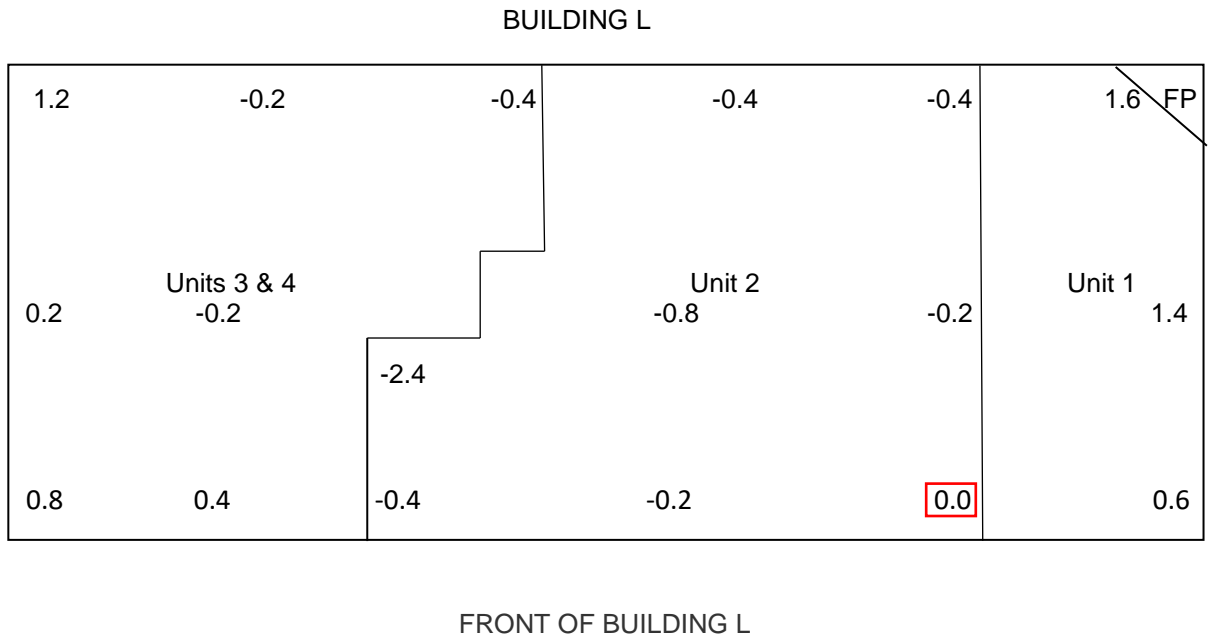
FOUNDATION LEVELNESS SURVEYS

The following foundation levelness survey is measured to the nearest 1/10th inch. All readings are the variances from the 0.0 in the read boxes. The surveys showed the overall variances in the levelness of the foundations to be larger than normal parameters for a foundation of this size. Larger than normal variances were also found in relatively short distances between some of the check points.

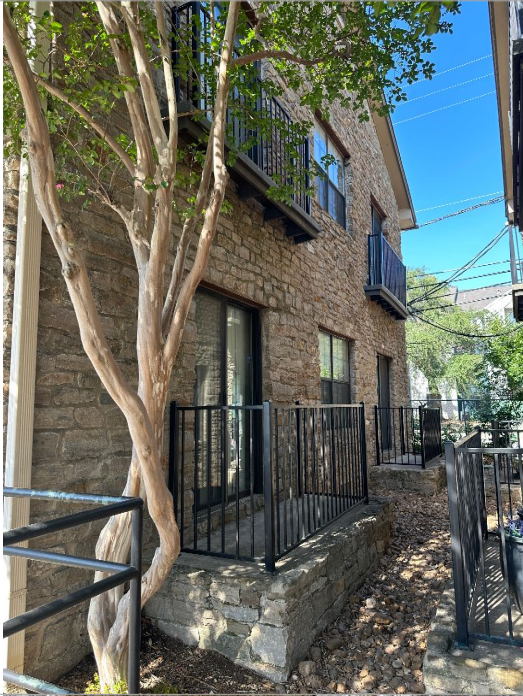
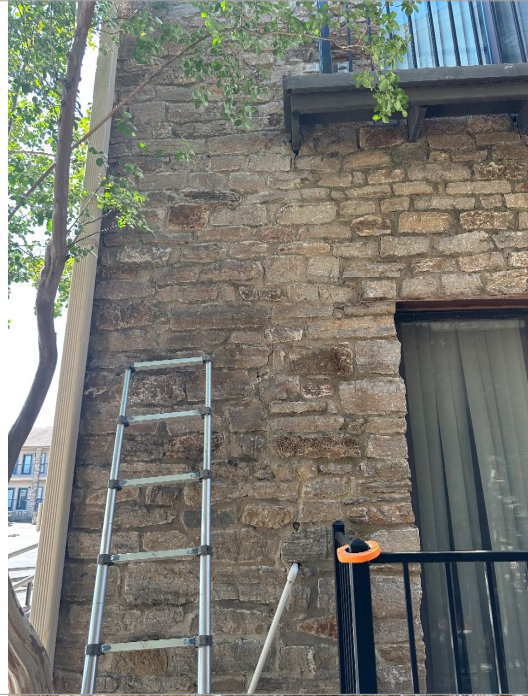
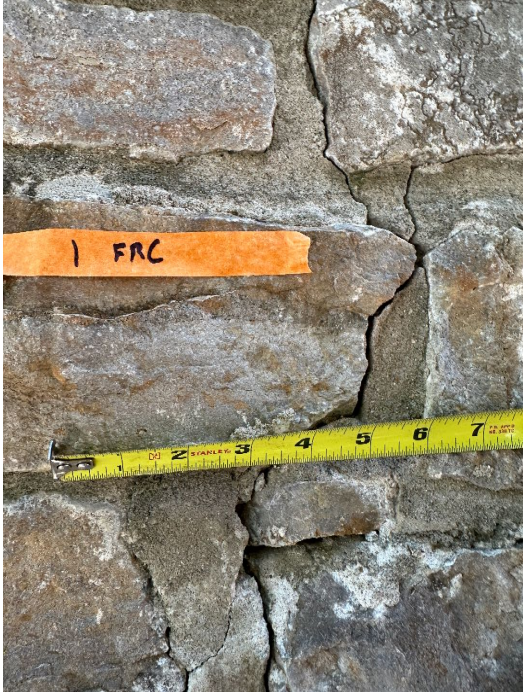
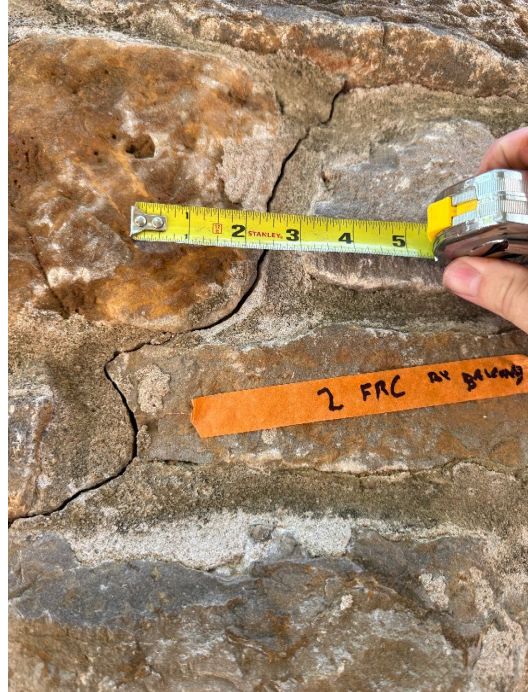
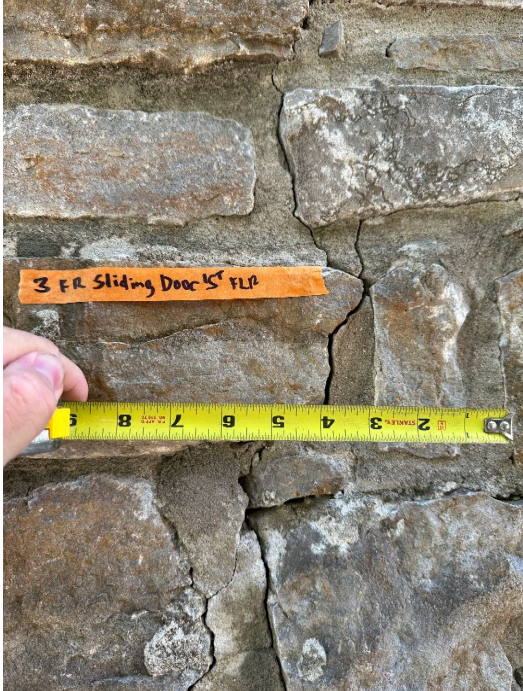
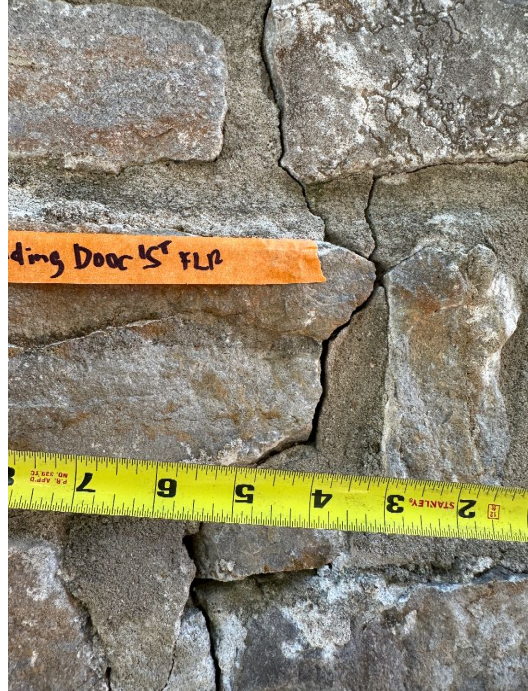
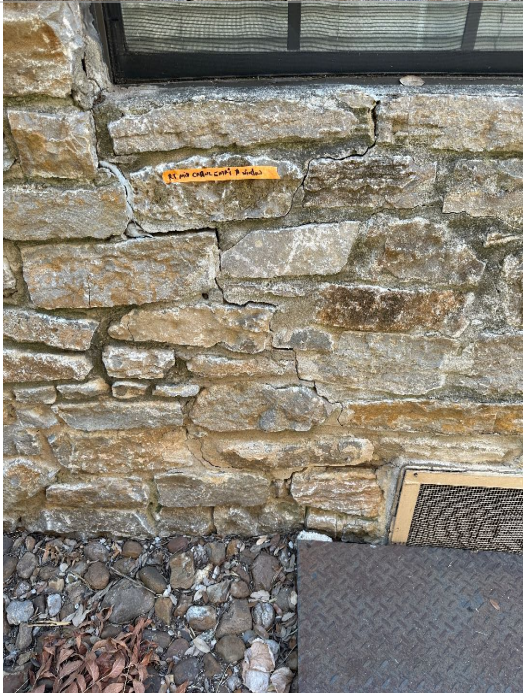
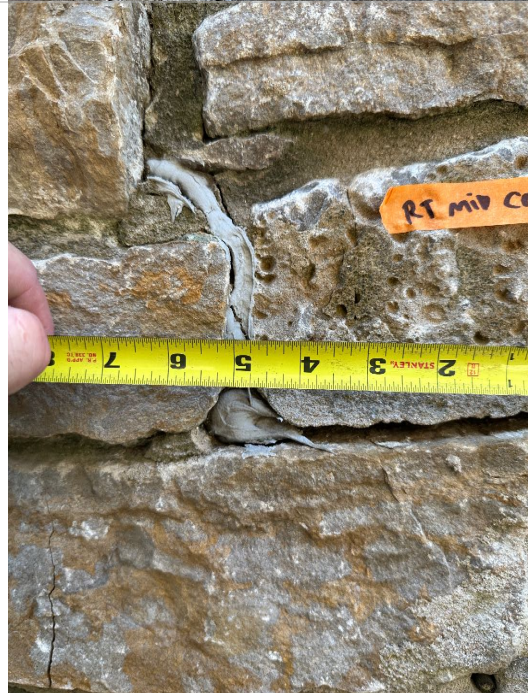
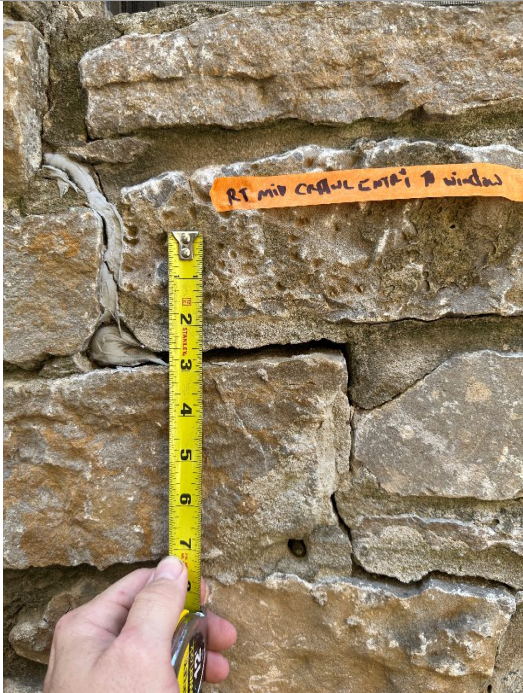
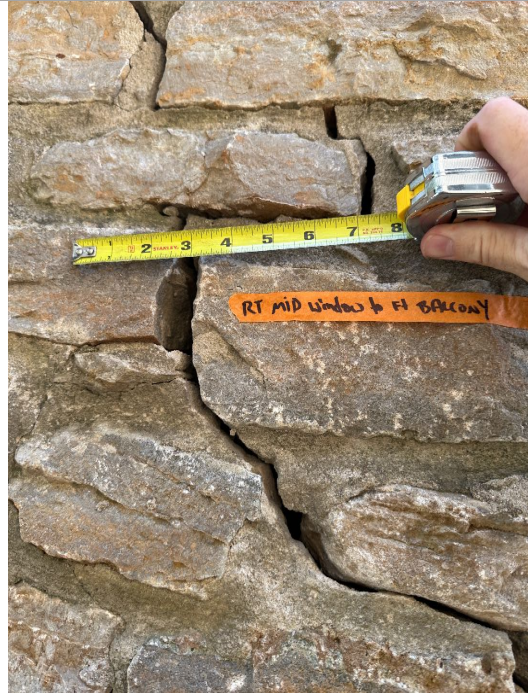
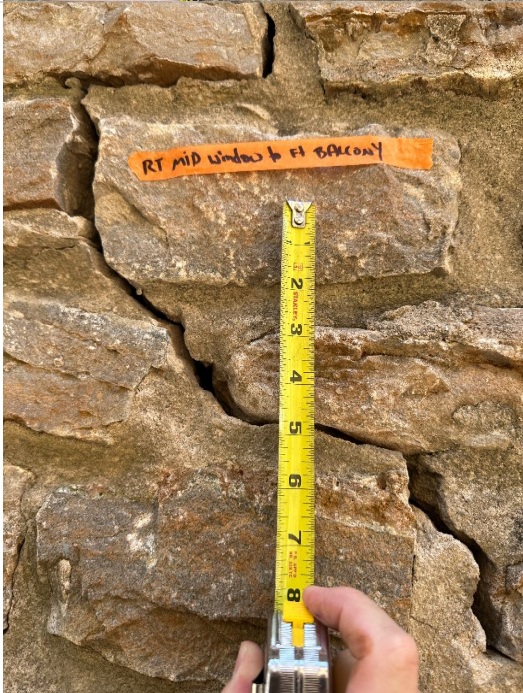
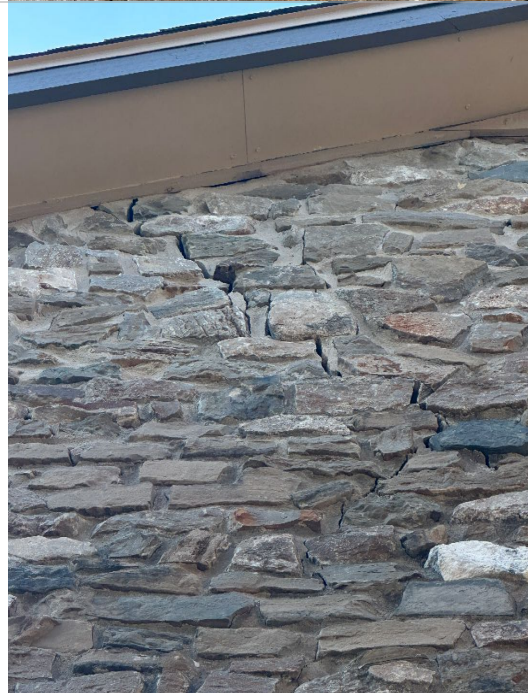
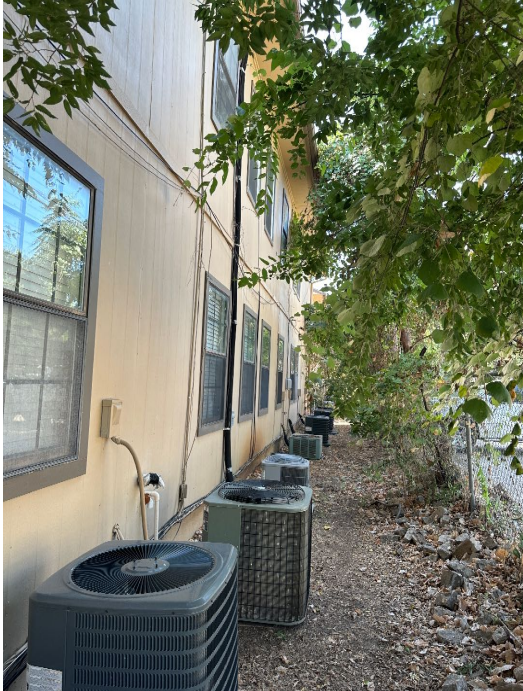
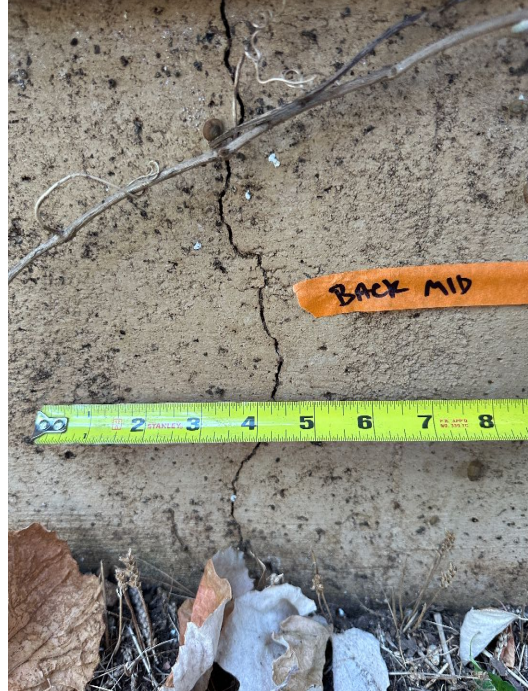
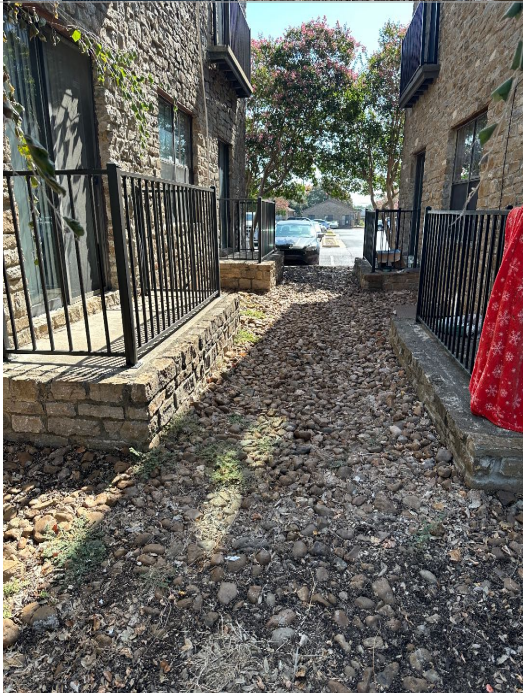
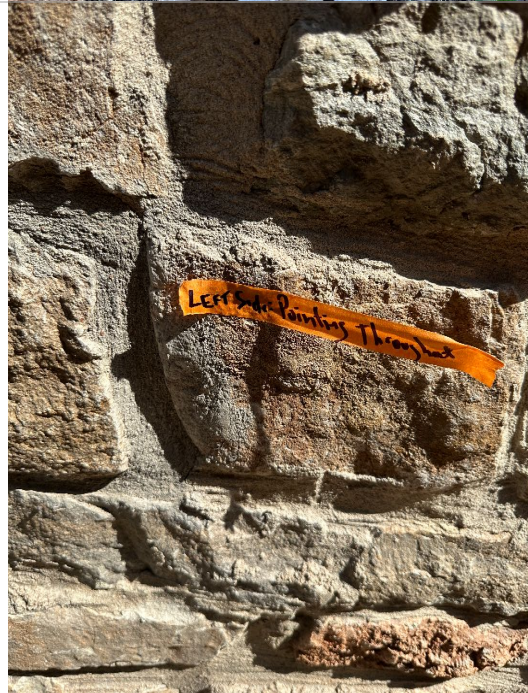
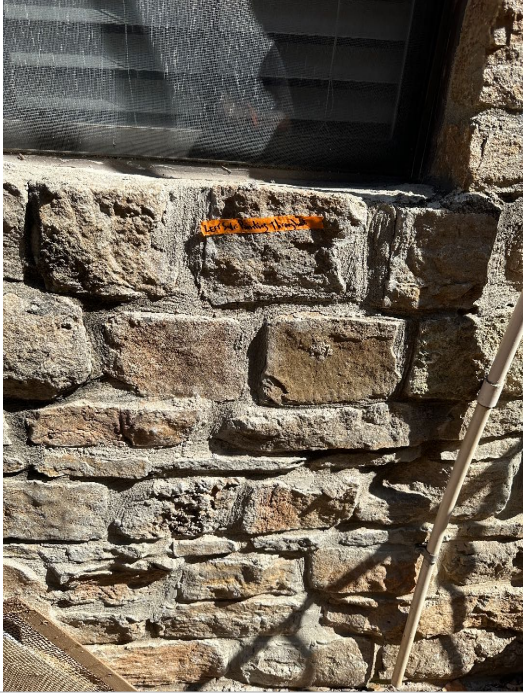
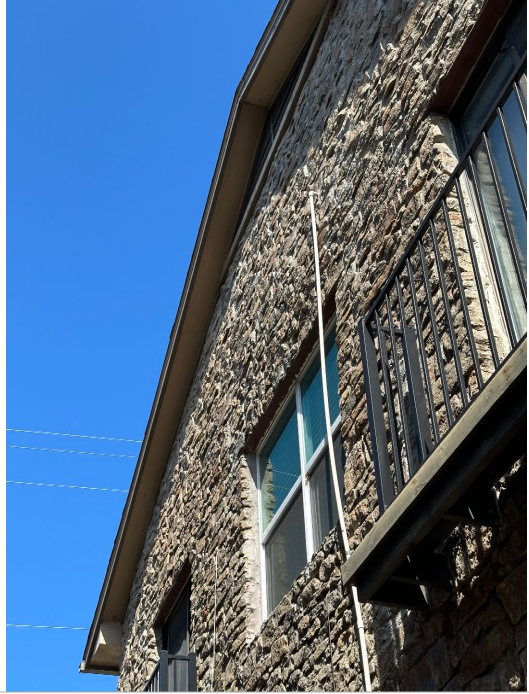
EXTERIOR WALLS

Exterior observations of the stone facade revealed stress cracking at various locations. The highest concentration of visible cracking was located at the right/north side of the structure (see photo details below). Most cracks took a diagonal or stair-step pattern running from various spans at the wall (2x windows and 4x sliding glass doors). Separation of cracks observed at the facade ranged from minor (less than 1/8") to substantial (exceeding 1/4" and up to 1/2").

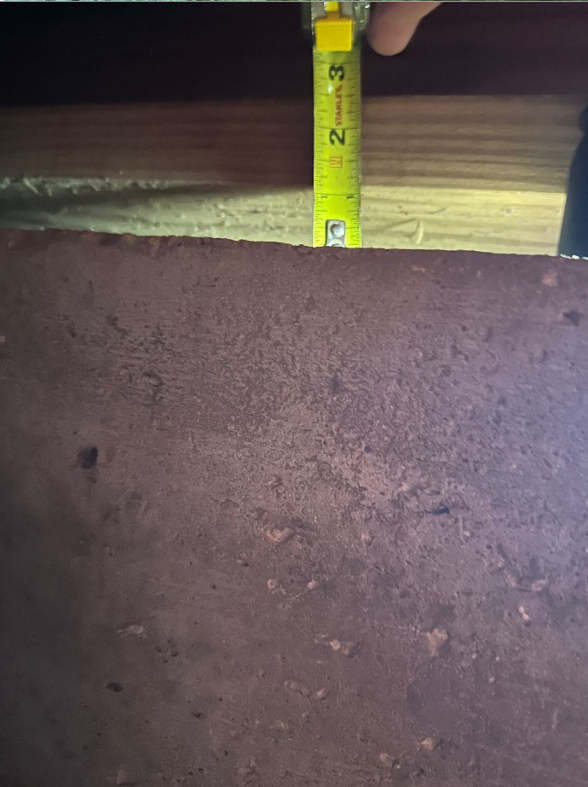
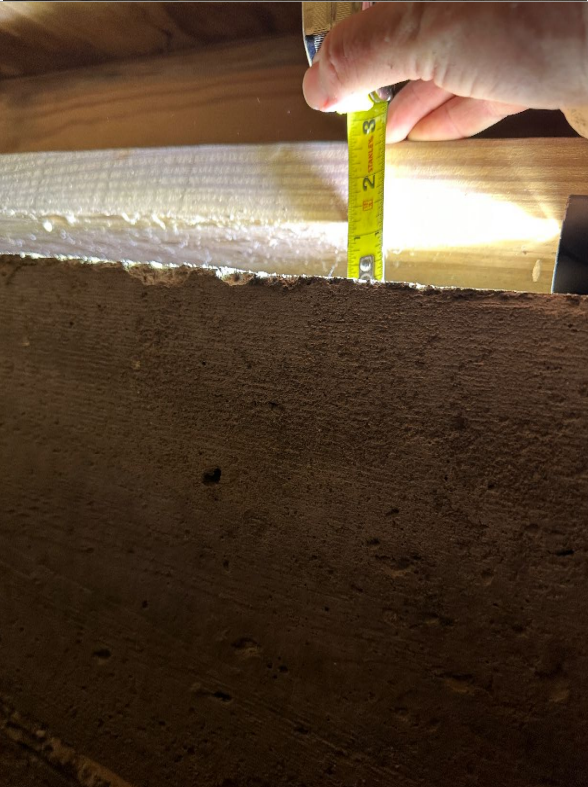
SILL PLATE UPLIFT

Upon entry at the right side of the building, we observed substantial lifting of the sill plate. The inside edge of the sill was lifted by up to 1 1/2". From our vantage, we did not observe any anchors or other method of connection between the sill and perimeter beam wall. No steel straps or other common connectors were present at interior piers and beams. Evidence of previous shimming and repair/improvements at interior piers and beams was noted. The installation of an additional pier/beam system was present at the mid/center portion of the crawlspace.

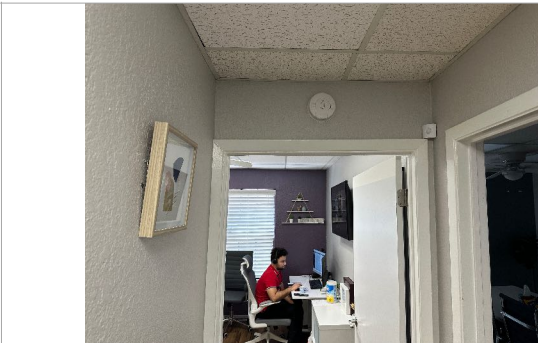
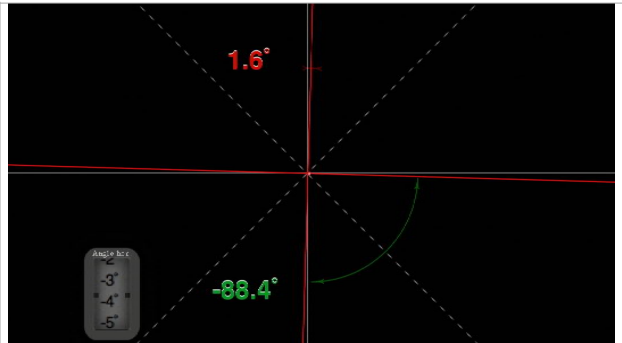
UNPLUMB DOOR FRAMING

Interior observations were limited to the left most 1st floor unit (all other units locked - no answer when we knocked). Stress cracking at interior drywall was minimal, however, visibly uneven/unplumb floors and door framing was observed at various locations. Door functionality issues due to unplumb framing was verified at several locations.
