GREENBELT STRUCTURAL SERVICES

On October 23, 2022, a site visit to the above-referenced property was made in order to assess and investigate the property and/or associated systems. A list of noted concerns, recommendations, and/or issues has been provided in the report below. This report is not a TREC associated document and should not be used or perceived as such. Based on the scope of work, a full TREC report and/or additional information may be delivered in addition to this document.

BUILDER PUNCH-LIST REPORT

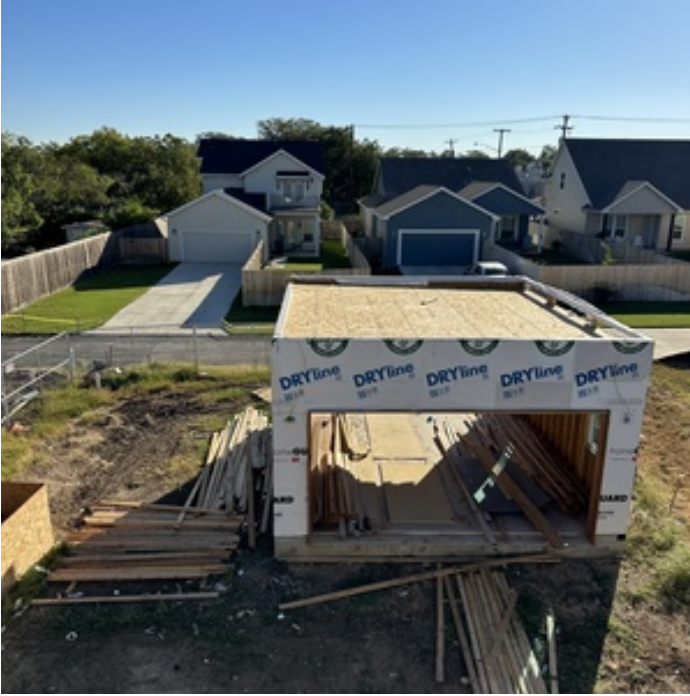
INCOMPLETE FLAT ROOF WORK

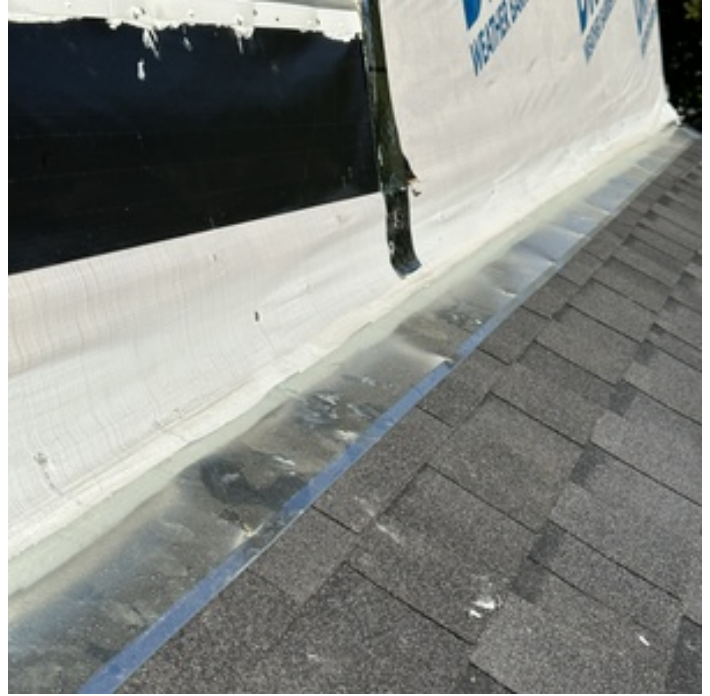
PROPER FLASHING INSTALL

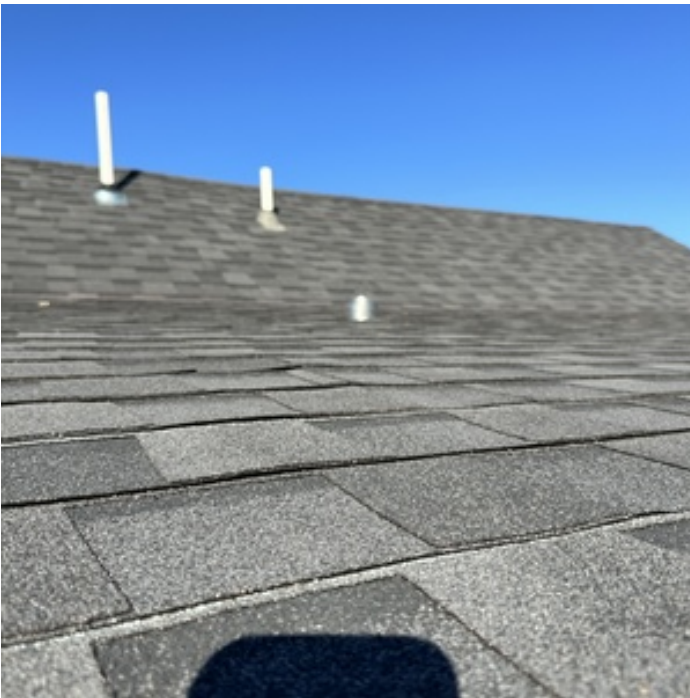
FINISH WORK NEEDS, MINOR FLAWS

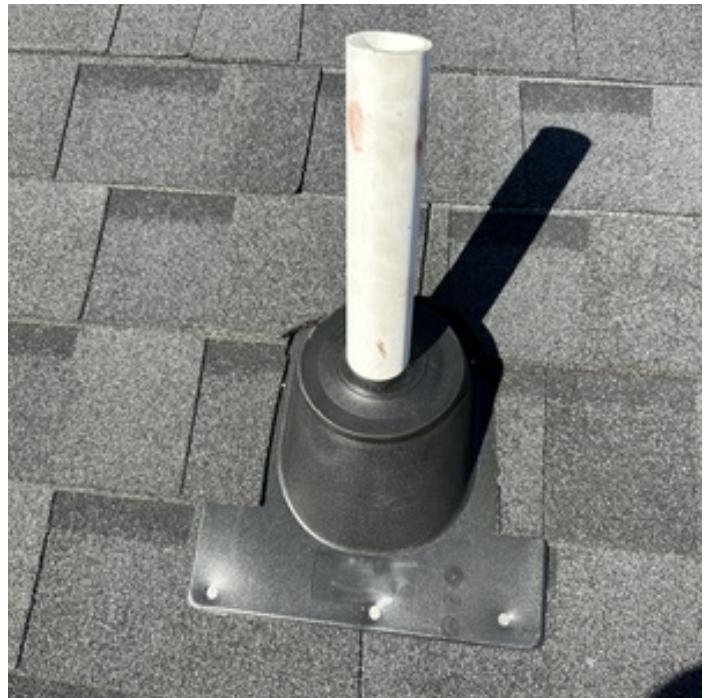
SEAL NAILS, PAINT PROTECT PVC

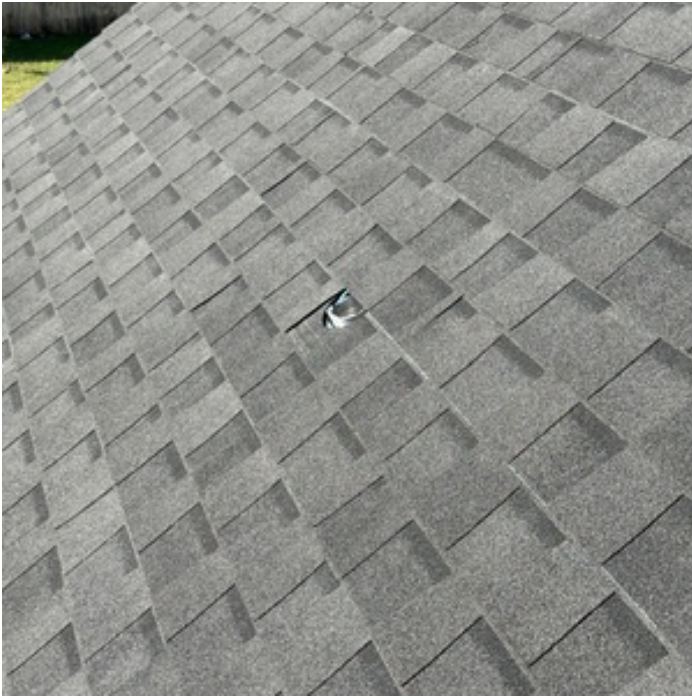
FULLY DRY IN PRIOR TO DRYWALL

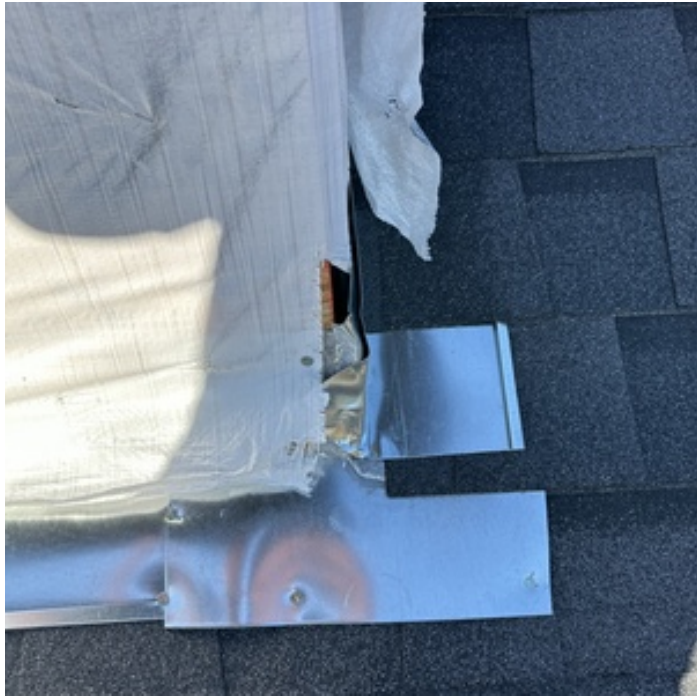
ADDRESS MINOR BARRIER FLAWS

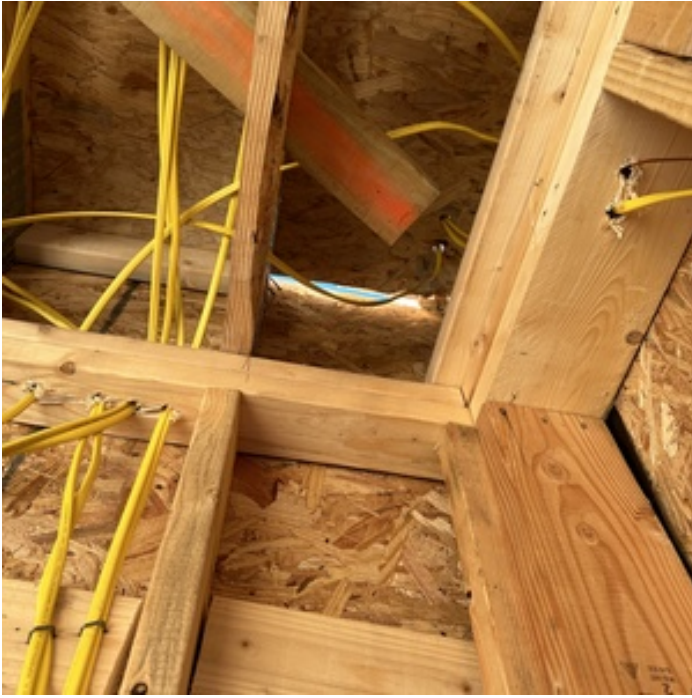
ADDRESS DECKING GAPS

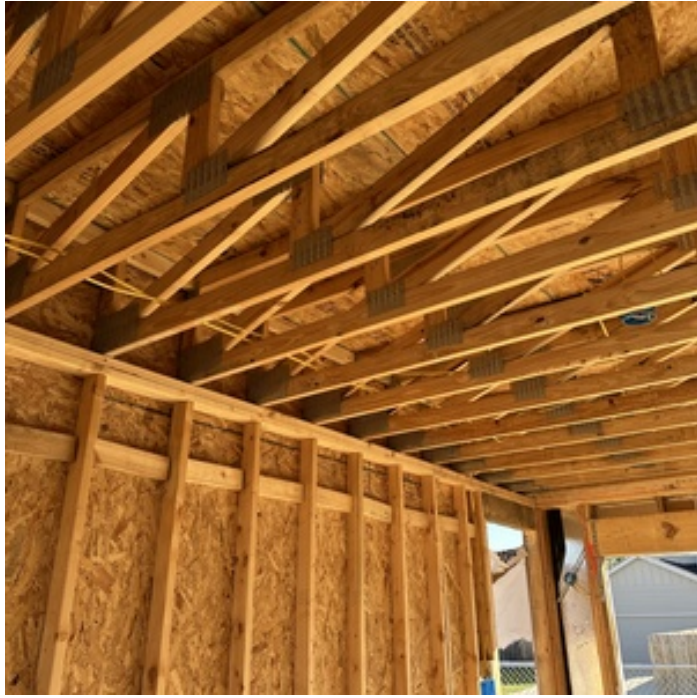
UPDATE TIES IF REQUIRED

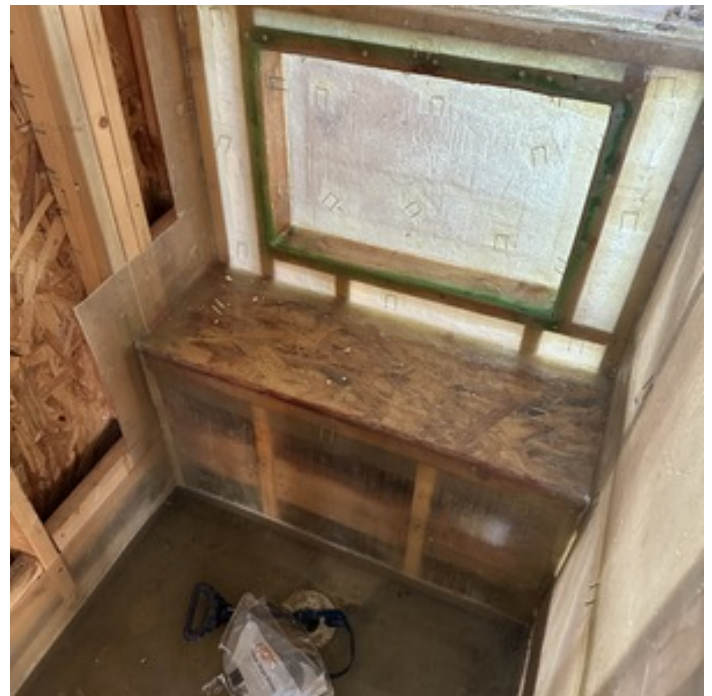
CONSIDER ACCESS HATCHES

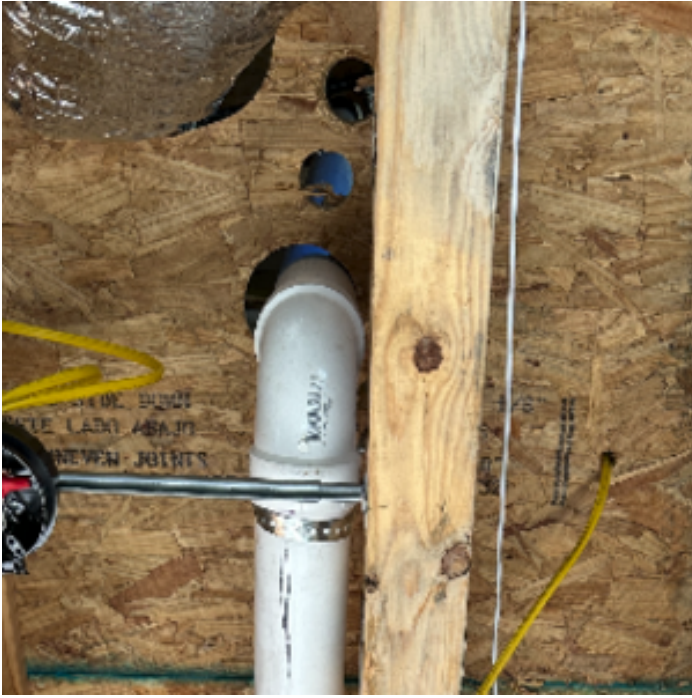
SEAL ALL BOREHOLES

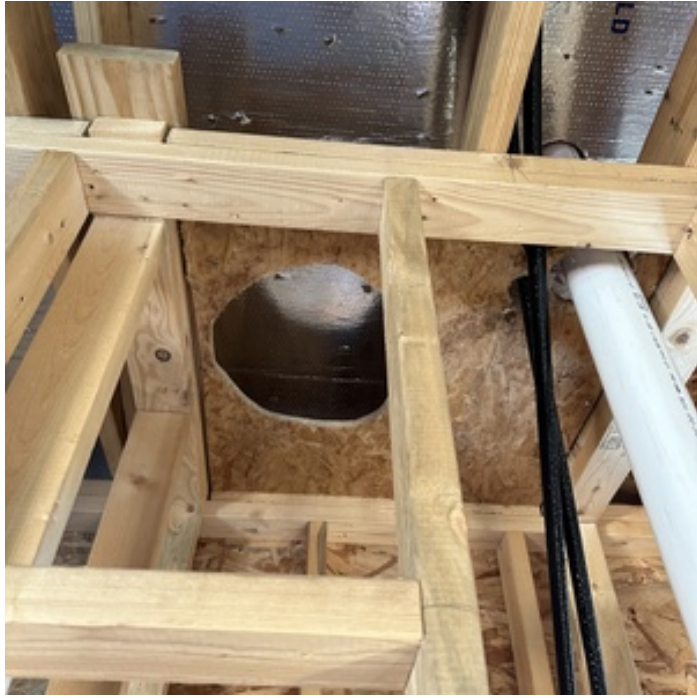
FIRE SEAL AS NEEDED

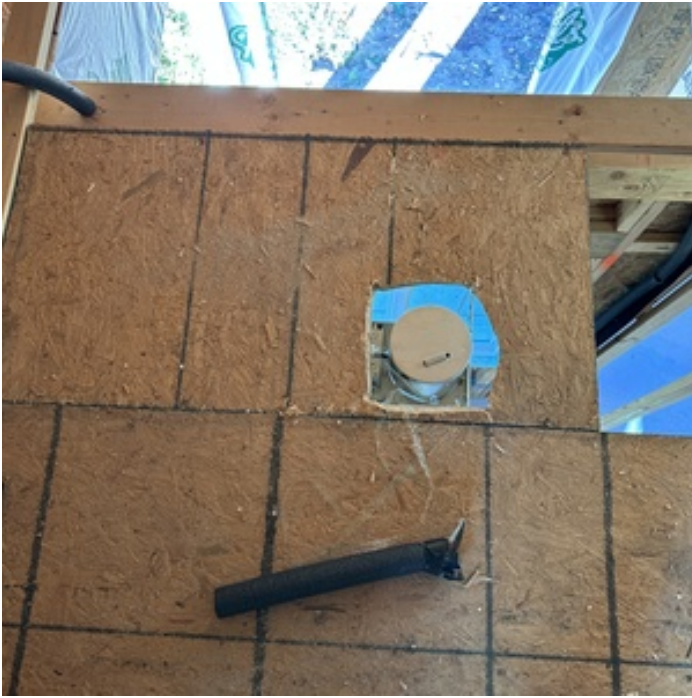
ADJUST DECKING AS NEEDED

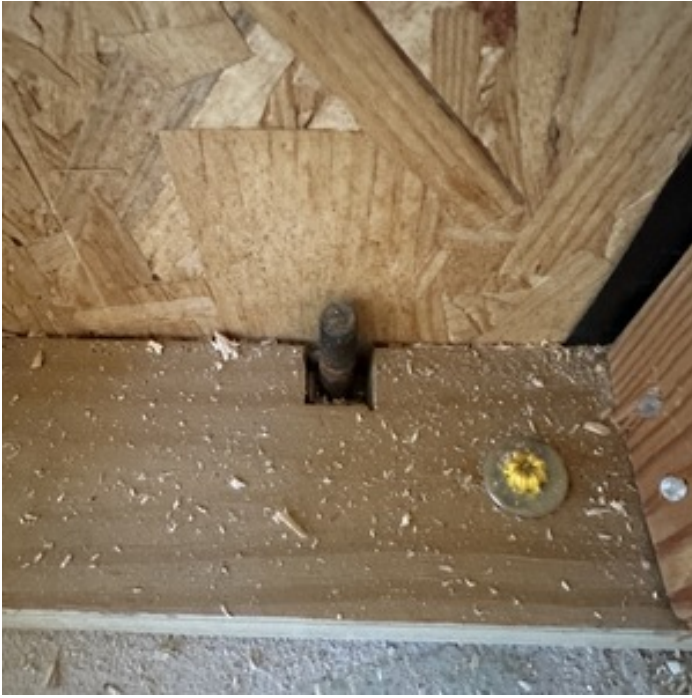
MISSED ANCHOR BOLT

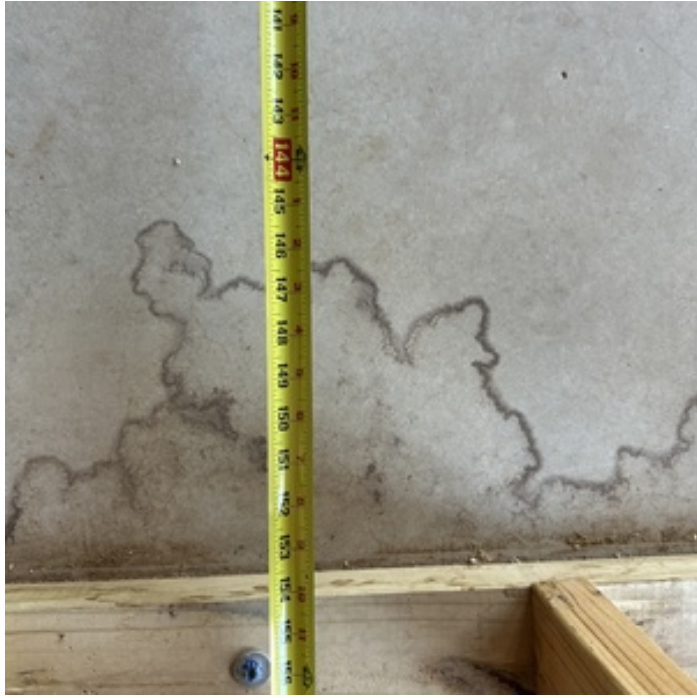
ENSURE ALL FRAMING DRY PRIOR TO INSTALLS

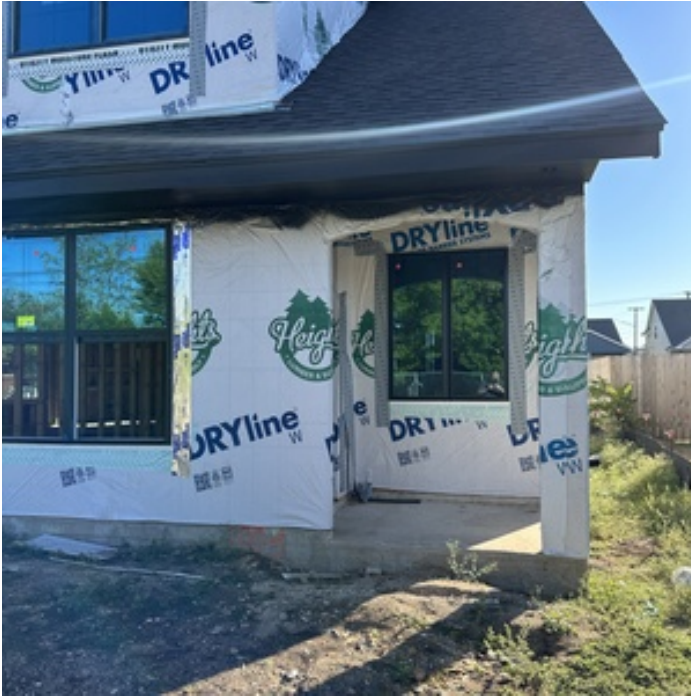
OVERALL INSTALL: PROFESSIONAL

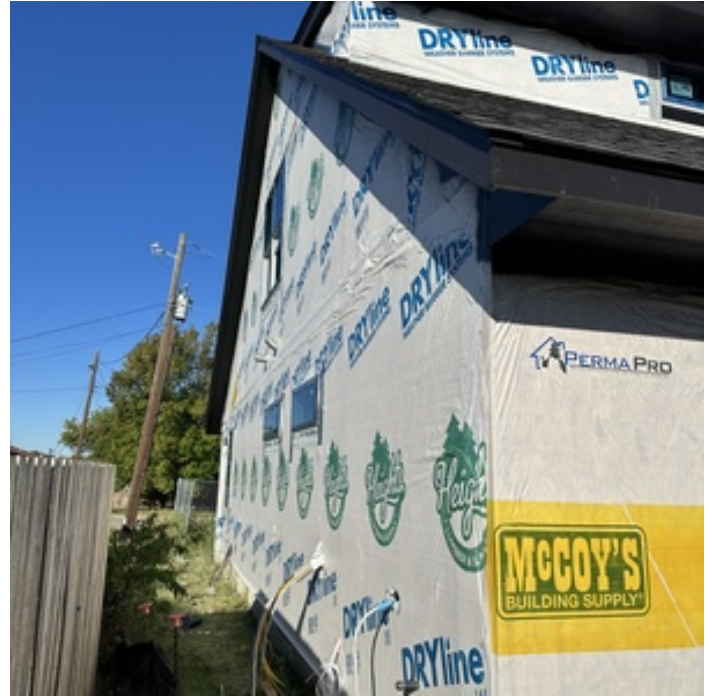
ADD TAPE AT PENETRATIONS

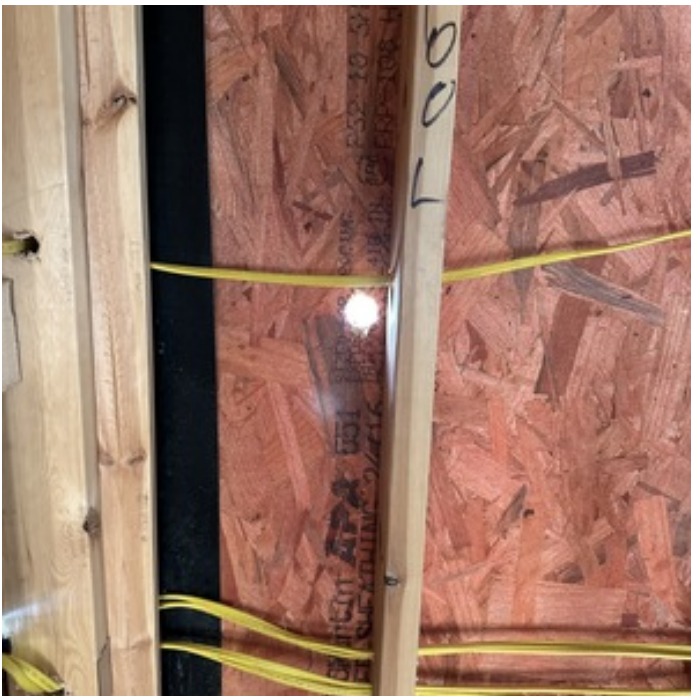
SEAL GAPS AS NEEDED

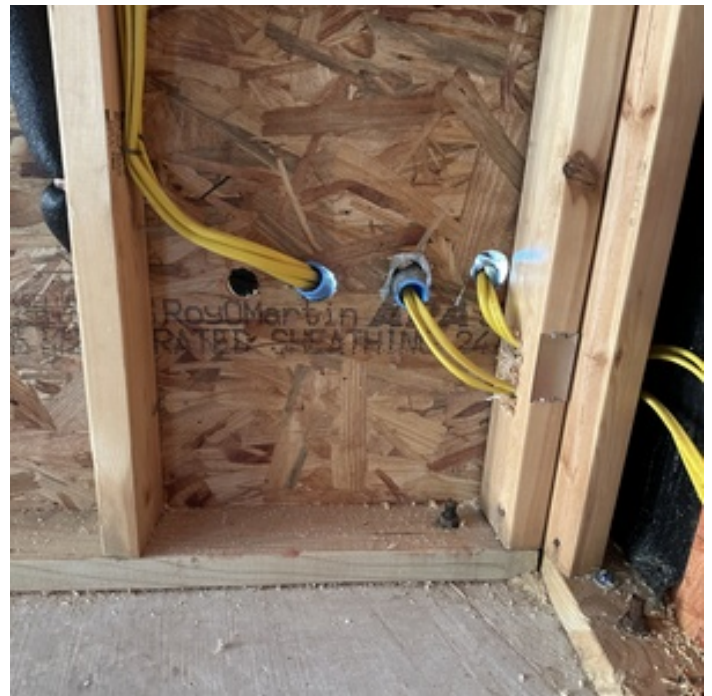
SEAL GAPS AS NEEDED

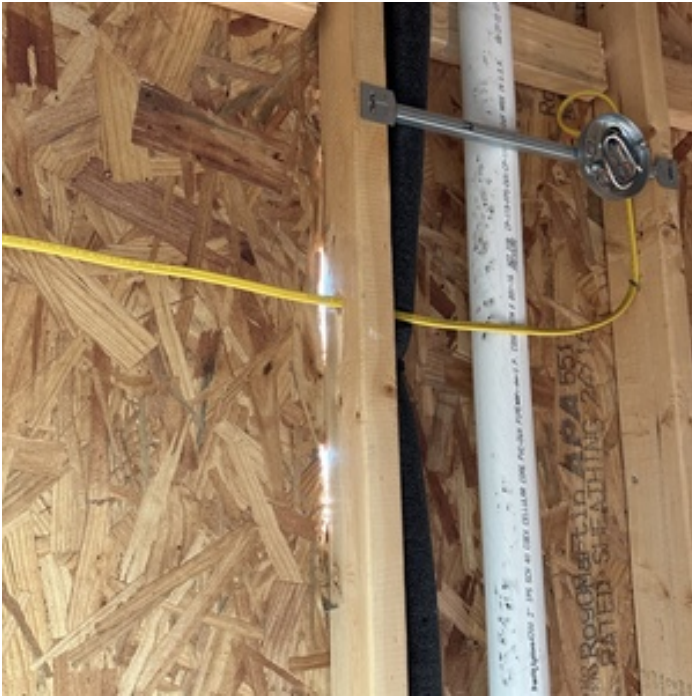
SEAL GAPS AS NEEDED

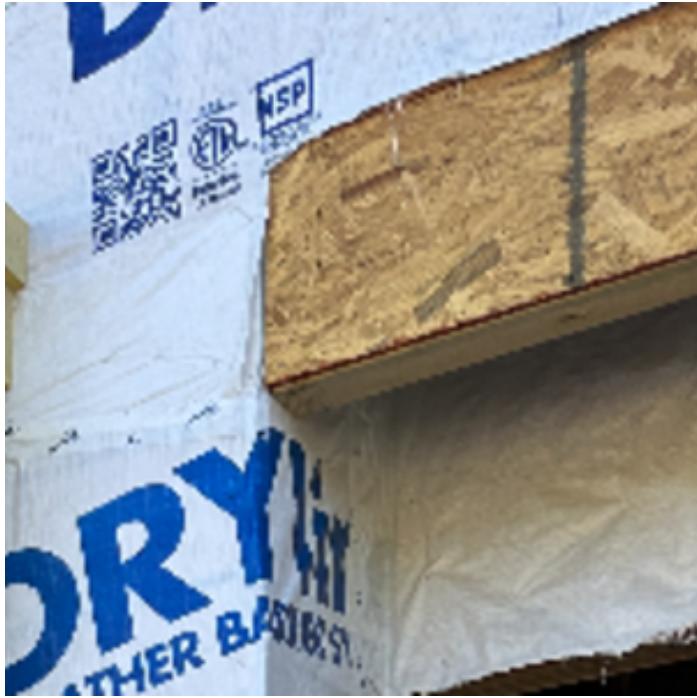
AREAS OF INCOMPLETE BARRIER

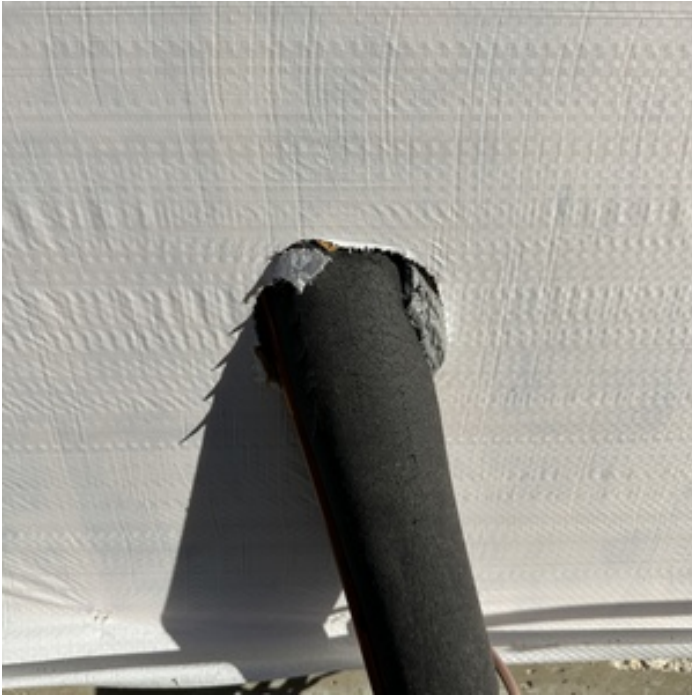
TAPE AT PENETRATIONS

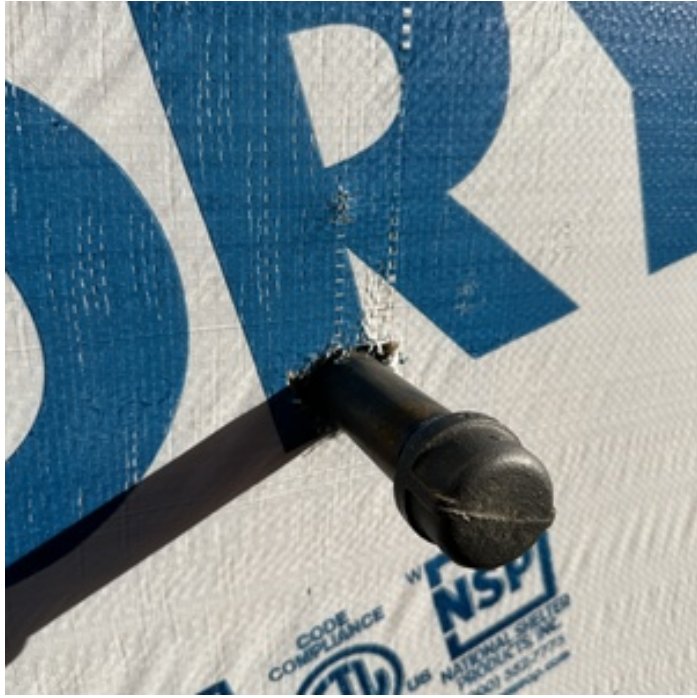
TAPE AT PENETRATIONS

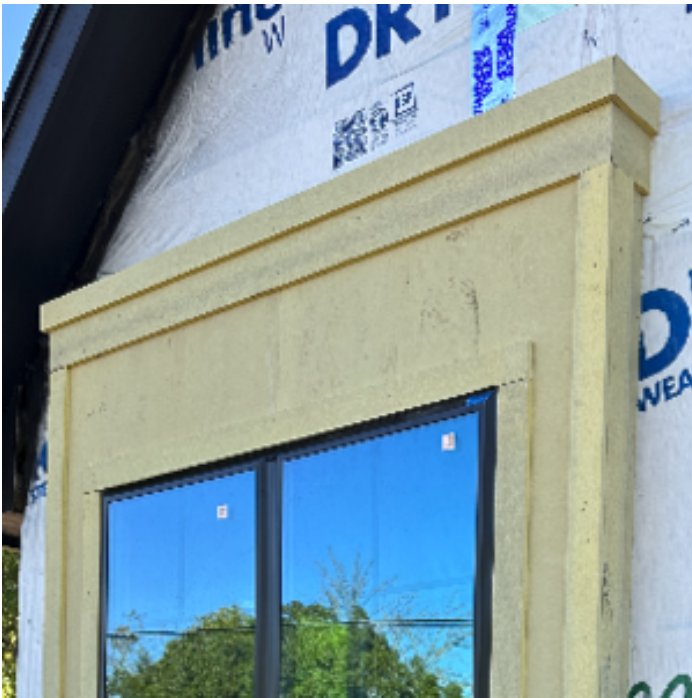
ENSURE PROPER FLASHING/PROTECTION

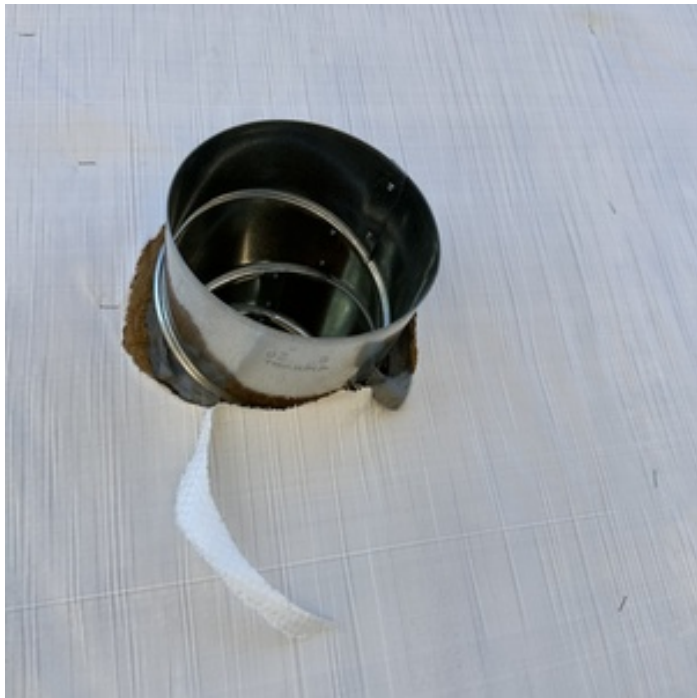
SEAL AT PENETRATIONS

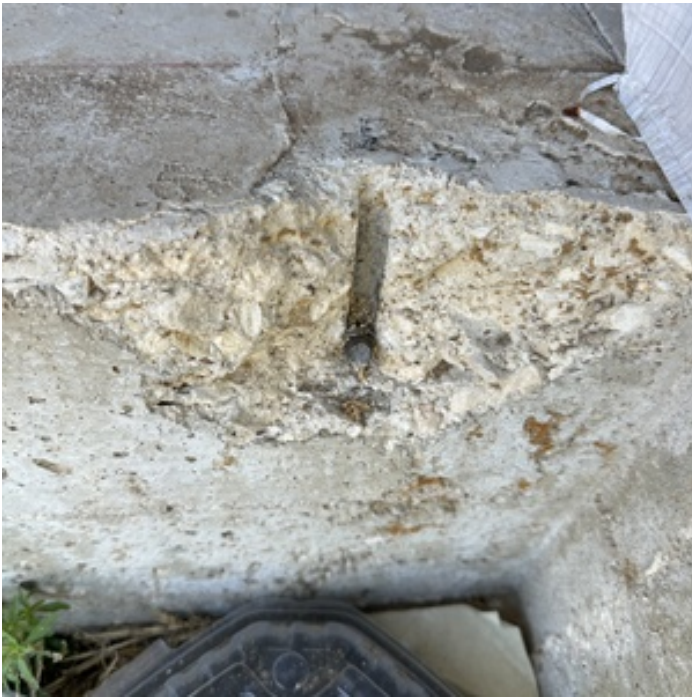
ADDRESS SLAB FLAWS AS NEEDED

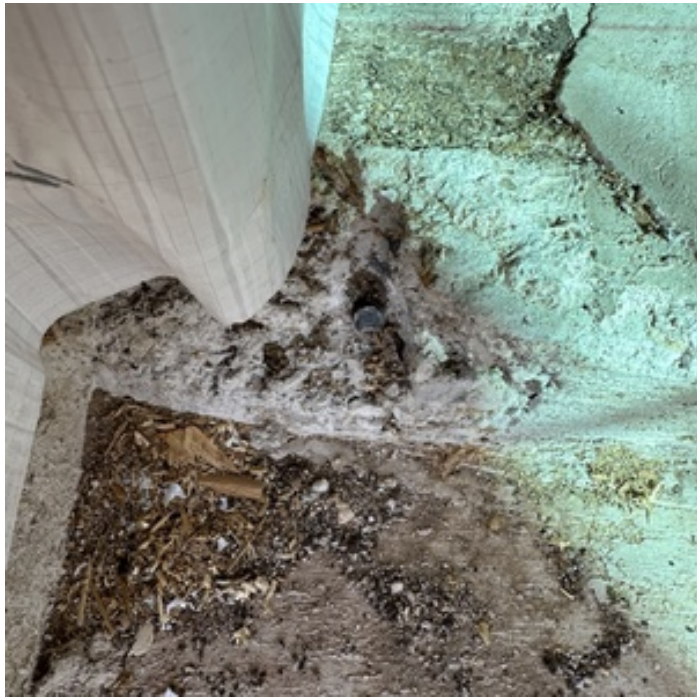
ADDRESS SLAB FLAWS AS NEEDED

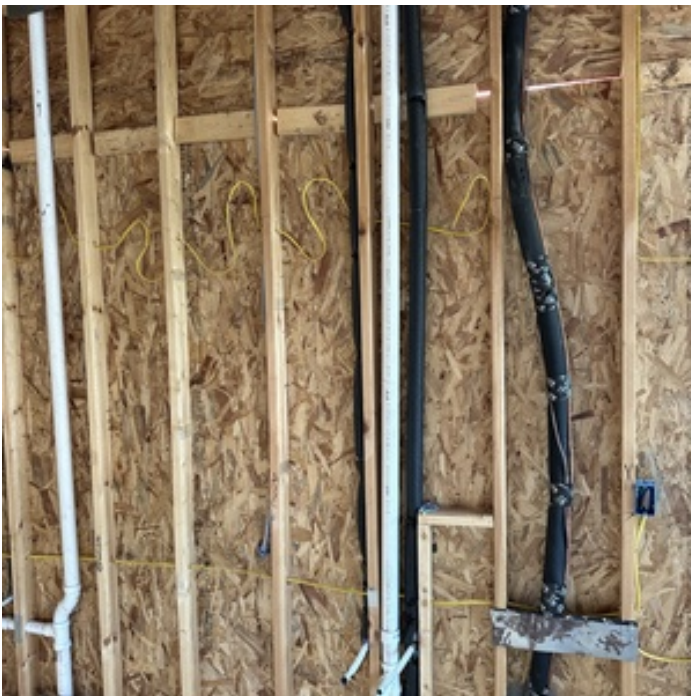
ENSURE INCOMPLETE CIRCUITS FINISHED

- Ensure all incomplete/loose wiring capped/spliced/connected as needed

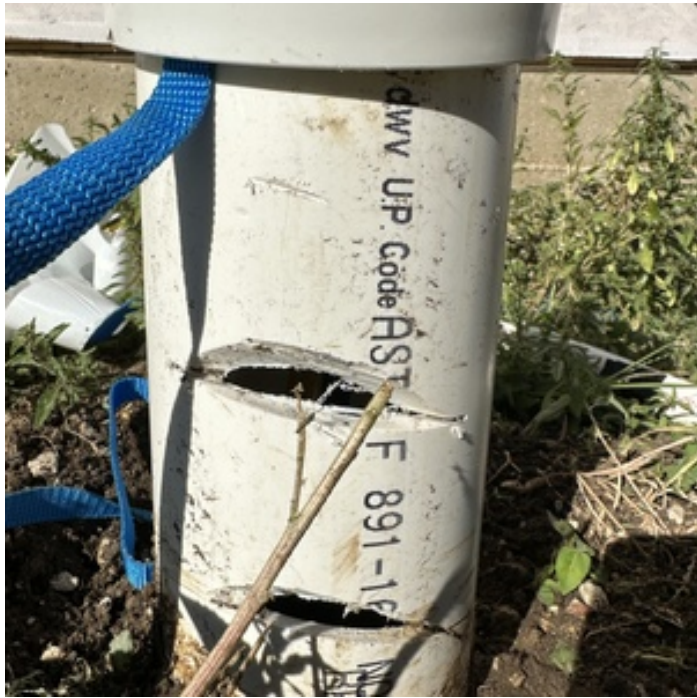
-Damaged clean out pipe at the rear of the home: Address as needed

DAMAGED CLEANOUT RISER
