GREENBELT STRUCTURAL SERVICES
A DIVISION OF TAHI LLC

Prepared By:

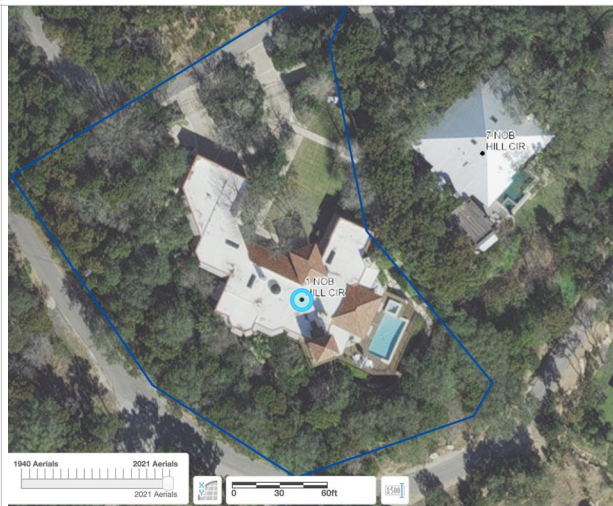
1ST Floor Factor: 1ST, Foundation: SLAB, Grade Factor: A, Roof Covering: BUILT-UP, Roof Style: FLAT, Shape Factor: I

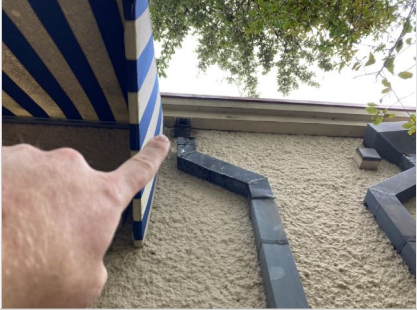
GUTTER/DRAINAGE ISSUES

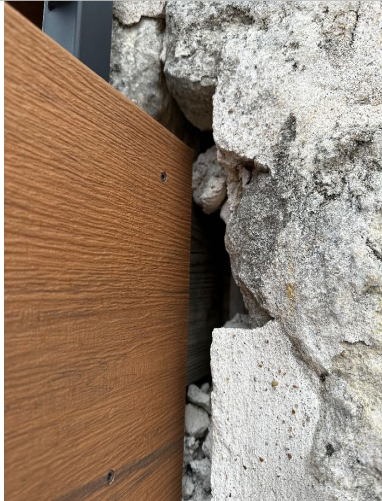
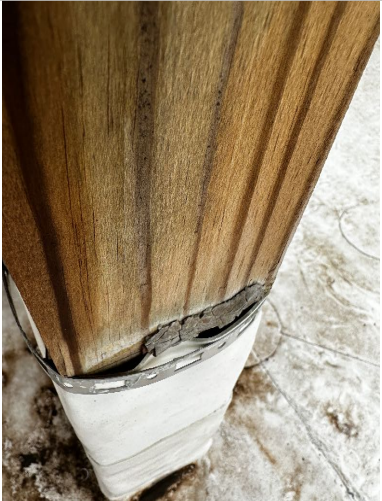
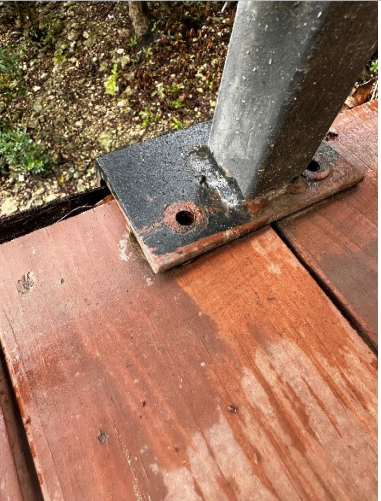
<p>GAPS AT DECK/WALL</p>	<p>GAPS AT DECK/ROOF</p>	<p>LOOSE DECK RAILING</p>

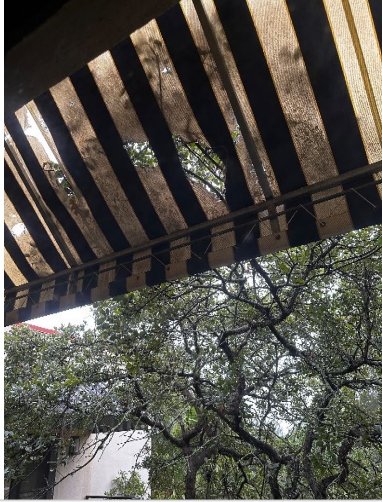
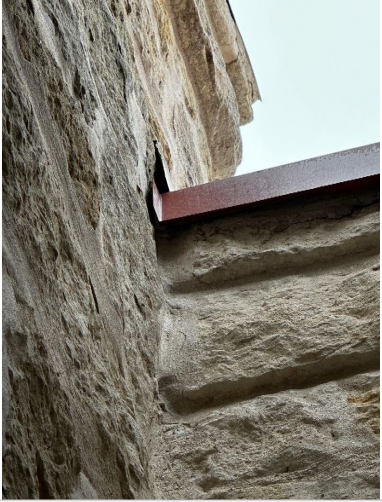
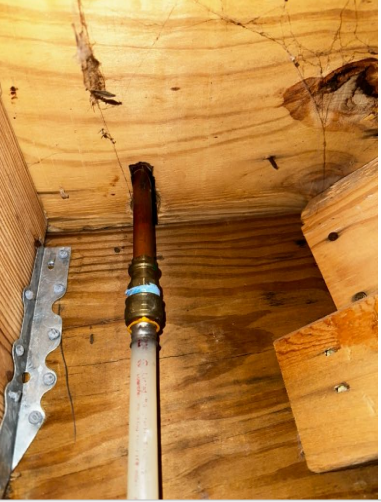
<p>EXT. DEFERRED MAINTENANCE</p>	<p>EXT. FLASHING UPDATE NEEDS</p>	<p>SEAL GAPS AT EXPOSED FLOOR DECKING</p>

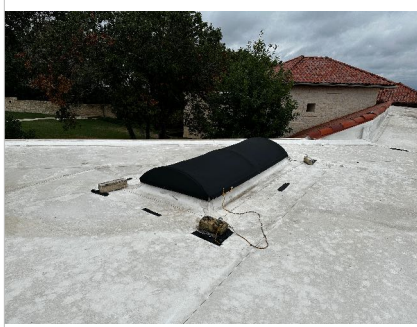
DATED, DAMAGED SKYLIGHTS

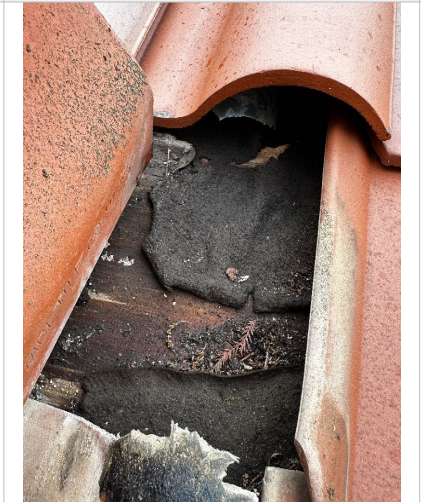
DAMAGED UNDERLAYMENT AND LEAKS

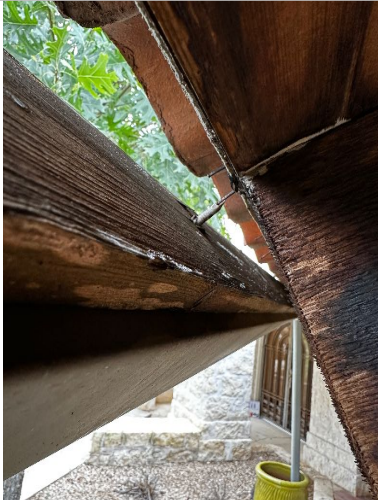
SOFFIT/FASCIA DAMAGE

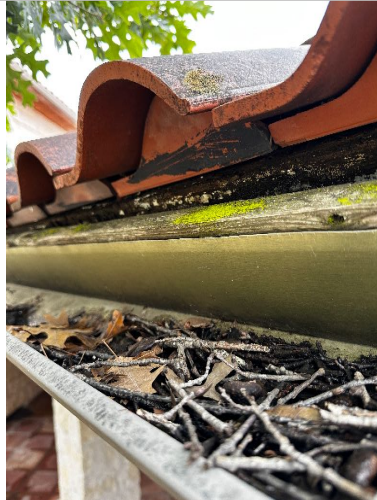
SOFFIT/FASCIA DAMAGE

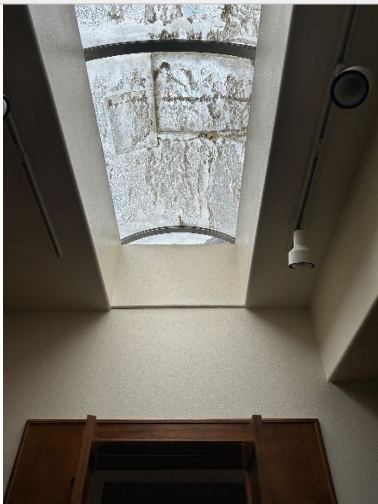
DATED/DAMAGED SKYLIGHTS

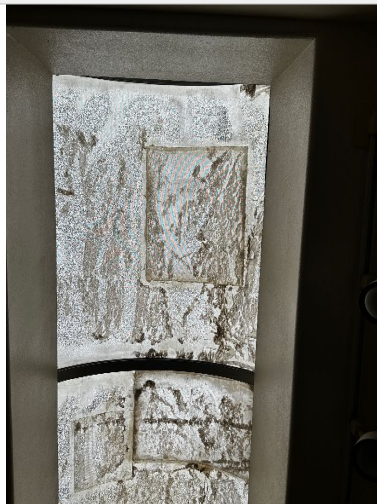
DATED/DAMAGED SKYLIGHTS

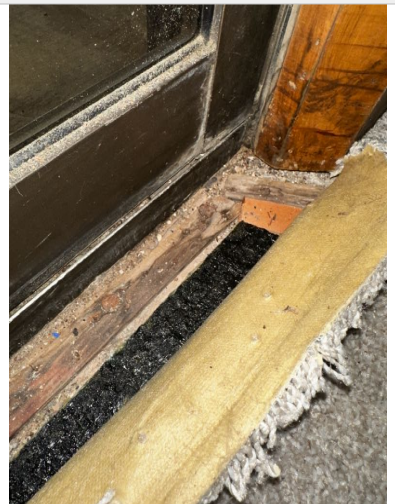
MOISTURE STAINING AT TACK STRIPS

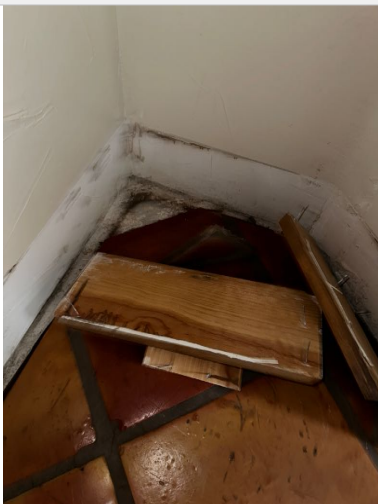
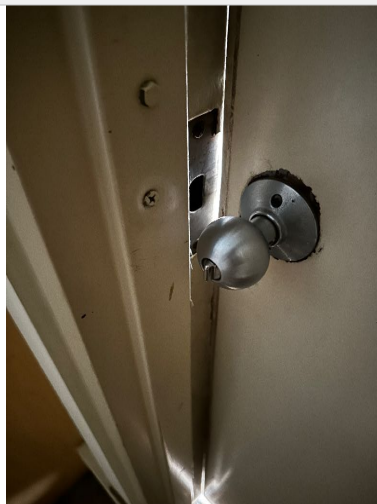
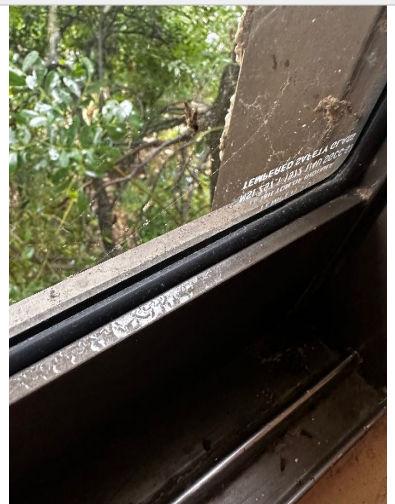
<p>LOOSE/MISSING MATERIAL</p>	<p>DOOR FUNCTIONALITY ISSUES</p>	<p>DATED WINDOWS AND SERVICING NEEDS</p>

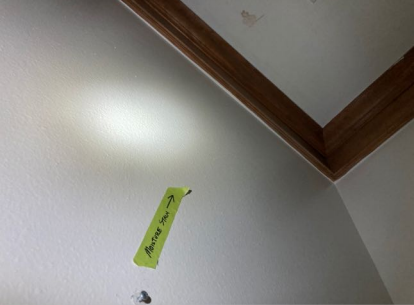
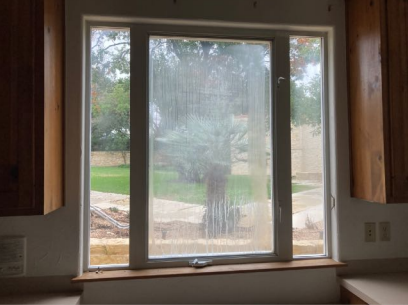
<p>FIREPLACES FAILED TO ENGAGE</p>	<p>AREAS OF LEAK STAINING</p>	<p>FAILED WINDOW SEALS</p>

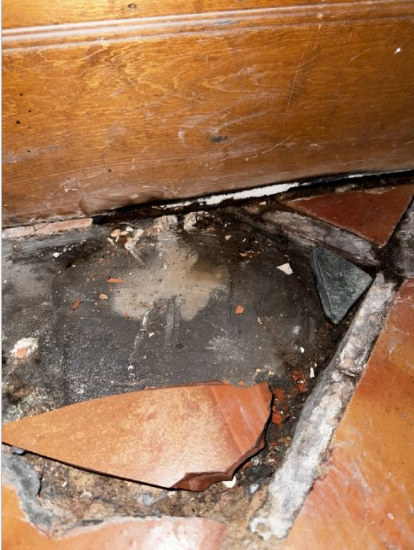
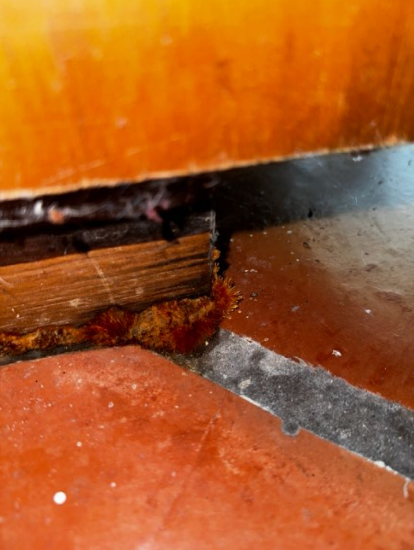
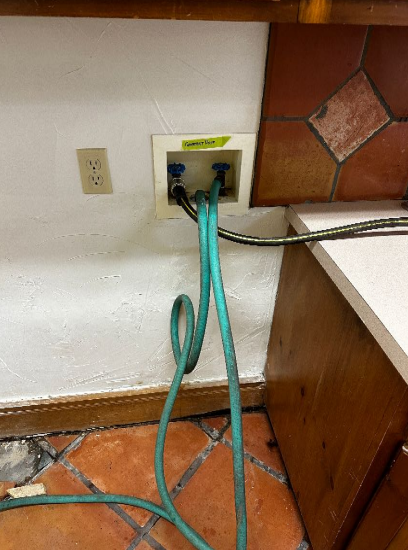
<p>ACTIVE LEAK</p>	<p>LEAK DAMAGE</p>	<p>LEAKING LAUNDRY HOOK UPS CONNECTED TO HOSES</p>

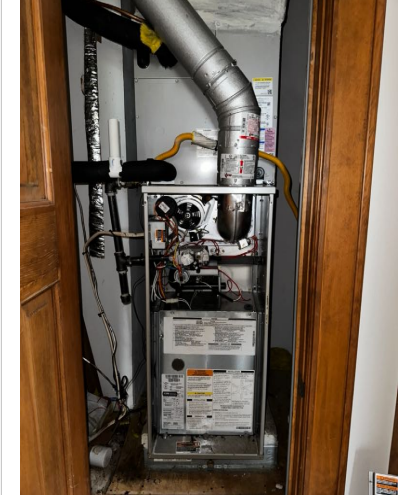
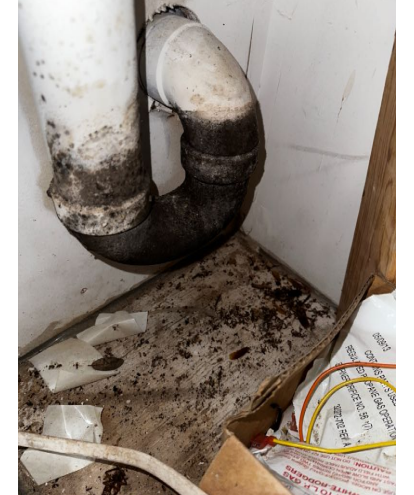
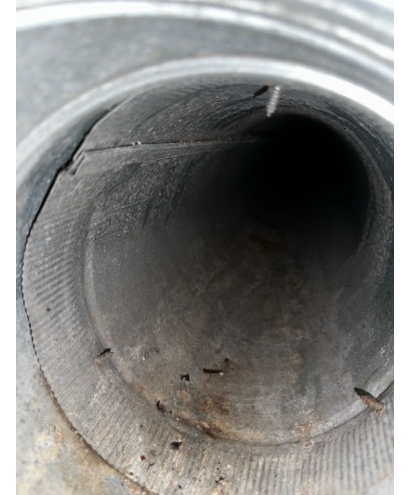
<p>GAS AND HEAT PUMP HVAC SYSTEMS PRESENT</p>	<p>UPDATE NEEDS IN MECH CLOSETS</p>	<p>DUCT REQUIRE CLEANING DUE TO AIR QUALITY</p>

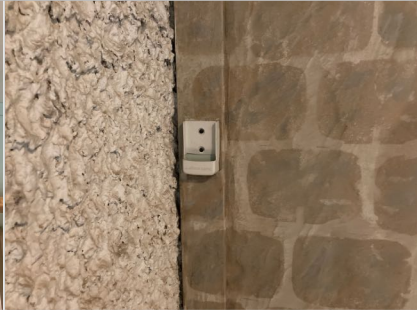
MINI-SPLIT NOT TESTED

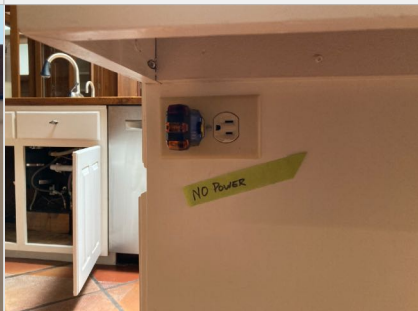
DEAD OUTLETS/FAILED BREAKERS

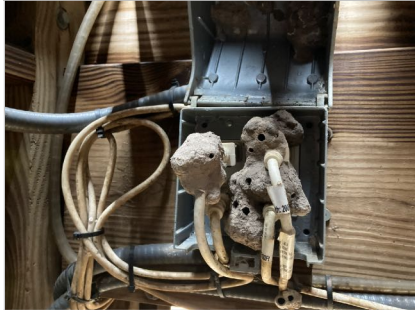
EQUIP. SERVICE NEEDS

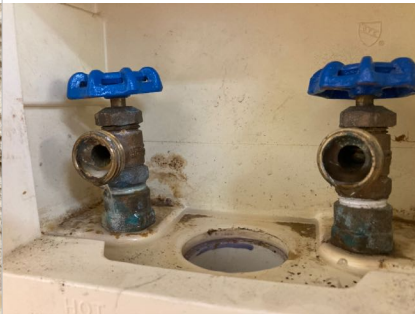
LEAKING LAUNDRY HOOK-UPS

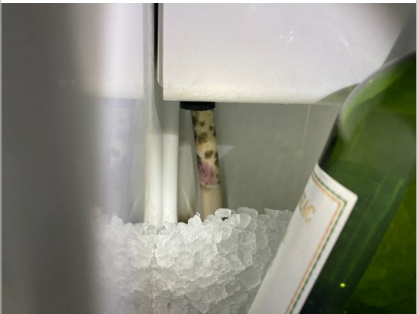
DATED APPLIANCES REQUIRE SERVICING

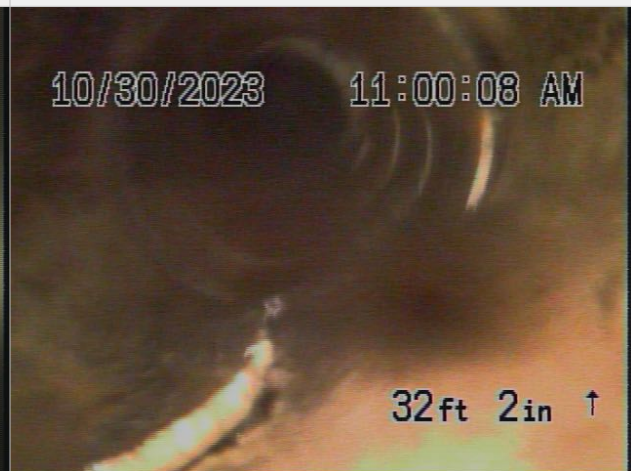
<p>10/30/2023 11:00:08 AM 32ft 2in ↑</p>
<p>CRACKED/DAMAGED PIPE NEAR OSSF</p>	<p>CRACKED/DAMAGED PIPE NEAR OSSF</p>

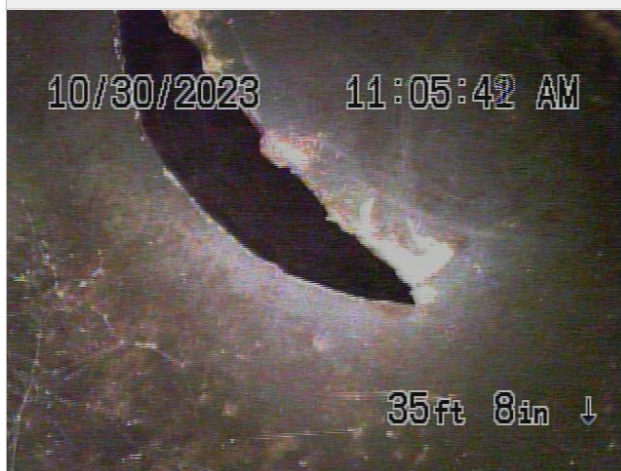
<p>10/30/2023 11:05:42 AM 35ft 8in ↓</p>

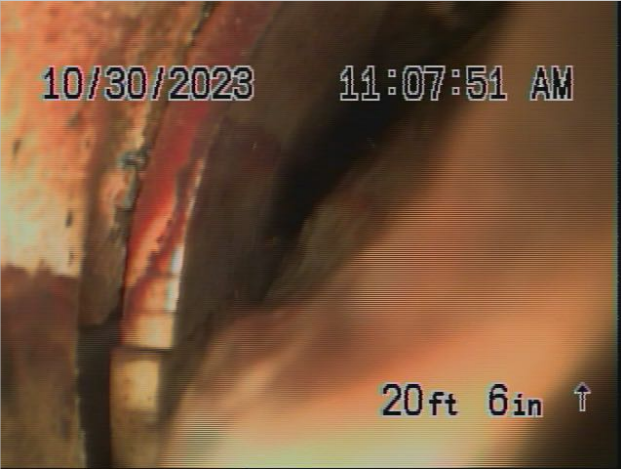
DRAINAGE CONTINUES AT DAMAGED AREAS

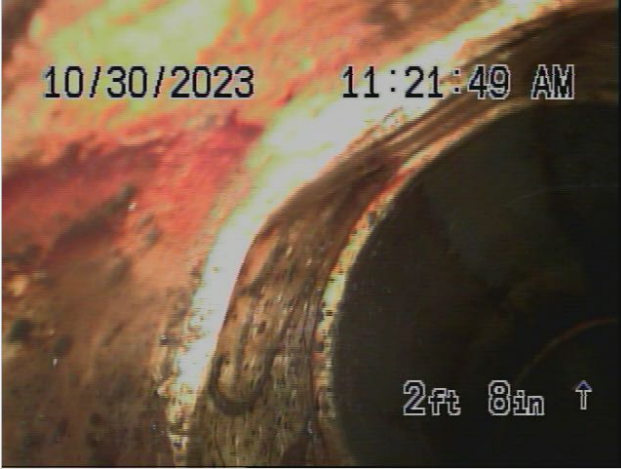
ATTEMPTED ENTRY TOWARDS BUILDING AT MAIN CLEAN OUT

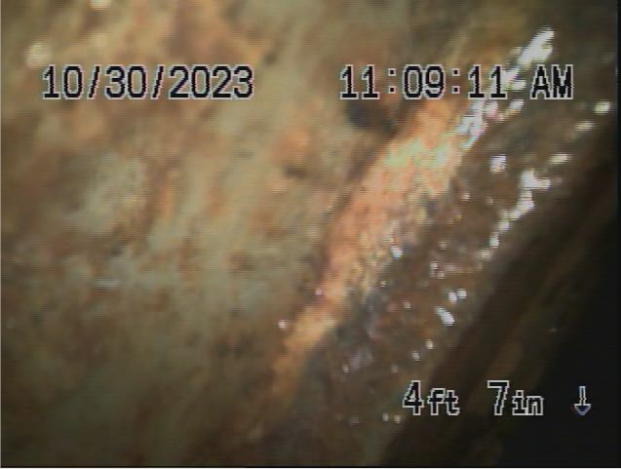
ENTRY FROM CLEAN OUT FAILED, INDICATOR OF CAST IRON NOTED

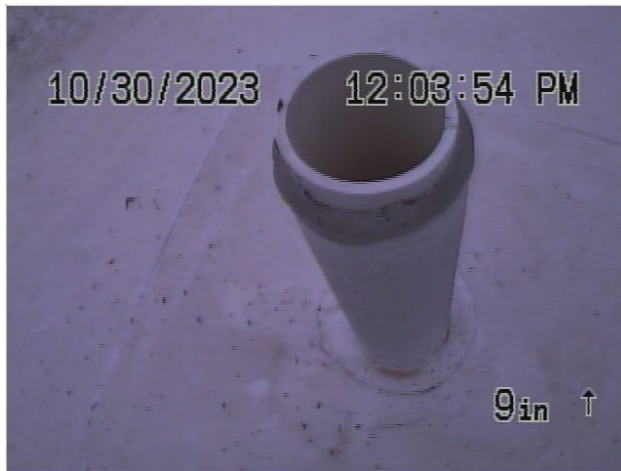
ENTRY FROM ROOF LEVEL (V1)

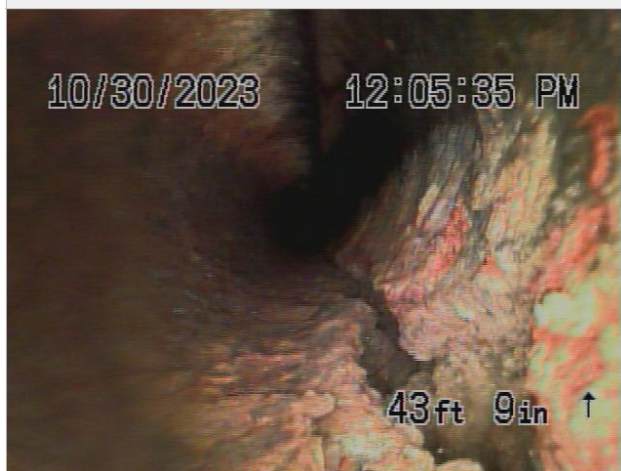
PIPE DAMAGE/FAILURE: 43' FROM V1

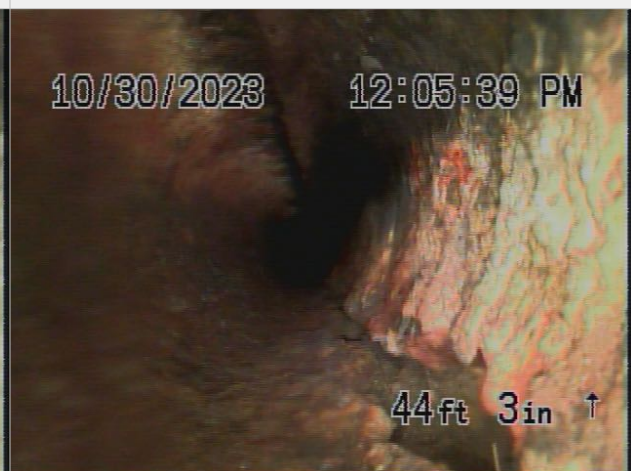
PIPE DAMAGE/FAILURE: 44' FROM V1

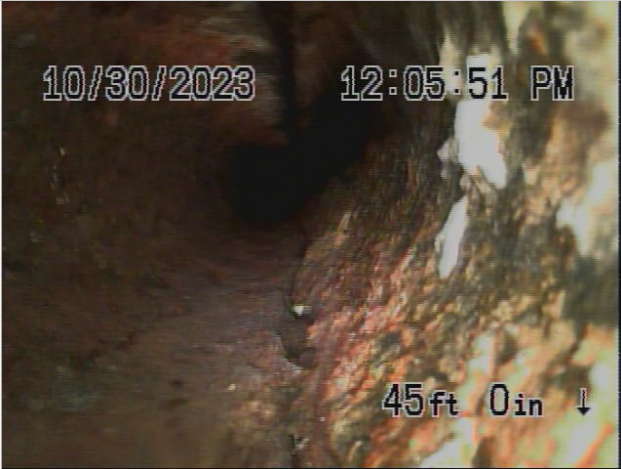
PIPE DAMAGE/FAILURE: 45' FROM V1

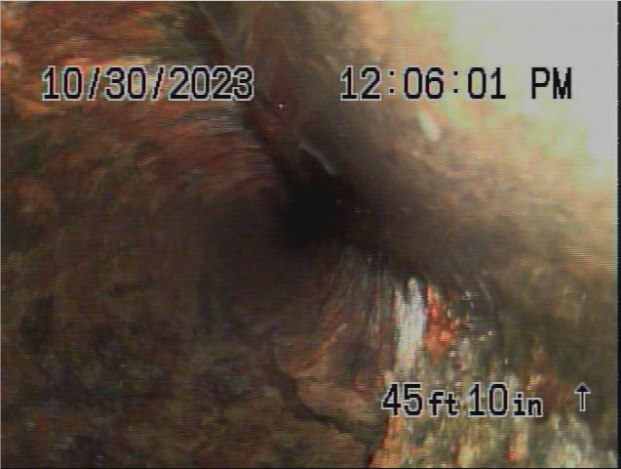
PIPE DAMAGE/FAILURE: 45' 10" FROM V1

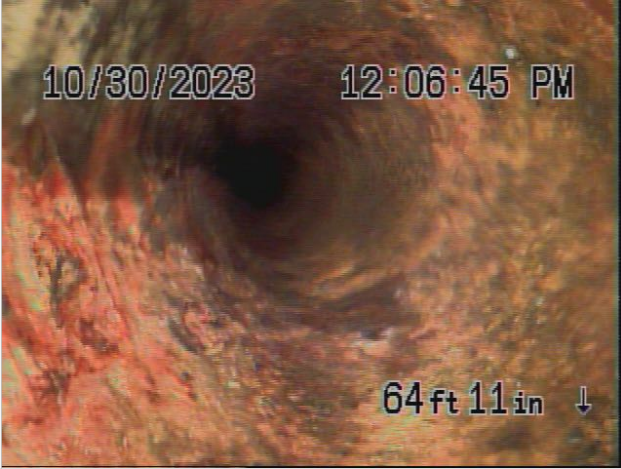
SUB GRADE PIPING REMAINS CAST IRON

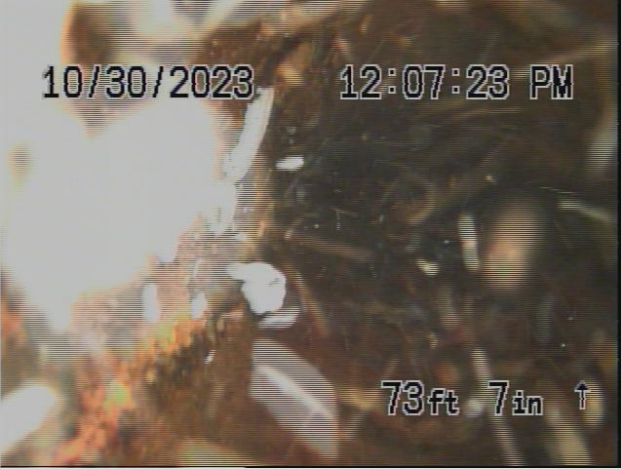
DRAINAGE OBSERVED AT CAST IRON

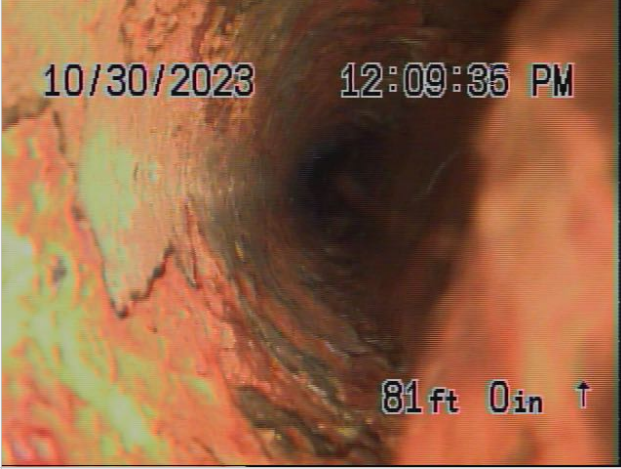
DRAINAGE OBSERVED AT 81' FROM V1

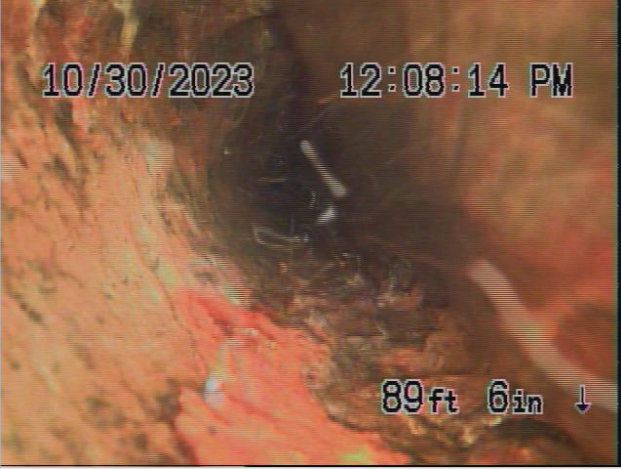
CAST IRON REMAINS AT 90' FROM V1

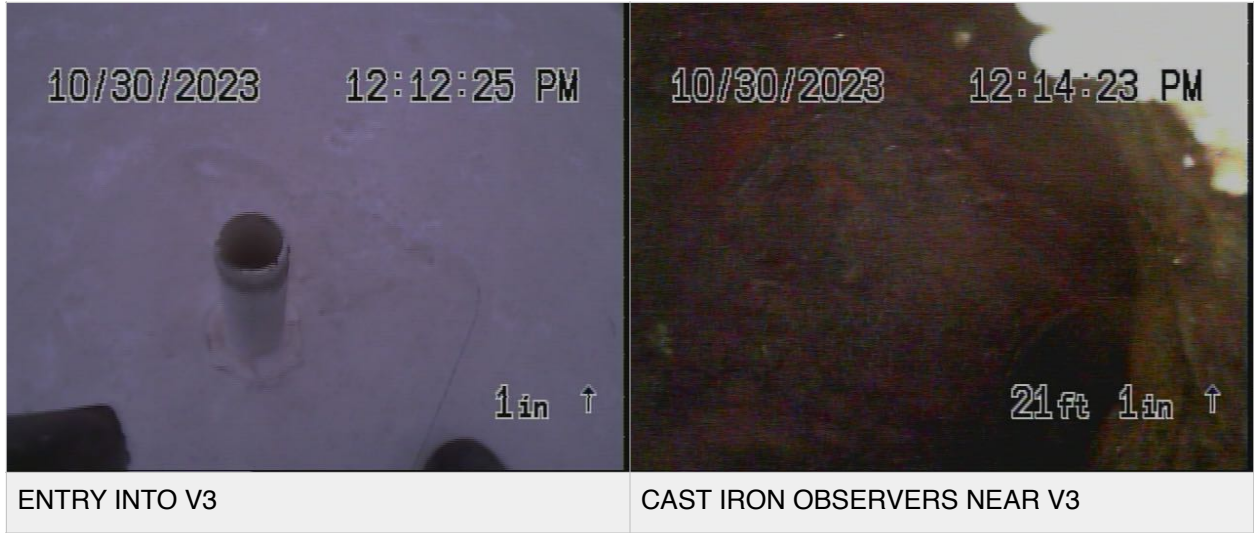
ADDITIONAL NOTICE OF LIMITATIONS:

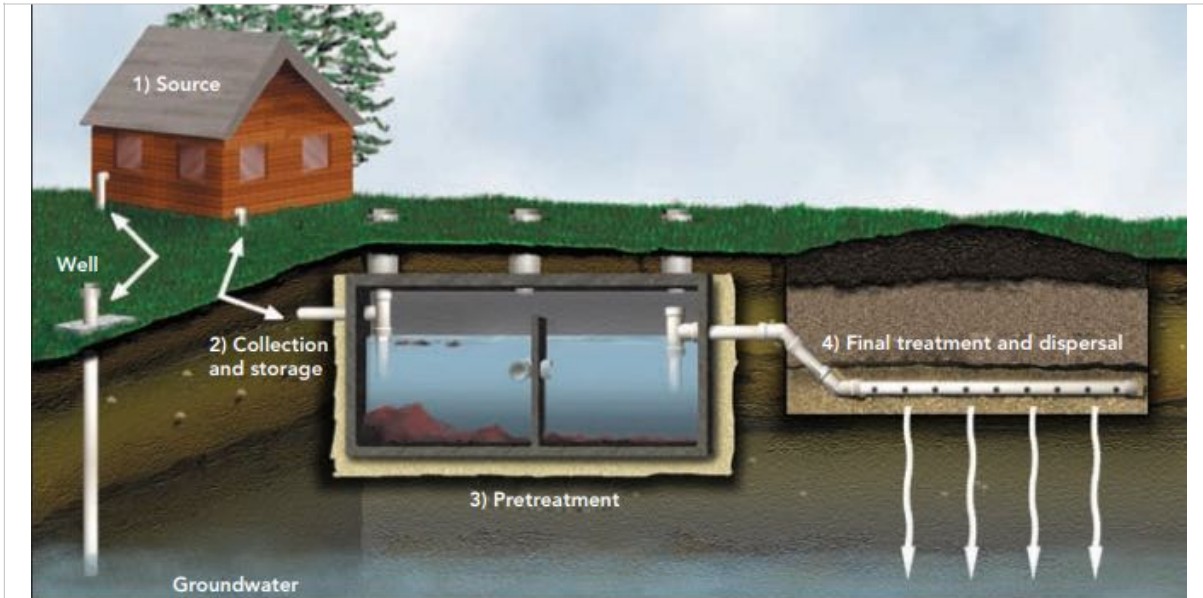
Figure 1: Components of an onsite wastewater treatment system.

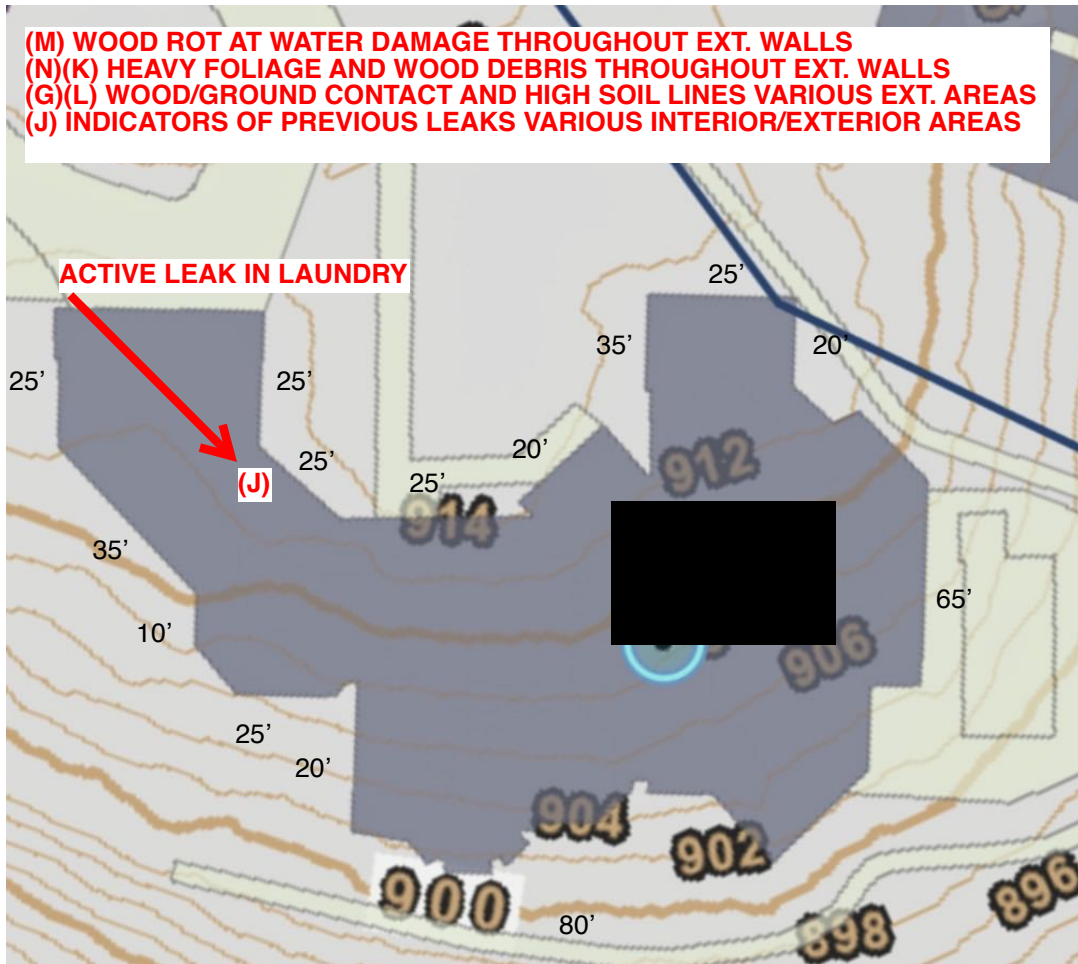
Additional Comments _____

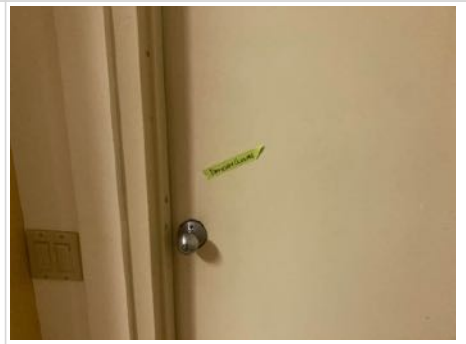
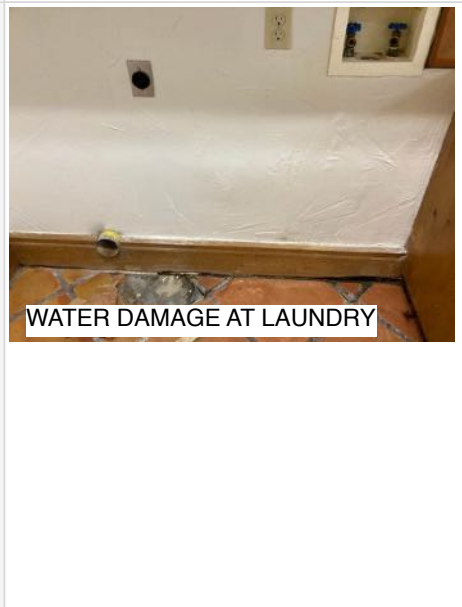
<p>WATER DAMAGE AT LAUNDRY</p>

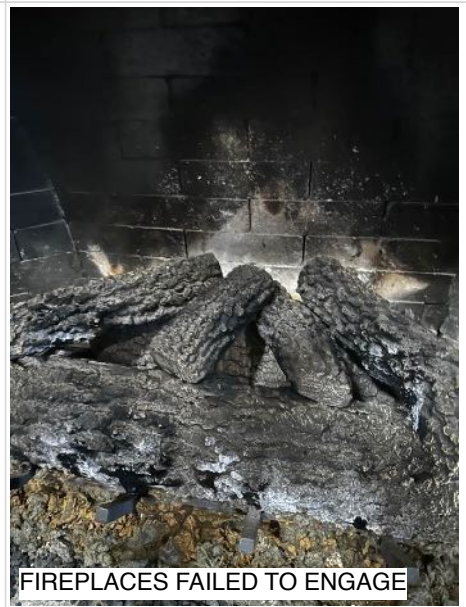
<p>FIREPLACES FAILED TO ENGAGE</p>

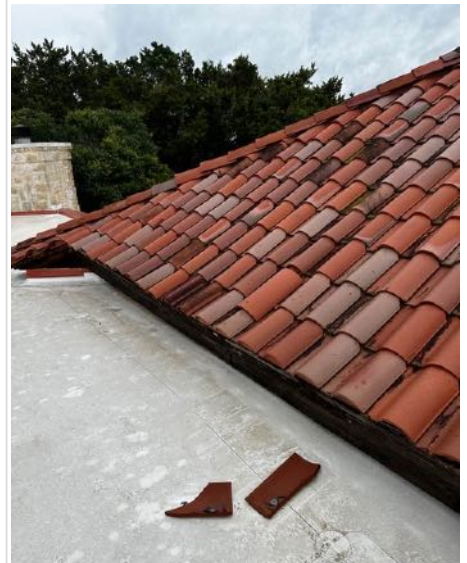
CLAY TILE DAMAGE AND ISSUES

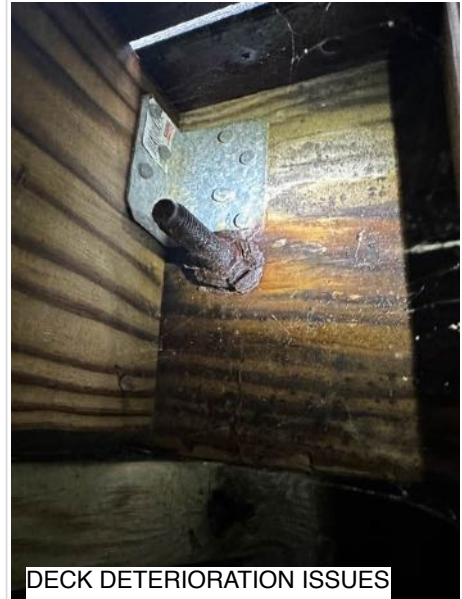
DECK DETERIORATION ISSUES

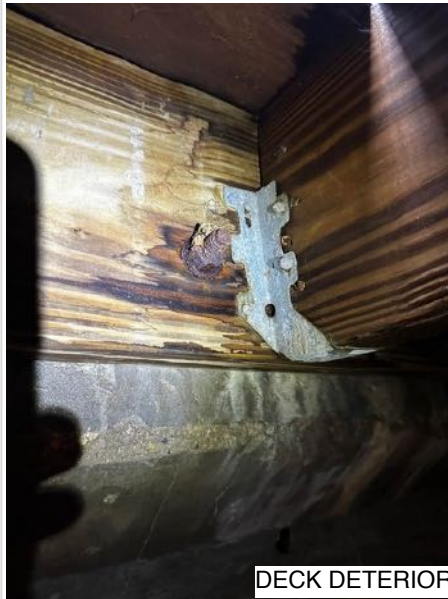
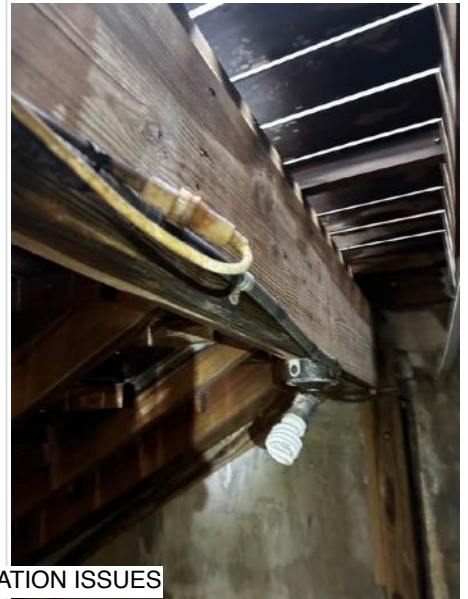
DECK DETERIORATION ISSUES

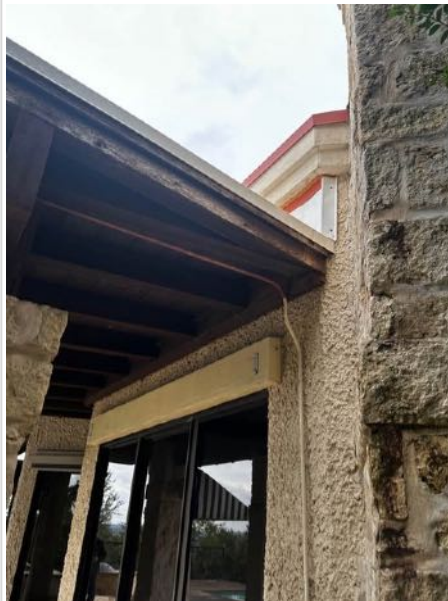
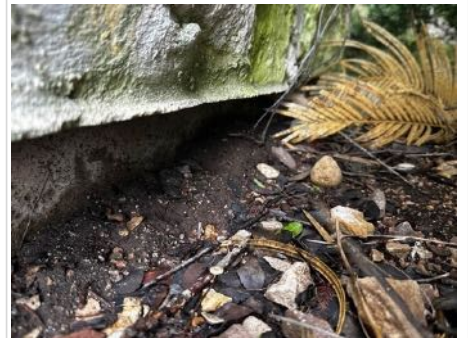
UNSUPPORTED MASONRY WALL

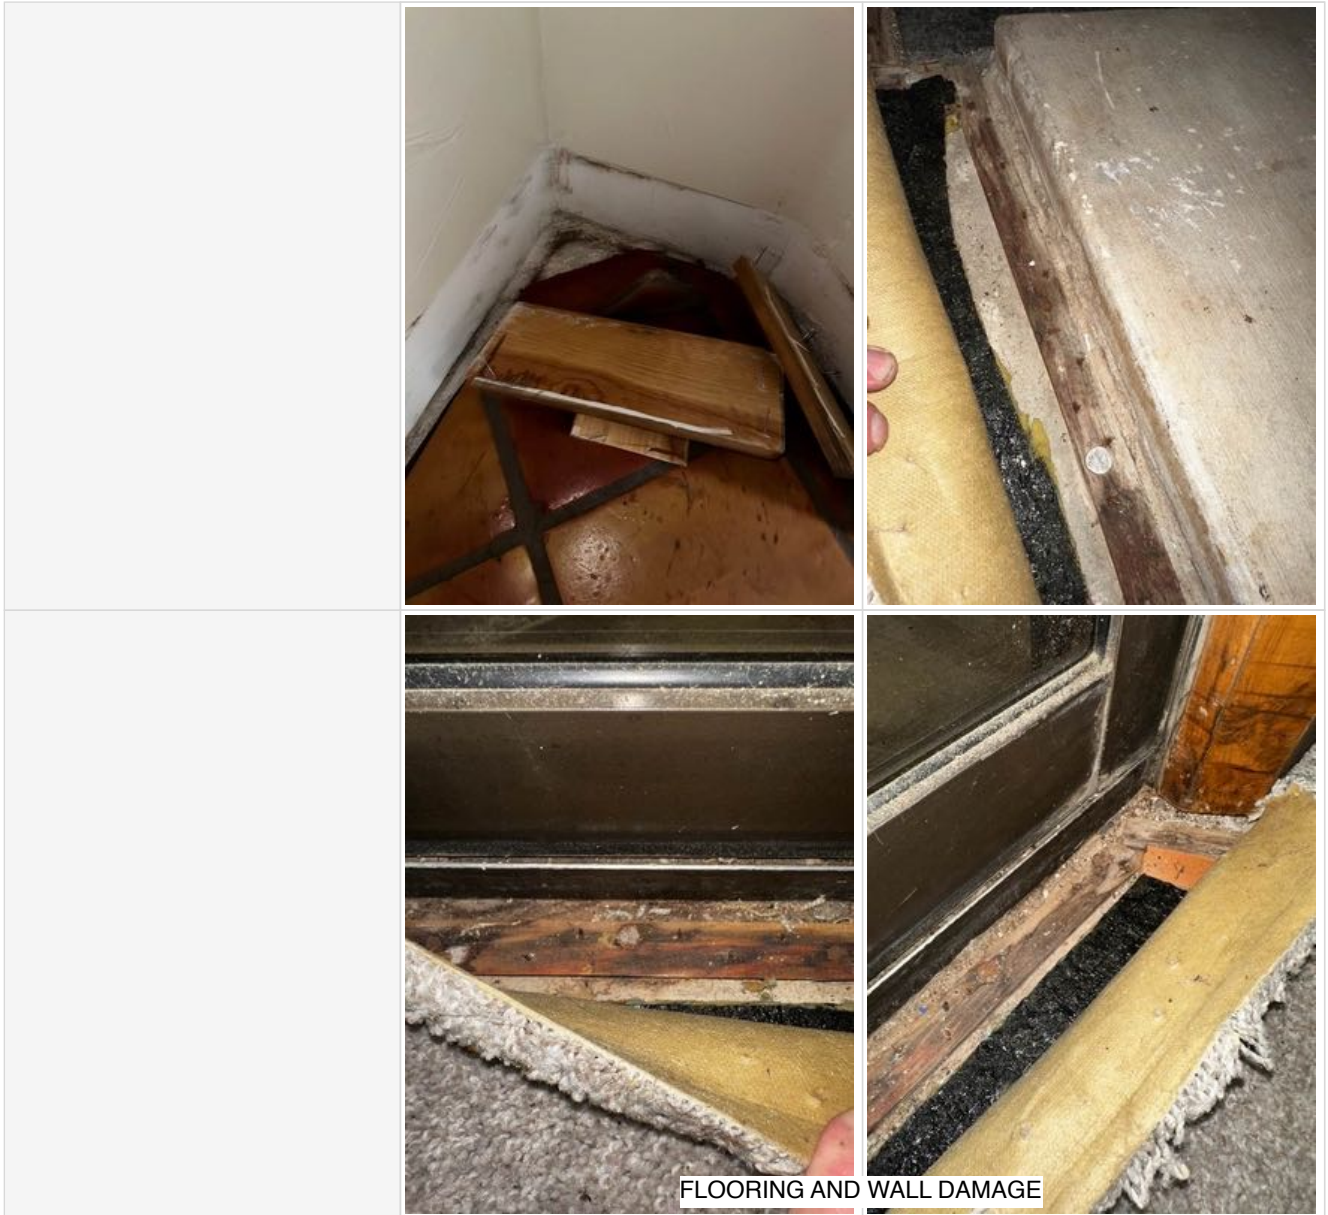
FLOORING AND WALL DAMAGE

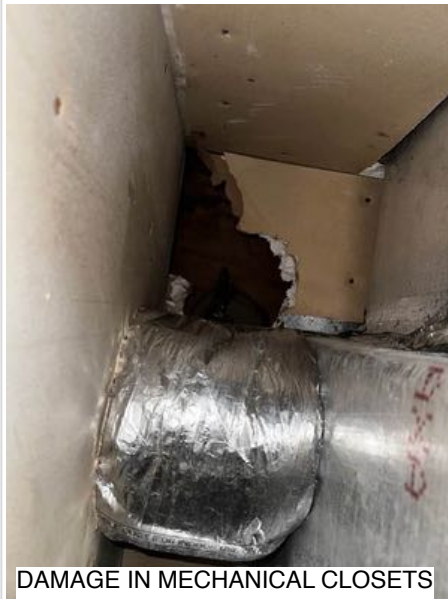
DAMAGE IN MECHANICAL CLOSETS

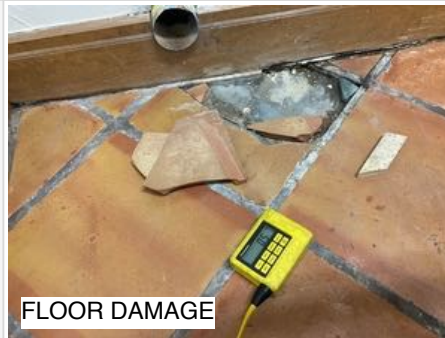
SITE PHOTOS AND MEDIA

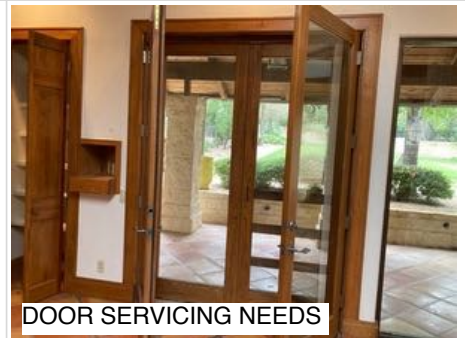
DOOR SERVICING NEEDS

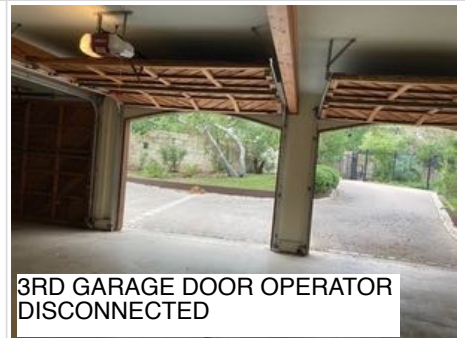
3RD GARAGE DOOR OPERATOR
DISCONNECTED

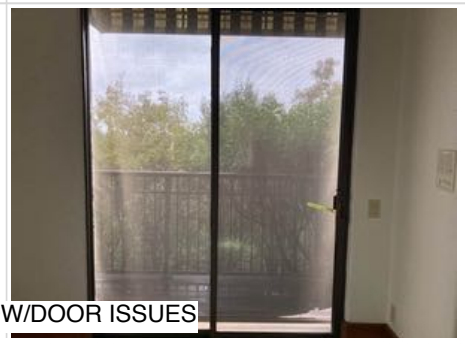
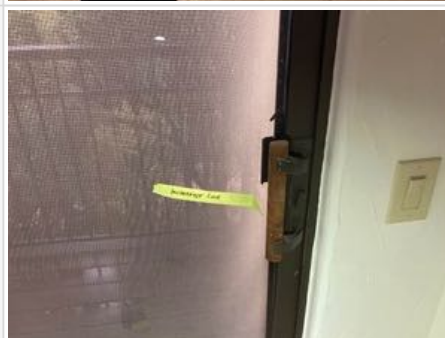
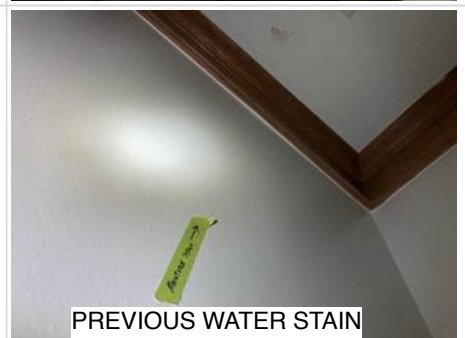
PREVIOUS WATER STAIN

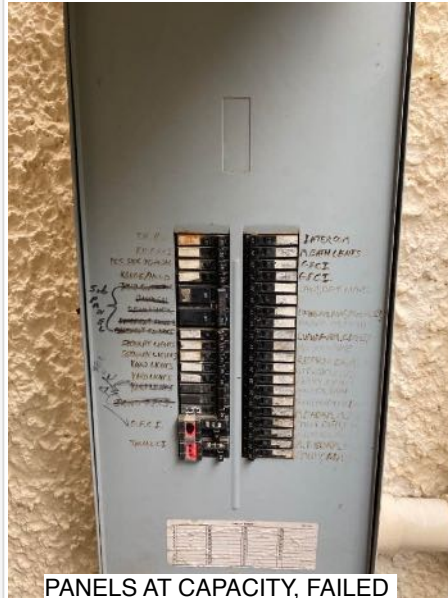
PANELS AT CAPACITY, FAILED BREAKERS

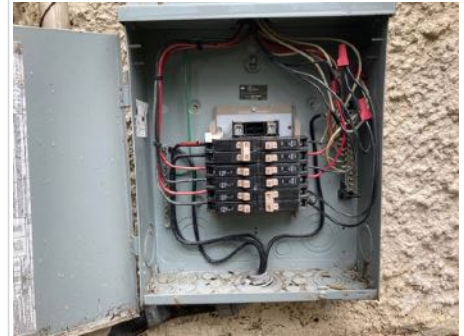
LABEL AND VERIFY PROPER BONDING

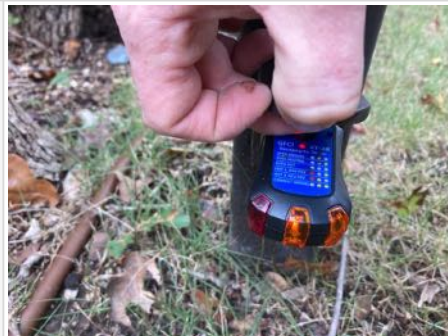
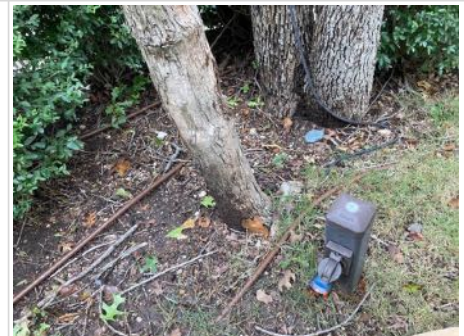
VARIOUS OUTLET ISSUES

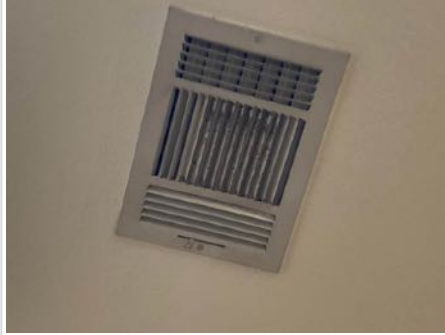
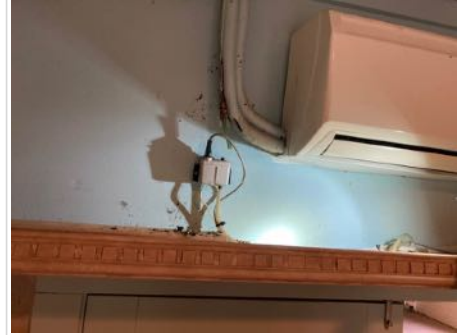
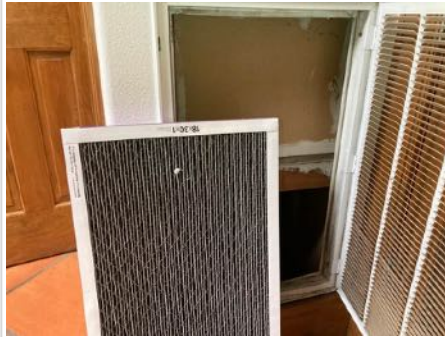
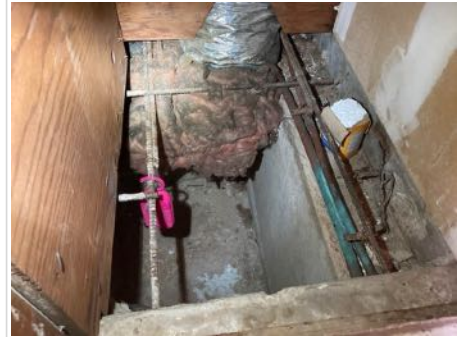
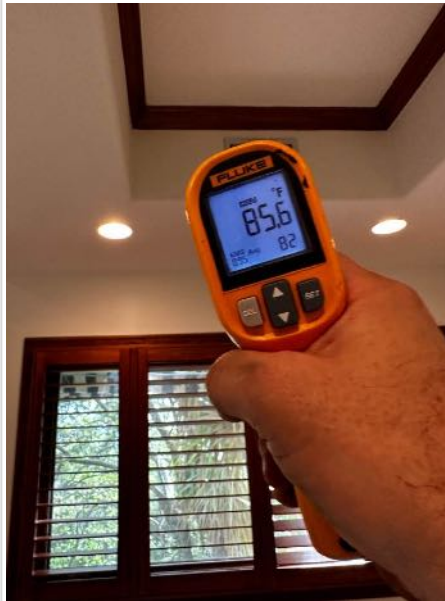
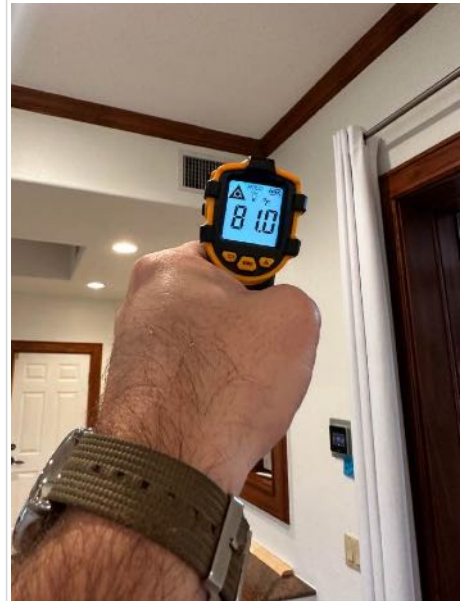
VARIOUS SERVICE, REPAIR, AND UPDATE NEEDS

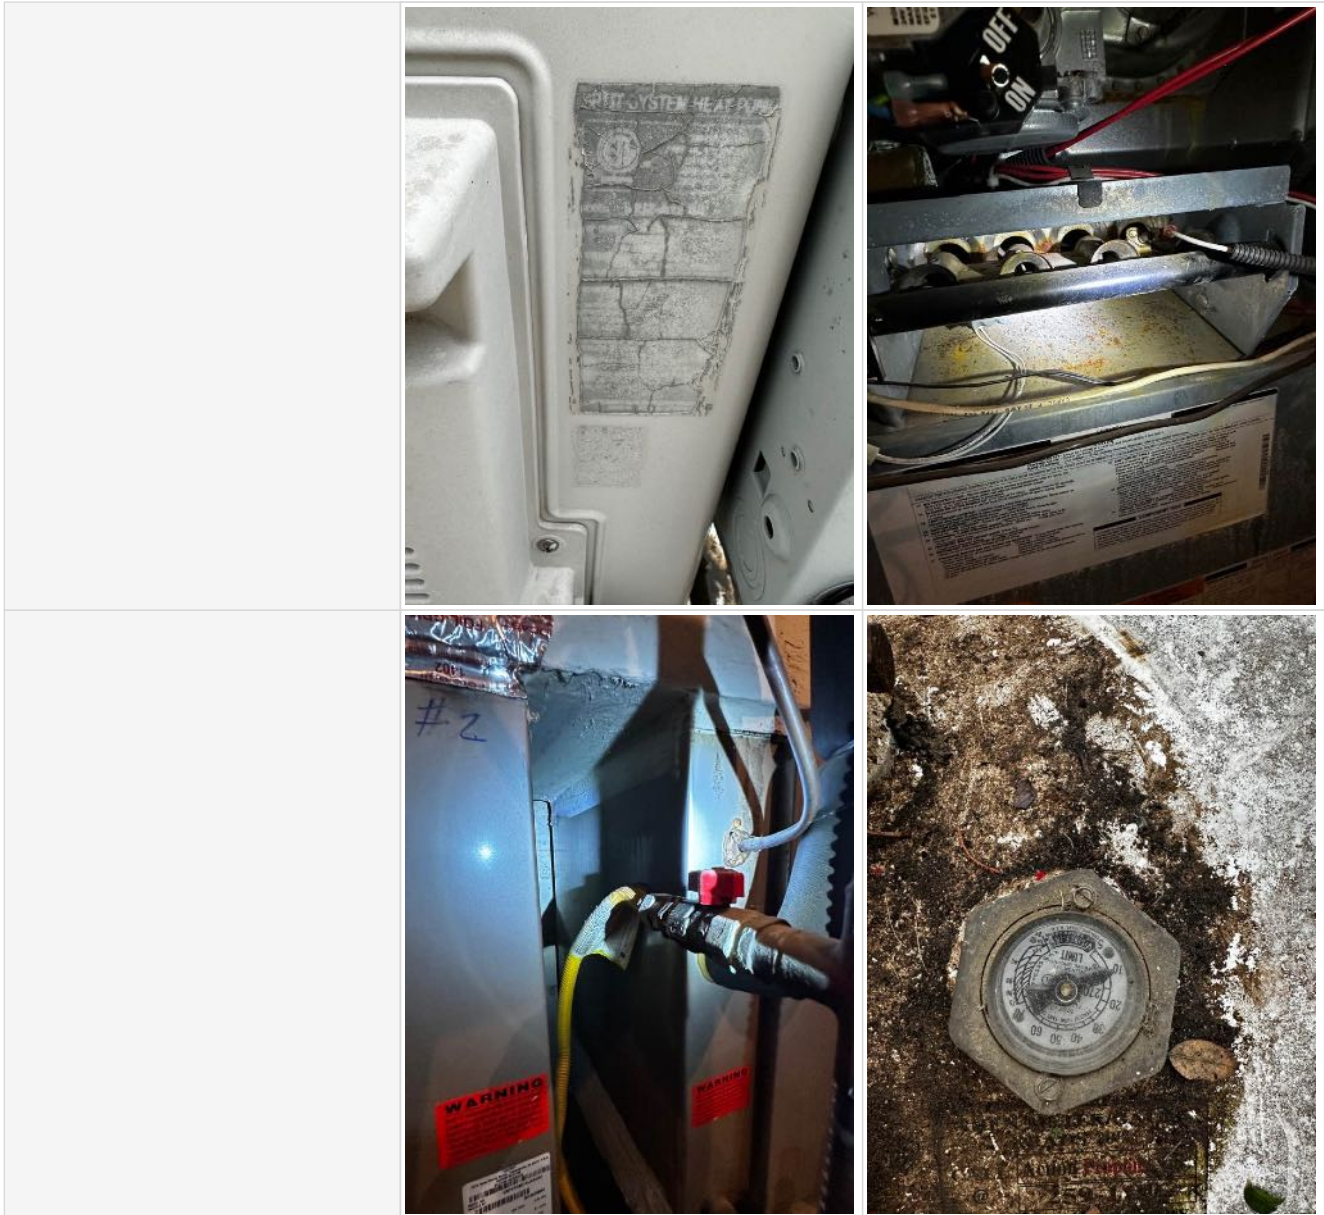
VARIOUS SERVICE, REPAIR, AND UPDATE NEEDS

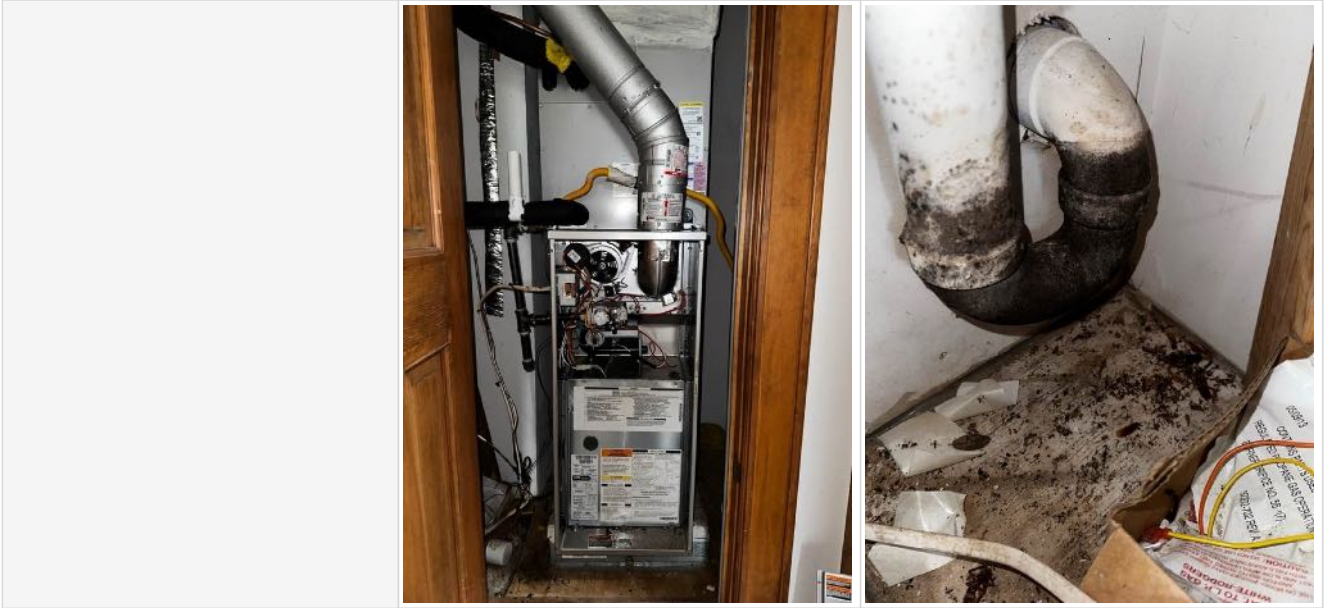
VARIOUS SERVICE, REPAIR, AND UPDATE NEEDS

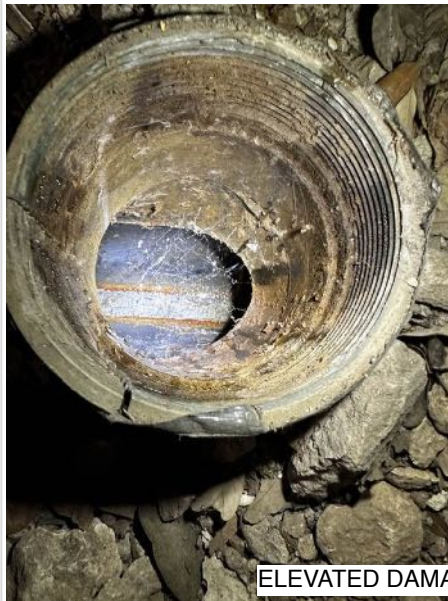
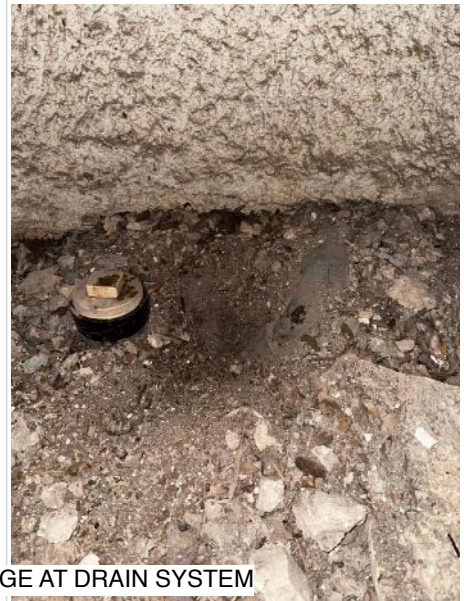
ELEVATED DAMAGE AT DRAIN SYSTEM

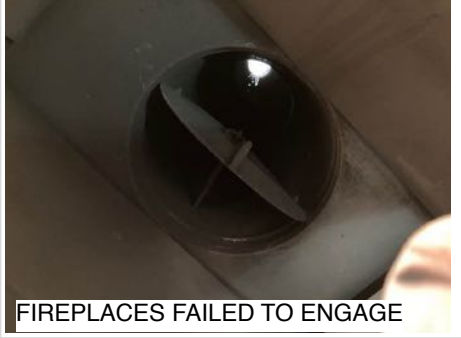
<p>FIREPLACES FAILED TO ENGAGE</p>

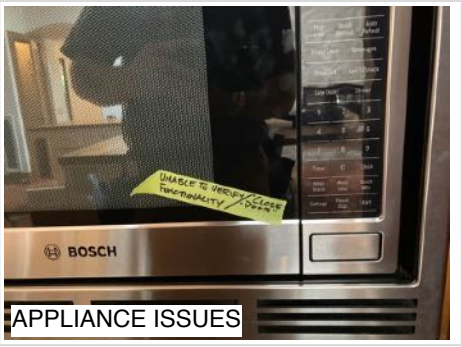
<p>APPLIANCE ISSUES</p>

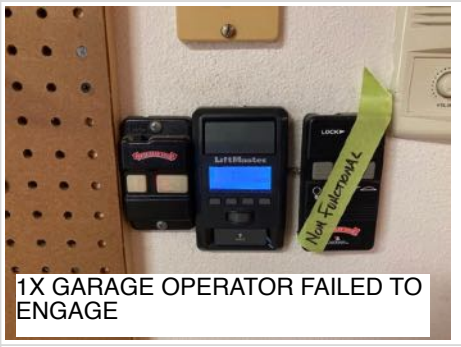
<p>1X GARAGE OPERATOR FAILED TO ENGAGE</p>
