GREENBELT STRUCTURAL SERVICES
A DIVISION OF TAHI LLC

Prepared By:

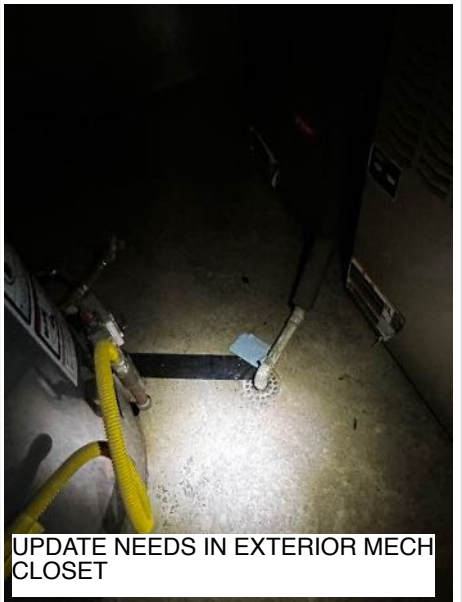
<p>UPDATE NEEDS IN EXTERIOR MECH CLOSET</p>

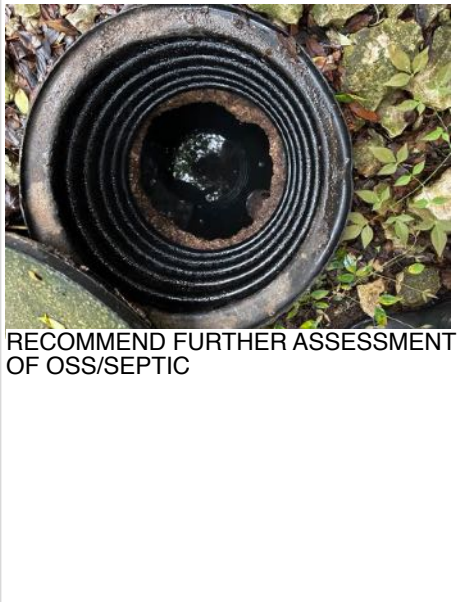
<p>RECOMMEND FURTHER ASSESSMENT OF OSS/SEPTIC</p>

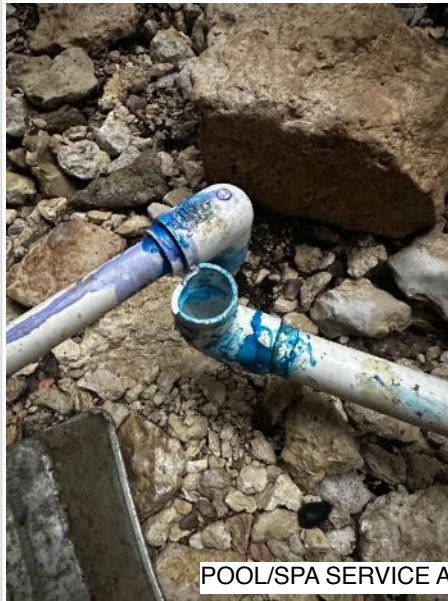
POOL/SPA SERVICE AND REPAIR NEEDS

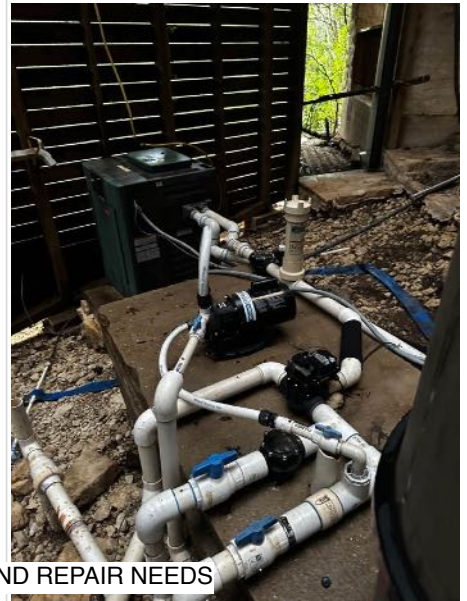
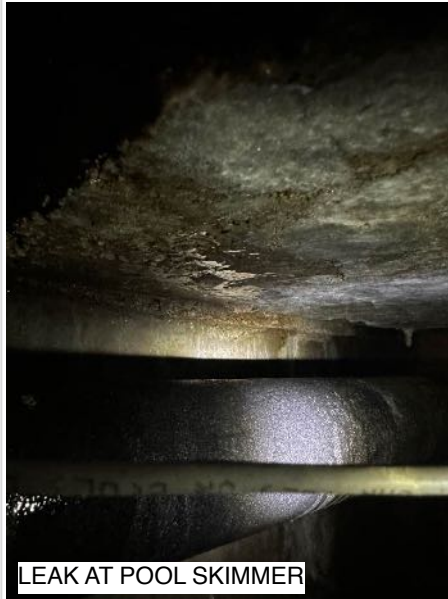
LEAK AT POOL SKIMMER

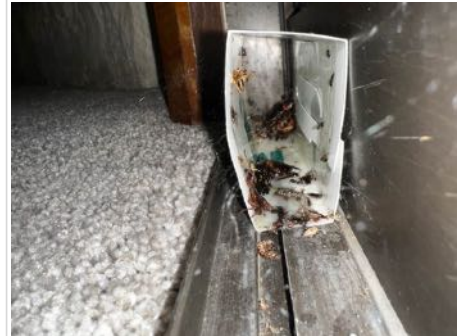
COMMON INSECT ISSUES

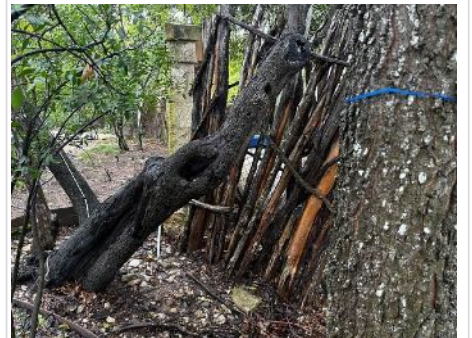
REMOVED CONTROLS/DEVICES

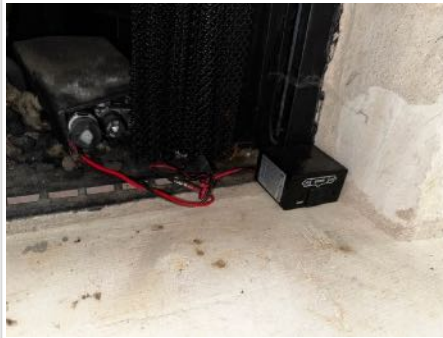
DAMAGED FIREPLACE DEVICES

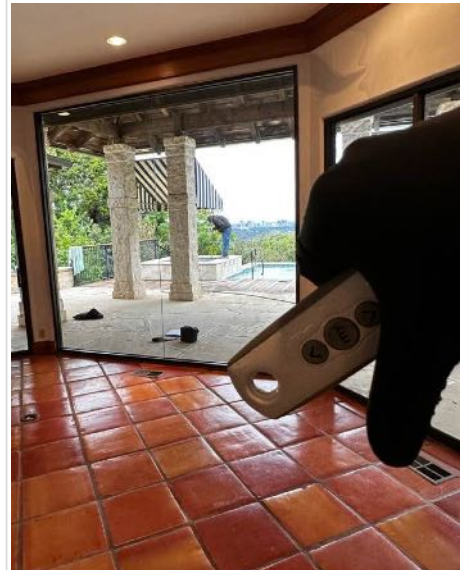
AUTOMATIC SHADES NOT FUNCTIONAL

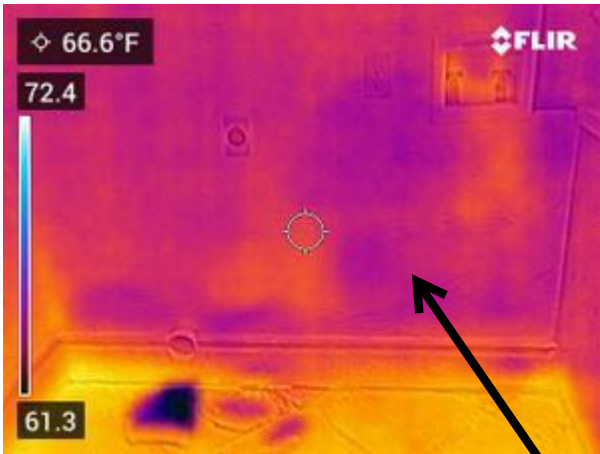
Oct 30, 2023, 1:48 PM

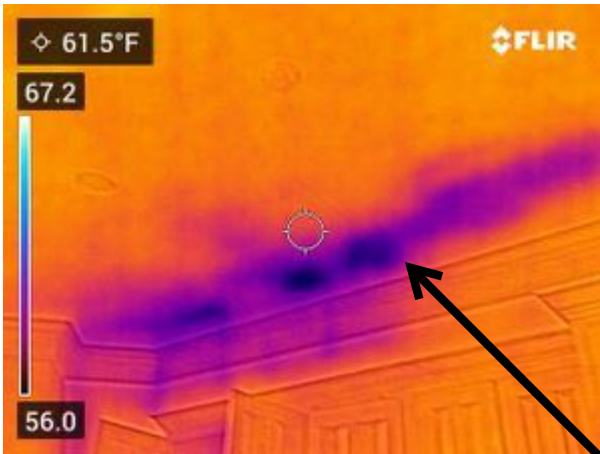
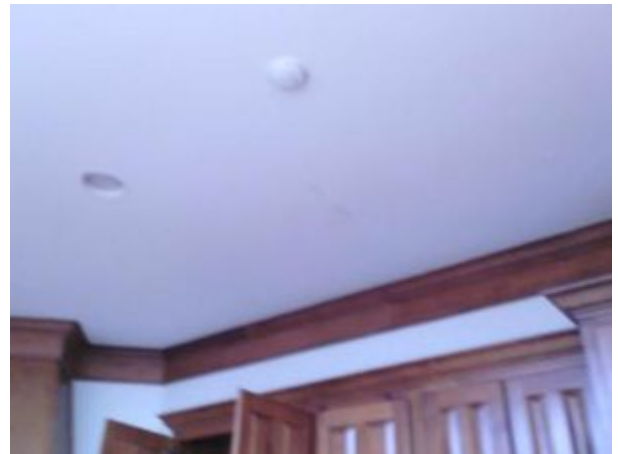
Oct 30, 2023, 1:44 PM

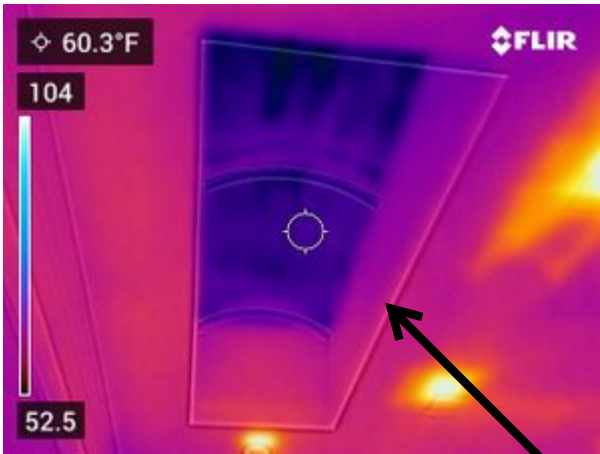
Oct 30, 2023, 3:17 PM
