GREENBELT STRUCTURAL SERVICES
A DIVISION OF TAHI LLC

TAHI Services and Greenbelt Structural performed a limited assessment at the above noted property. The purpose of the site visit was to assess the condition of the pool structure and surrounding outdoor features in order to collect additional information related to code and/or construction standard discrepancies identified in previous inspection reports.

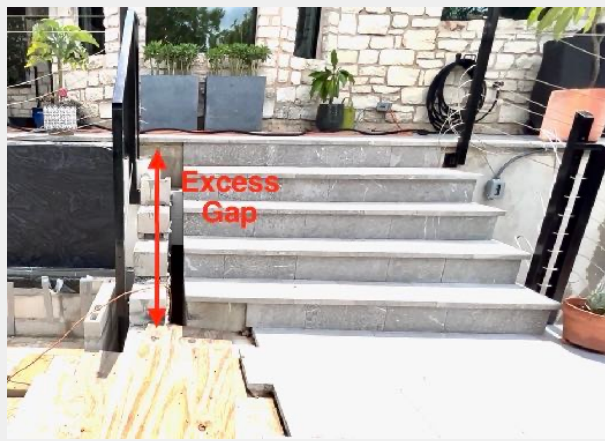
FIGURE #1

Review of photos provided in the pool inspection report are of note in that it appears the construction of the stairs was erroneous (as opposed to the issue being present due to incomplete construction). In the report photo (see Figure #1 below), it is apparent that the gap is located between the rough installed hand railing and stair tread. The concern associated with the construction method (as discovered during the pool inspection) is further noted on page 8 of the pool inspection report:

Gap at Stairs

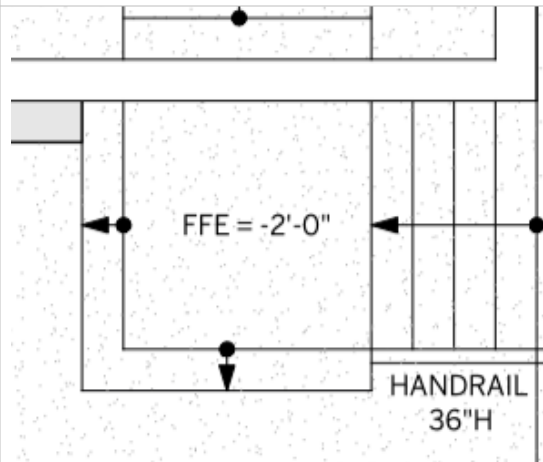
Intended Stair Construction
