Property: 123 Sample Rd.
Austin , TX 78703
Client: Sample Report - New Construction
Inspector: Andy Jordan #9458
Date: October 18, 2023

PROPERTY INSPECTION REPORT

Concerning: 123 Sample Rd. Austin, TX 78703
(Address or Other Identification of Inspected Property)

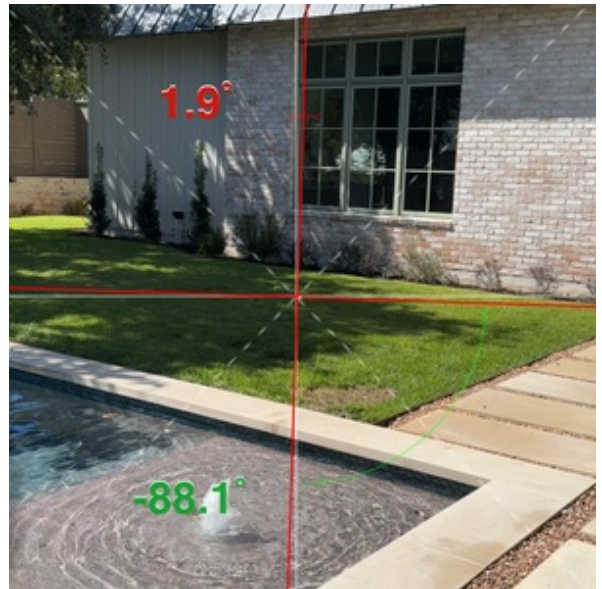
BACKYARD: MARGINAL DRAIN SLOPE

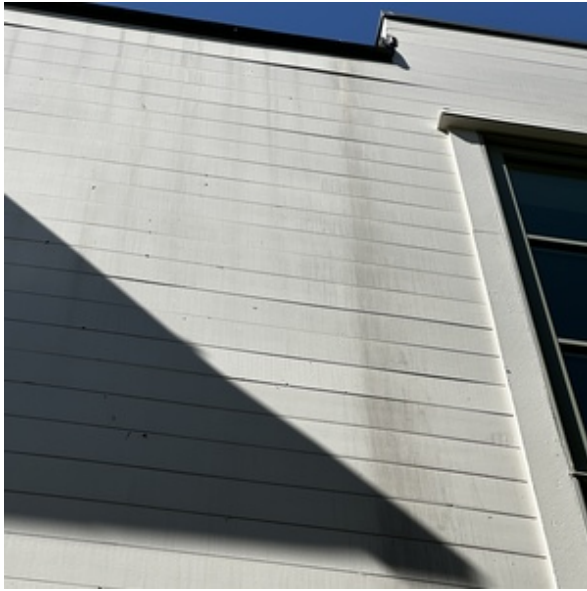
FLAT ROOF RUNOFF ON WALL

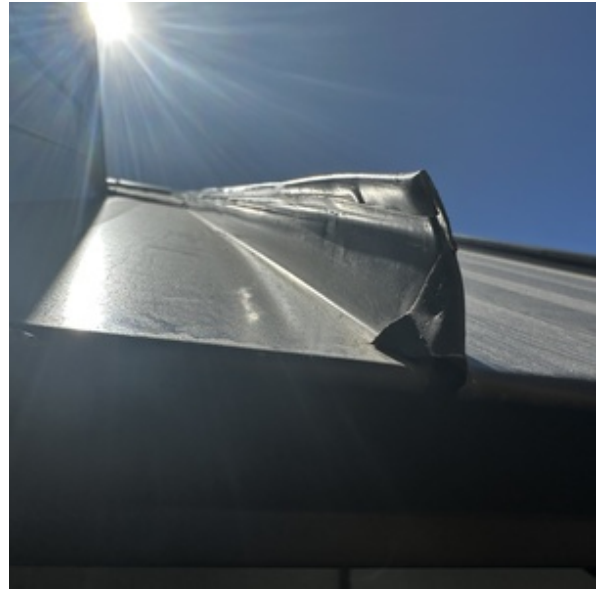
CRIMPING FLAWS/CONCERNS

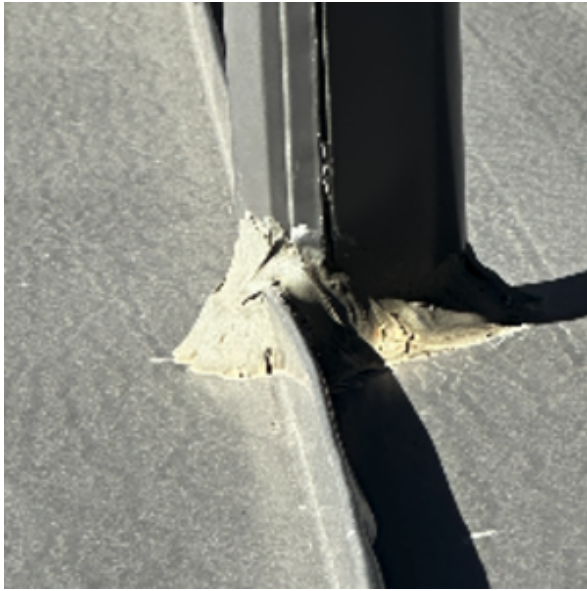
PENETRATIONS THROUGH SEAMS

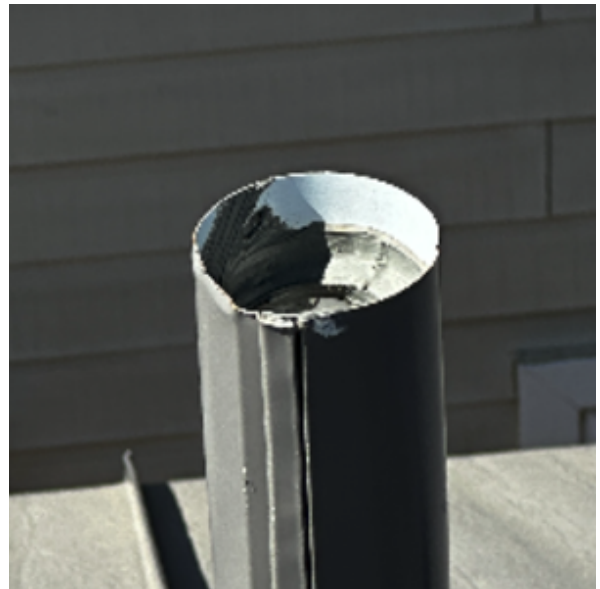
APPEARS CAULK DEPENDENT

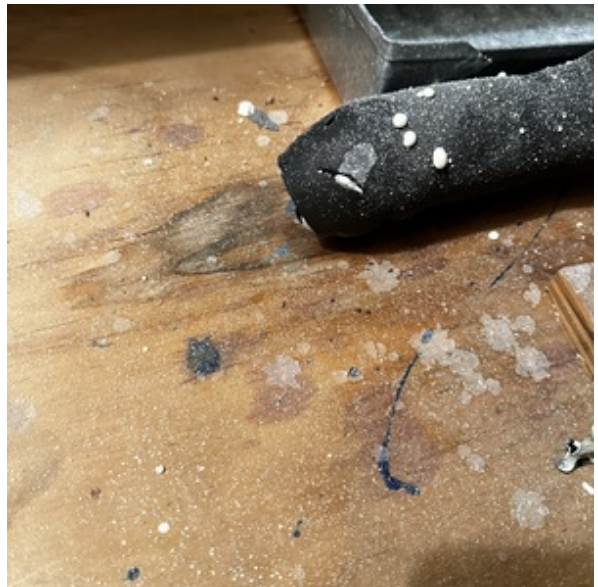
MOISTURE CONCERN NEAR DRAIN

-Moisture staining, condensation build up at wood platform near condensate drain pipe (2nd floor attic accessible through ceiling hatch): Improvements to HVAC condensate drain insulation advised to reduce likelihood of moisture issues over time (may require partial removal of platform near drain)

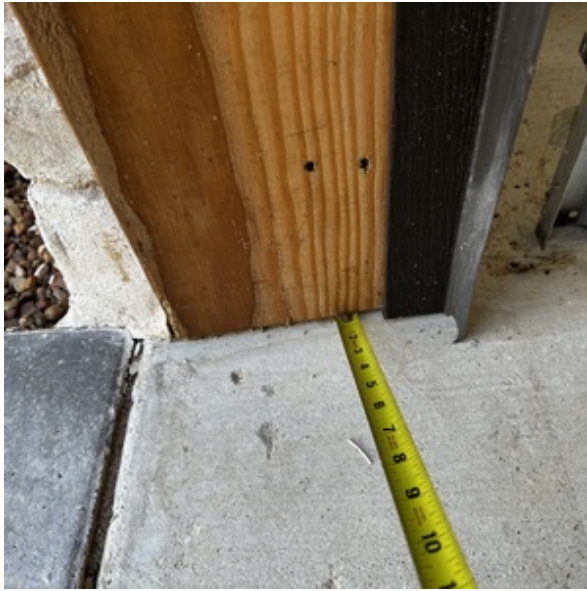
CREATE GAP AT TRIM

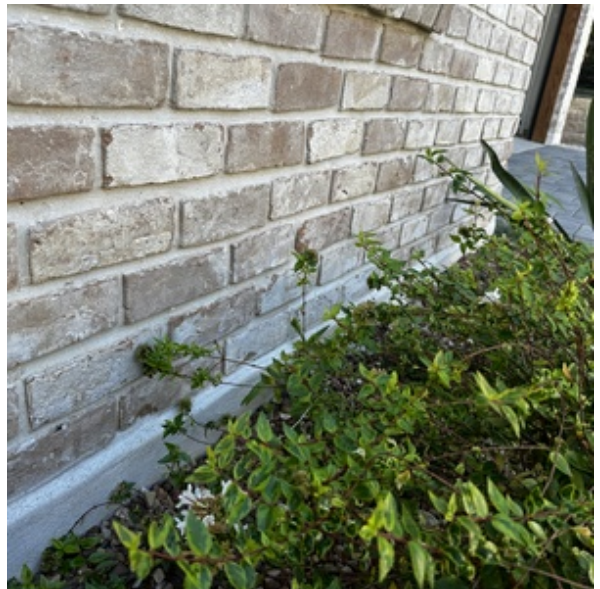
AREA OF MISSING/REDUCED WEEPHOLES

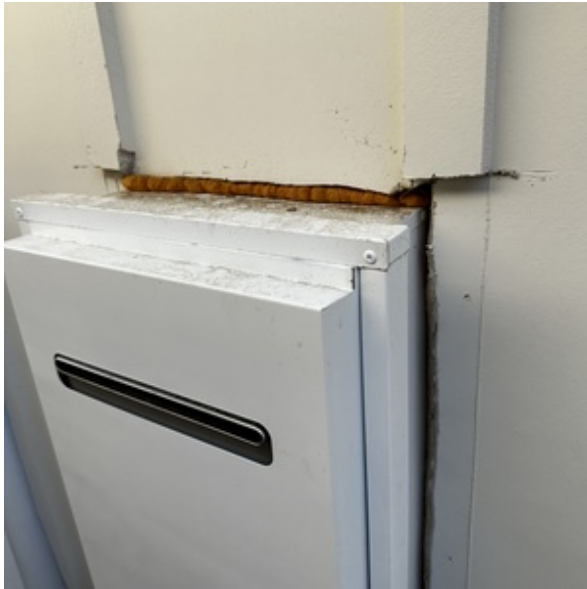
GAP/CUTS SURROUNDING W/H

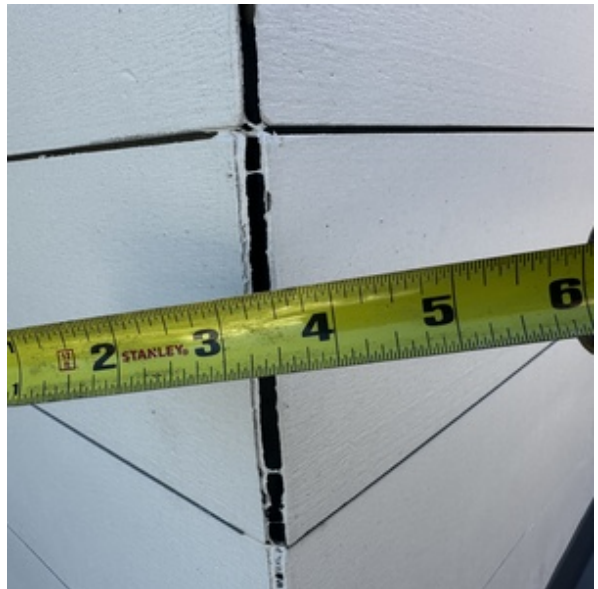
CLADDING GAP NEAR BARRIER FLAW

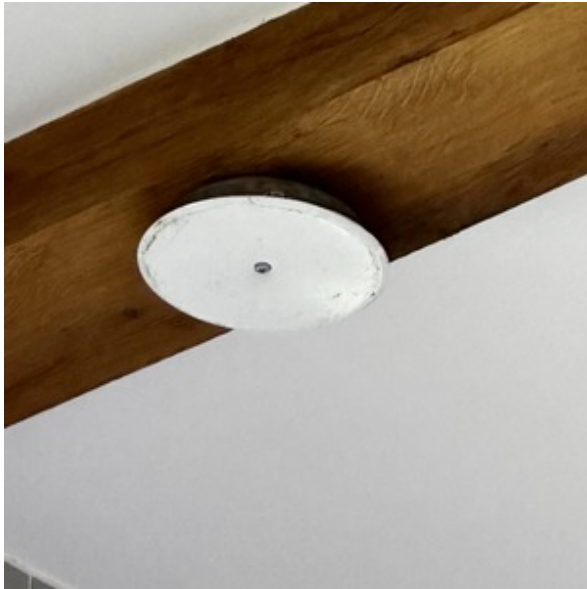
UNKNOWN FEATURE OVER TUB

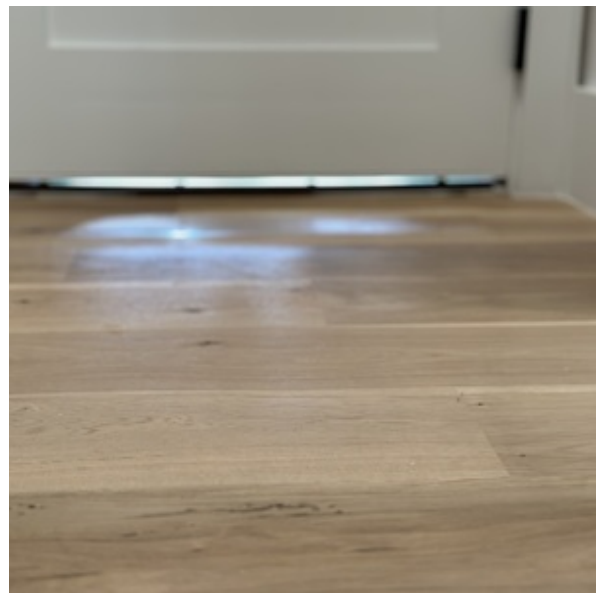
DRAFTING AT GARAGE ENTRY

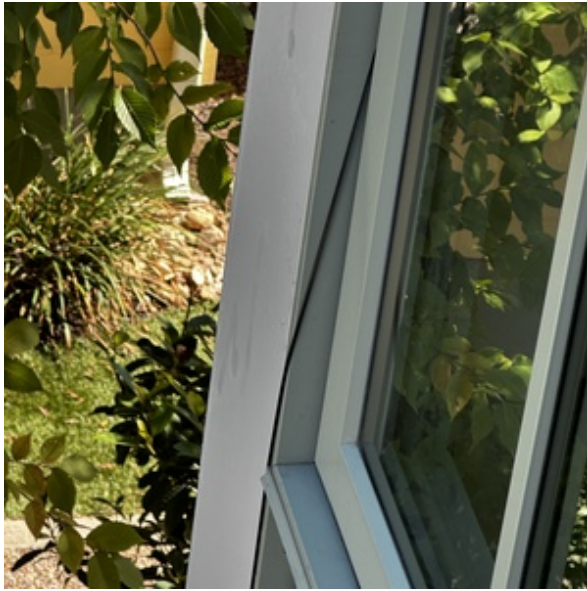
- A string or wire was observed hanging from the exterior front facing stair window (viewed from roof unable to determine what the material was): Further assess and address as needed
- Missing hardware (latch) at most functional windows: Provide latches throughout
- Recheck hardware during upcoming servicing (some loose latches, safety devices)
- Several issues difficult to open, not properly latching (builder was made aware, servicing schedule): Re-test as needed
- NOTE: Most issues marked on site (painters tape with brief explanation of issue)

STRING OR WIRE NEAR WINDOW

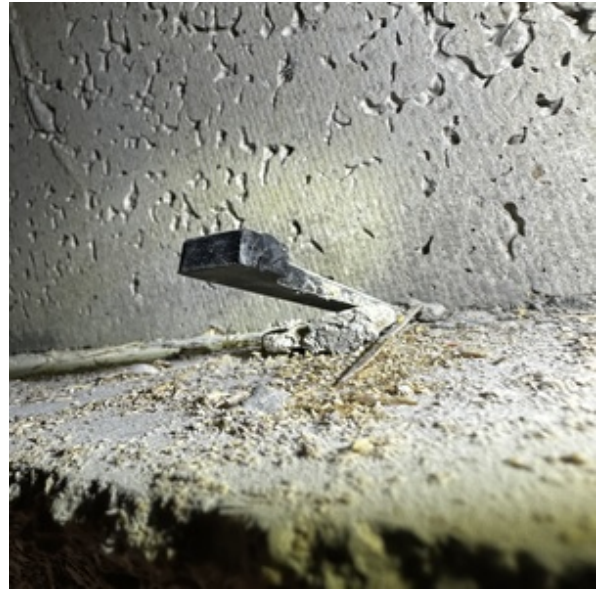
CUT/REMOVE PLASTIC SHIM

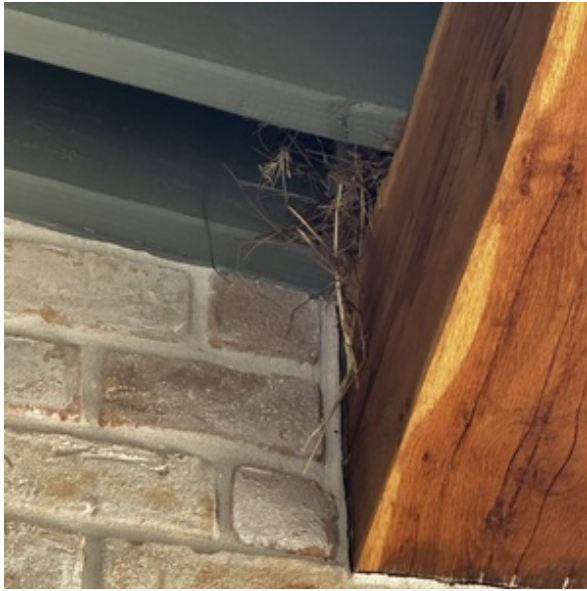
REMOVE BIRD NEST

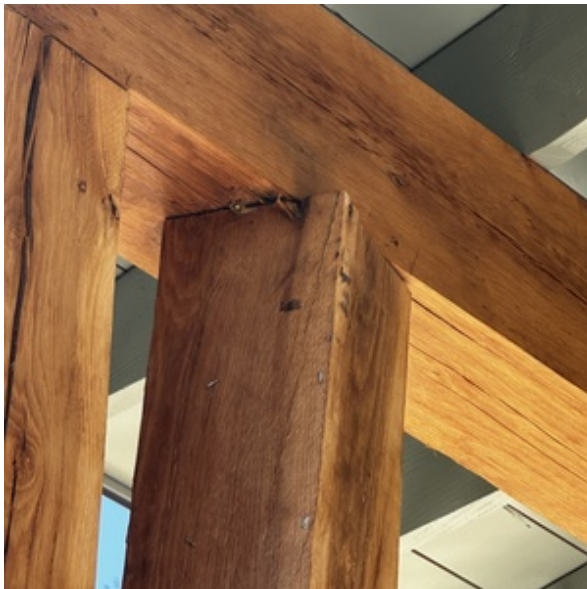
A bowed and twisted column at the back porch was discovered. Although the flaw in its current condition does not pose a structural concern, replacement may be needed to address the uneven nature of the feature.

BOWED/TWISTED COLUMN

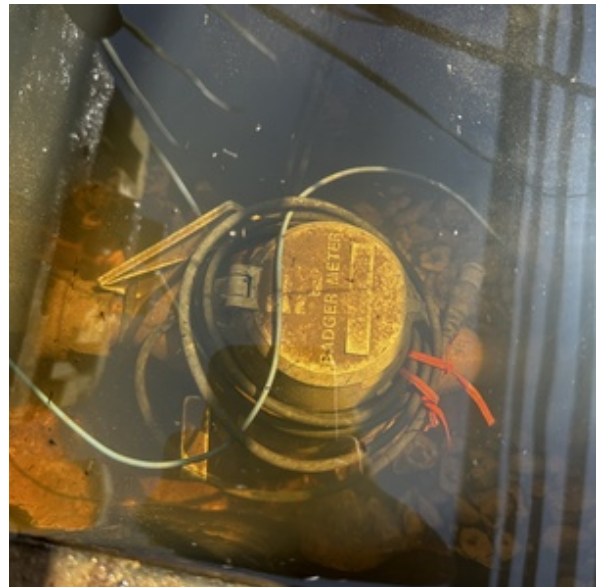
NOTE: Due to standing water at front yard, it is likely that the point of water loss is related to the irrigation system.

STANDING WATER IN METER BOX

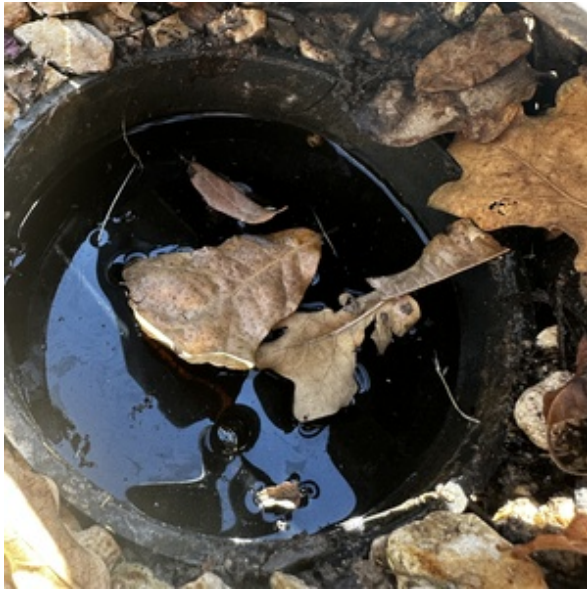
STANDING WATER IN VALVE BOX

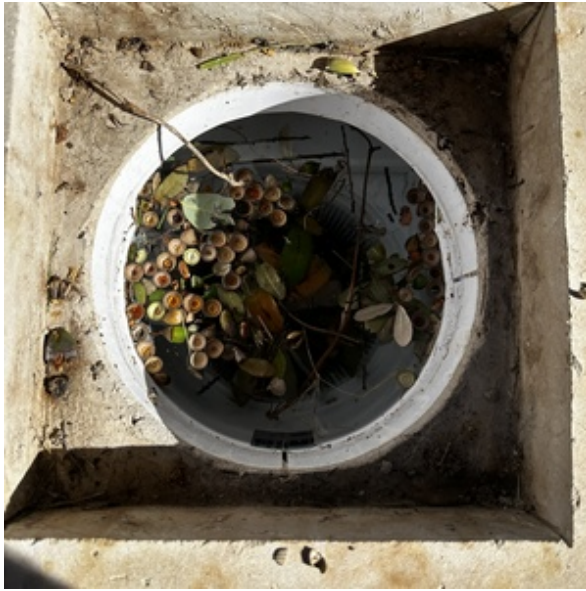
TREES NEAR POOL, SINGLE RETURN
