**GREENBELT STRUCTURAL SERVICES**  
A DIVISION OF TAHI LLC

Property: 123 Sample Rd.  
Austin , TX 78736  
Client: Sample Report - Existing Building  
Inspector: Andy Jordan #9458  
Date: September 8, 2023

# PROPERTY INSPECTION REPORT

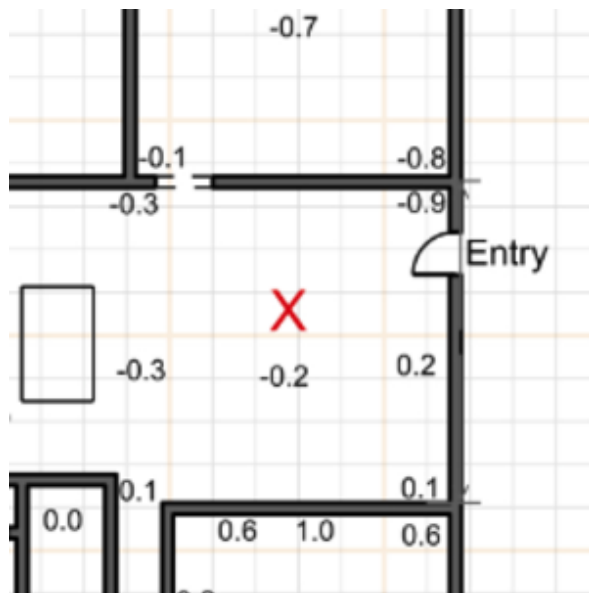
APPX. 1" DROP: COMMON AREA

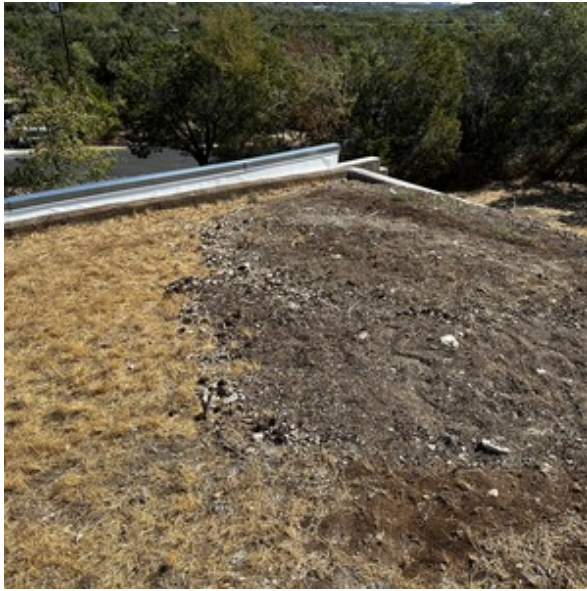
AREA OF PREVIOUS REPAIR

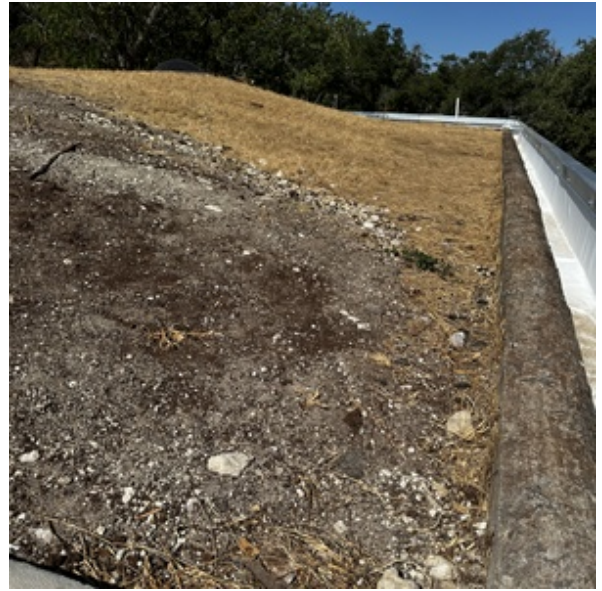
FRONT ROOF GUTTER PROVIDED

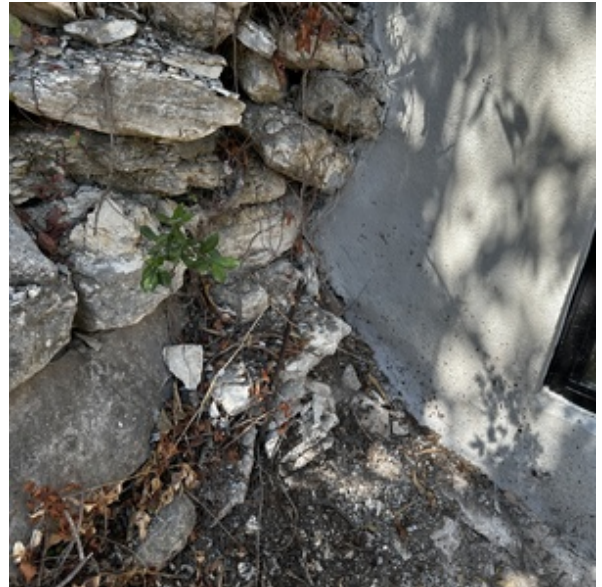
-Loose dry-stacked retaining walls shifted/stones fell during the inspection process (additional shifting/falling stones may result in a need for repair/updates)

LOOSE DRY STACK ABUTTING WALLS

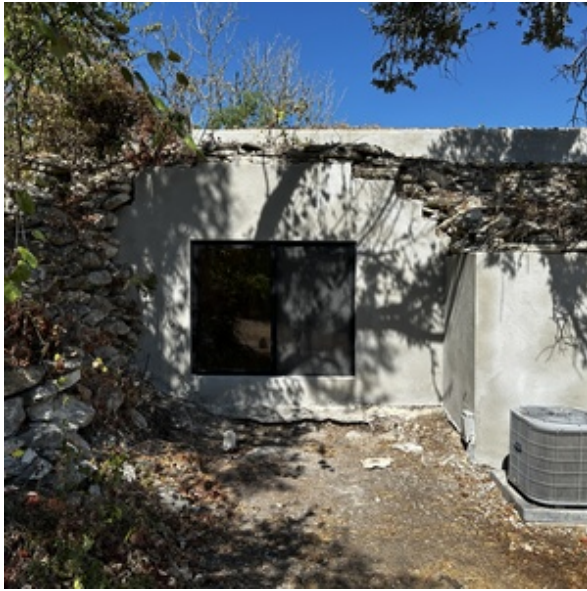
DRAINAGE CONCERN OVER WINDOW

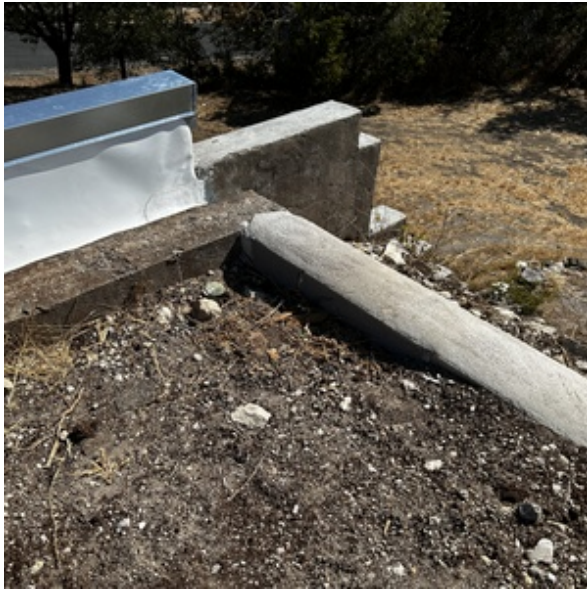
PREVIOUS ROOF/WALL REPAIRS

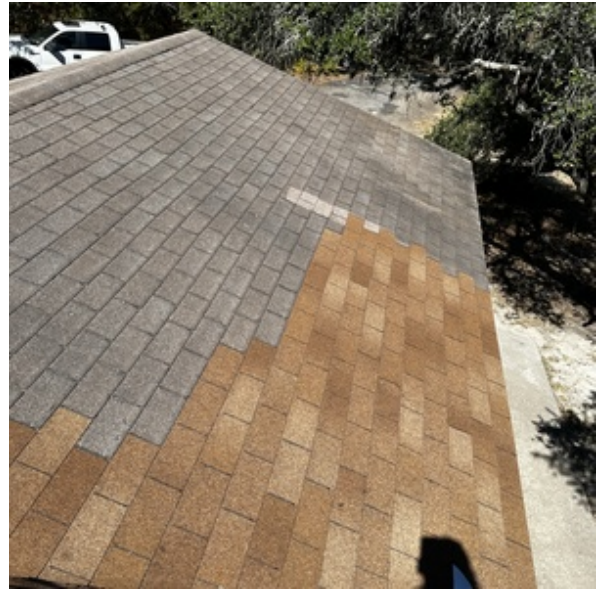
PARTIAL SHINGLE REPLACEMENT

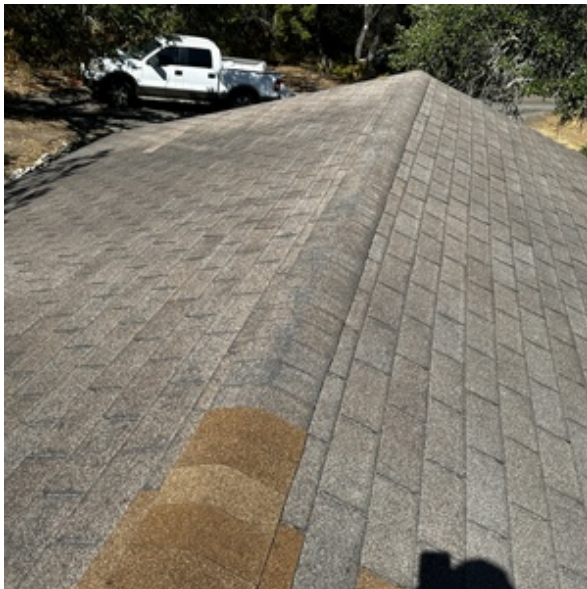
REMAINING SHINGLES IN POOR CONDITION

- REPLACE COMPOSITE SHINGLE ROOFING MATERIAL:  
The roofing material is considered to be in a state of deterioration and has surpassed its overall useful life span. Due to current condition of the roof covering, it is recommended that action take place to replace the coverings (repair no longer a feasible option). Contacting a roofing expert to provide options, costs and conduct professional work.

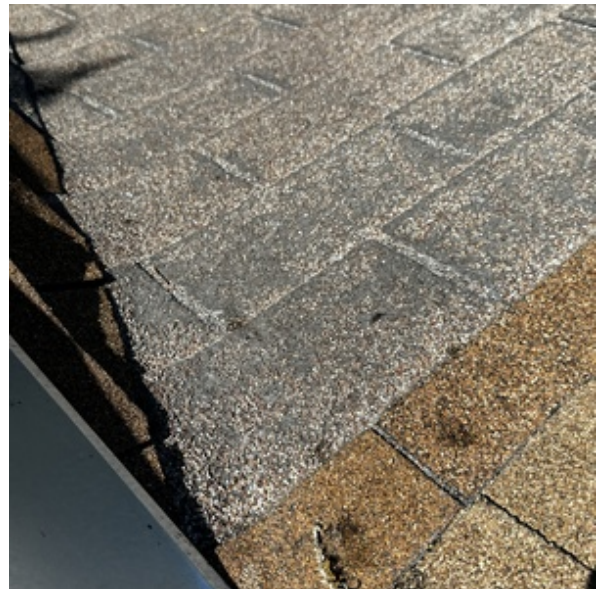
REMAINING SHINGLES IN POOR CONDITION

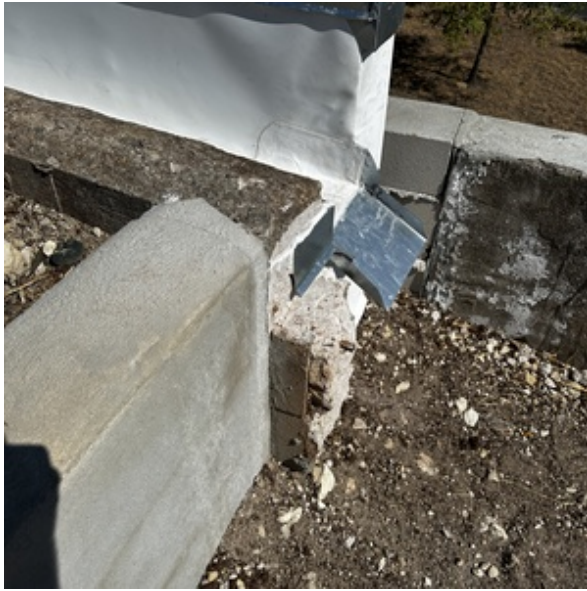
ROOF INTERSECTION CONCERNS

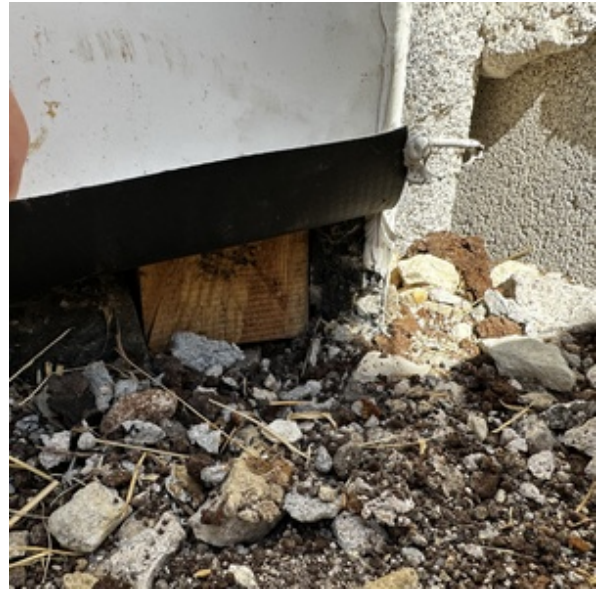
- Loose TPO and exposed plywood noted at the roof channel drain termination point (roofer to further inspect and update as needed)
  - Adjustments to allow for the proper drainage/diversion of water required

EXPOSED PLYWOOD, LOOSE TPO

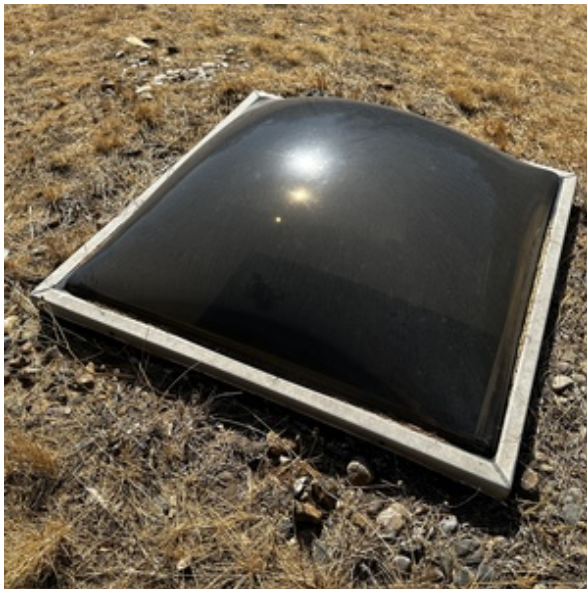
DATED SKYLIGHT

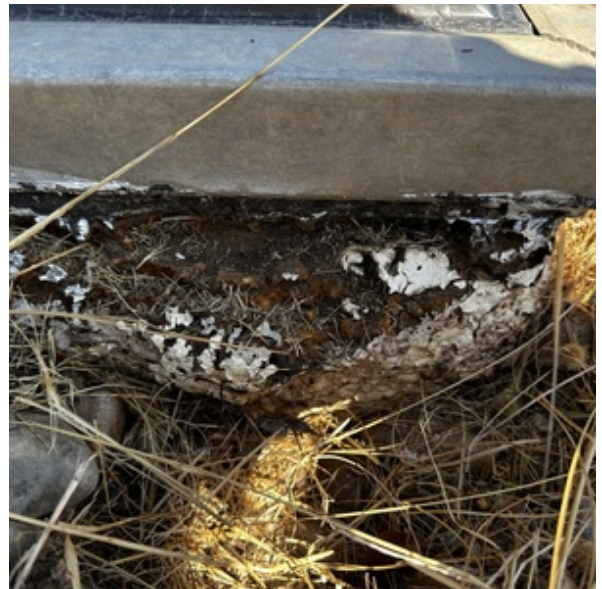
DETERIORATION OF FOAM SURROUNDING

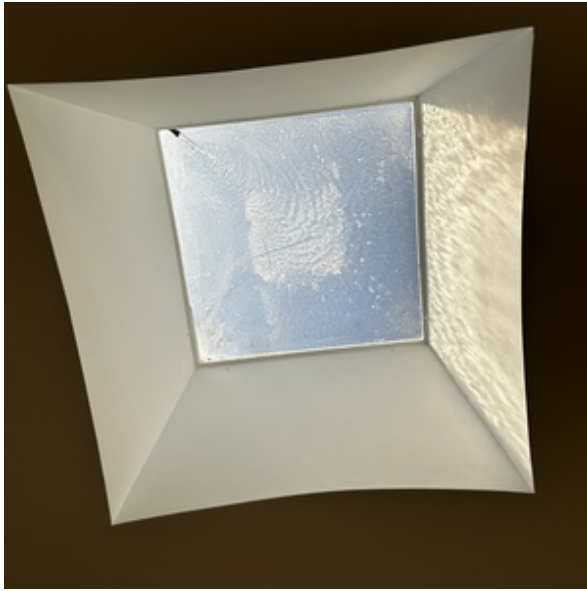
MOISTURE TESTING CONDUCTED

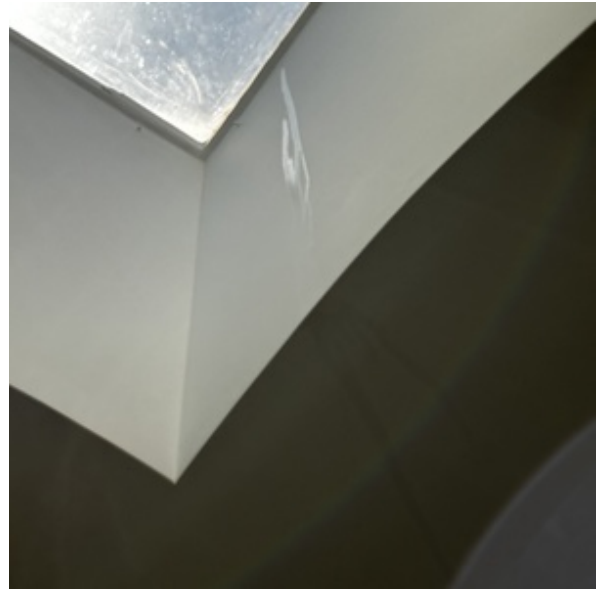
LEAK AT SKYLIGHT

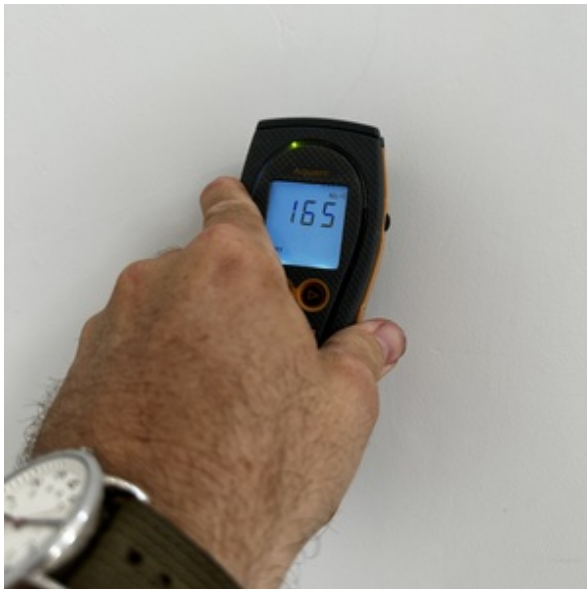
MOISTURE MAPPING: CONTROL READING

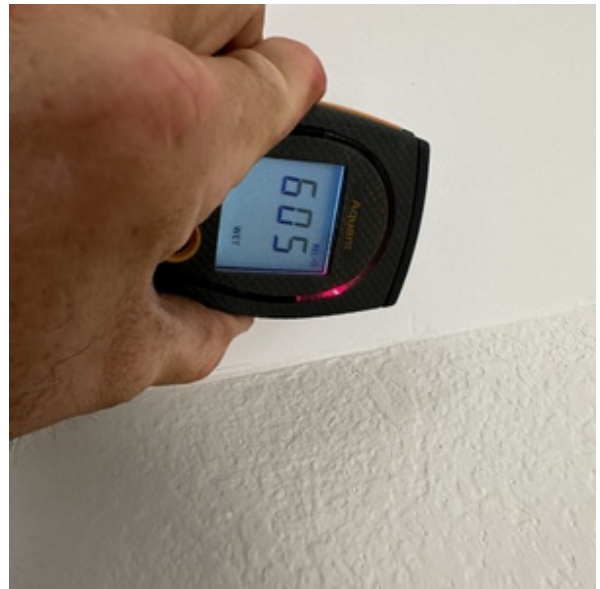
ELEVATED READING: NEAR DINING CEILING

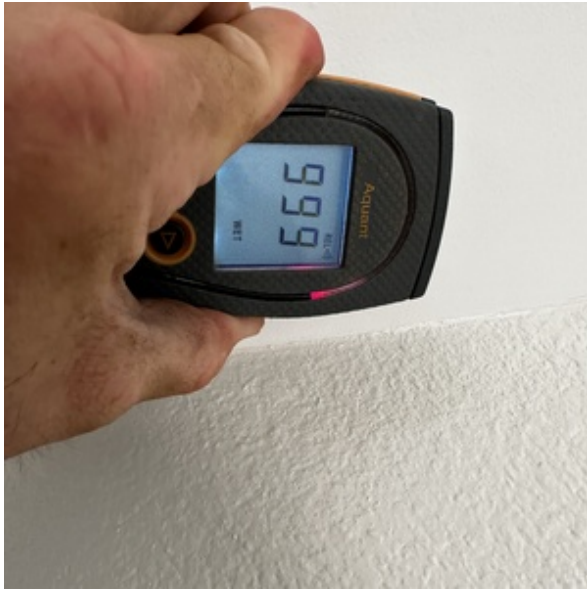
MAX READING: NEAR DINING CEILING

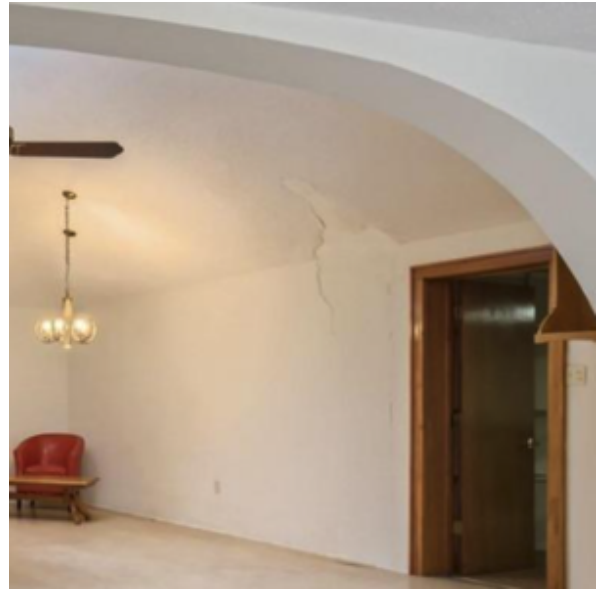
PREVIOUS DAMAGE NEAR HIGH READING

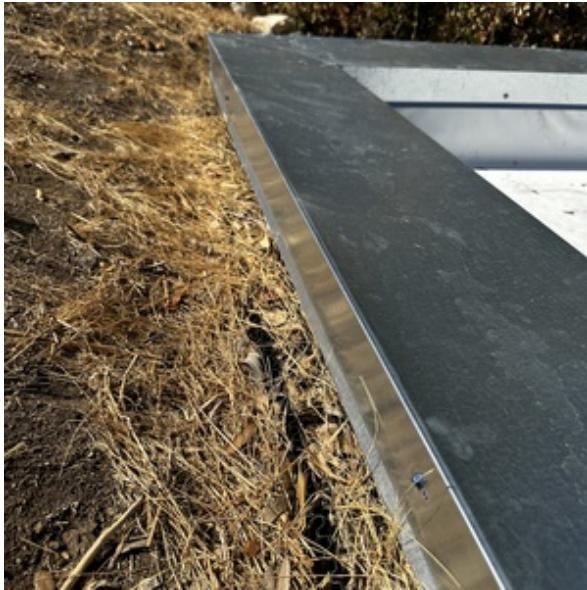
CONCERNS AT ROOF TRANSITION (TESTED)

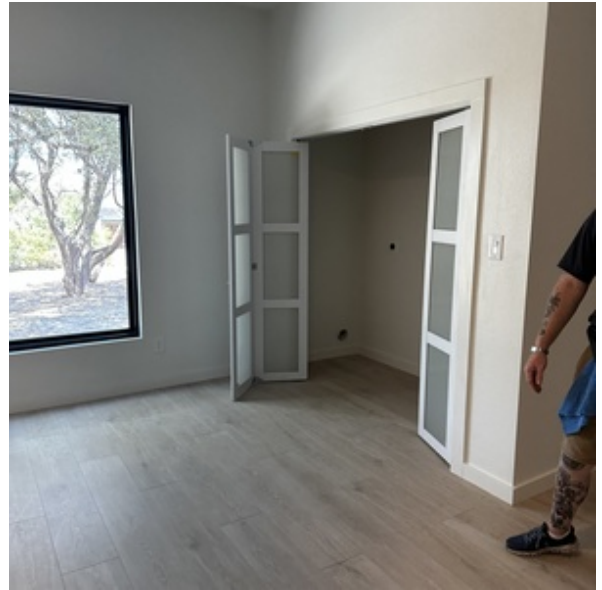
LEAK DISCOVERED IN LAUNDRY

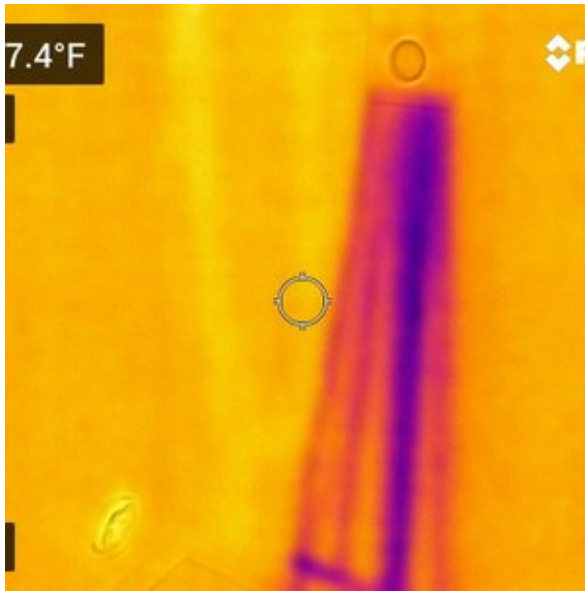
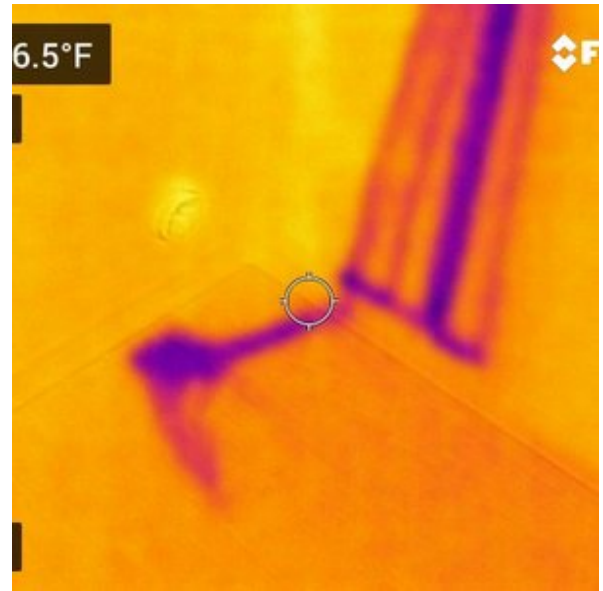
THERMAL: LAUNDRY AREA LEAK

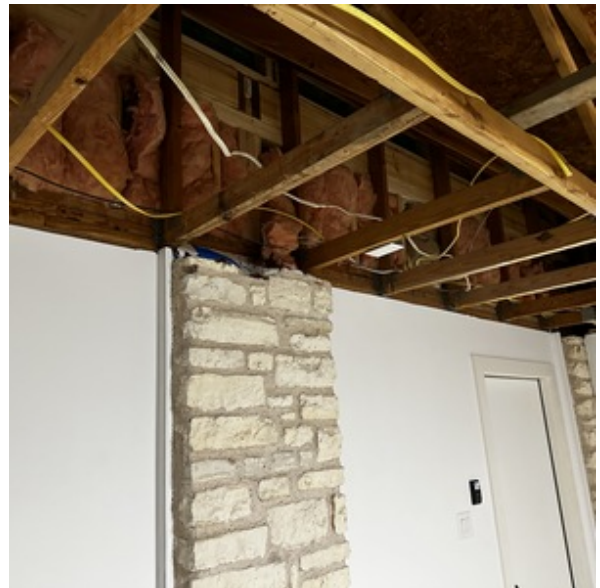
ENGINEERED TRUSS AT GARAGE

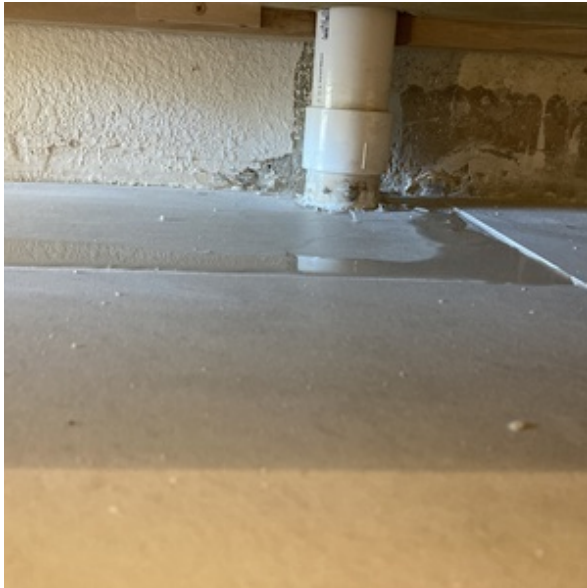
LEAK UNDER BATHROOM SINK

-Previous and current/active leak affecting interior material was discovered: Ensure any water damaged material is repaired/replaced as needed.

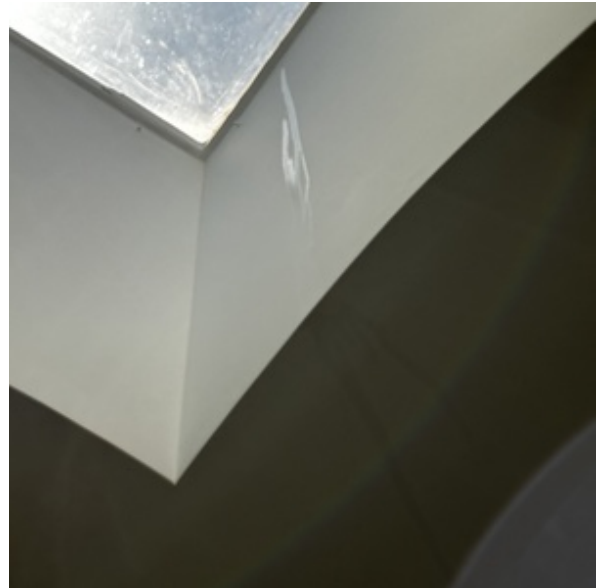
LEAK AT SKYLIGHT

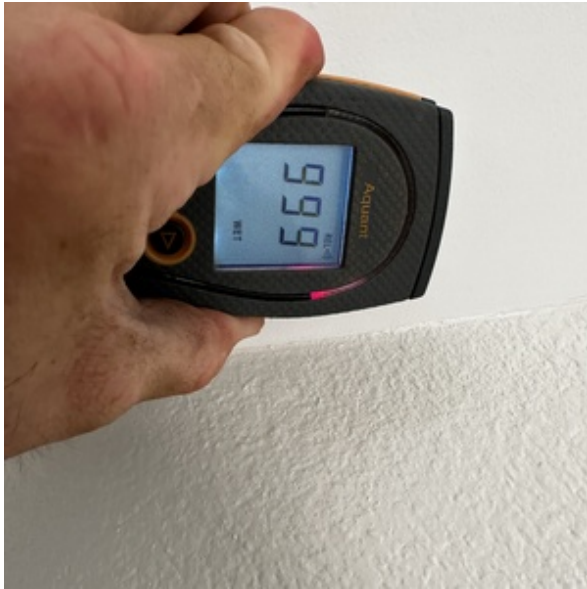
DINING: ELEVATED MOISTURE READINGS

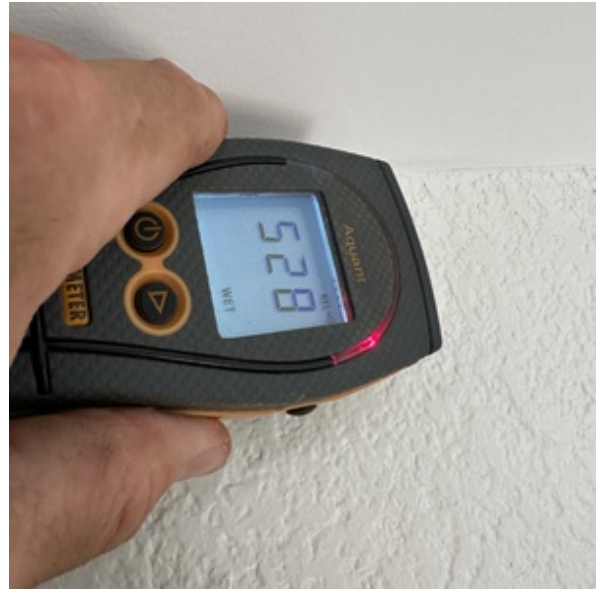
DINING: ELEVATED MOISTURE READINGS

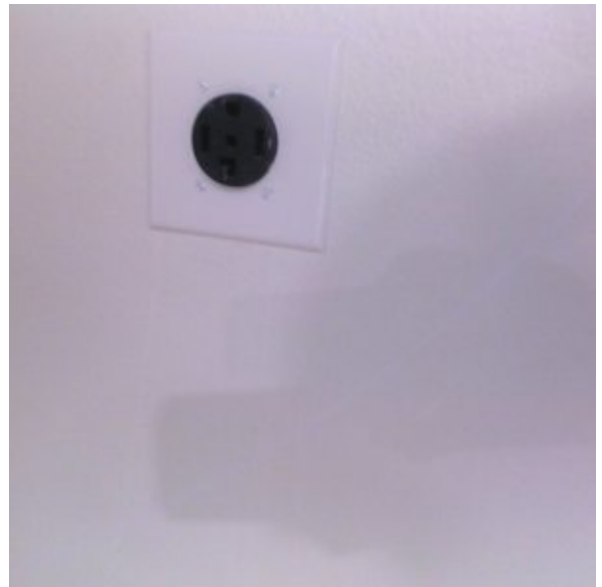
LEAK EXITING AT DRYER OUTLET

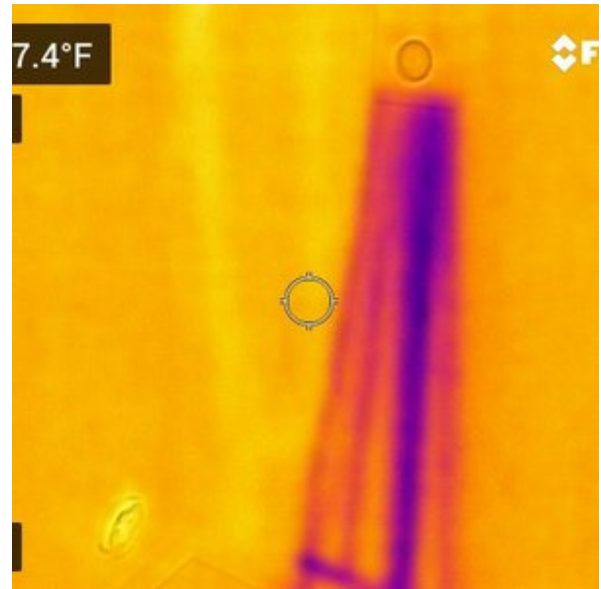
LEAK OVER LAUNDRY/NEAR MAIN ENTRY

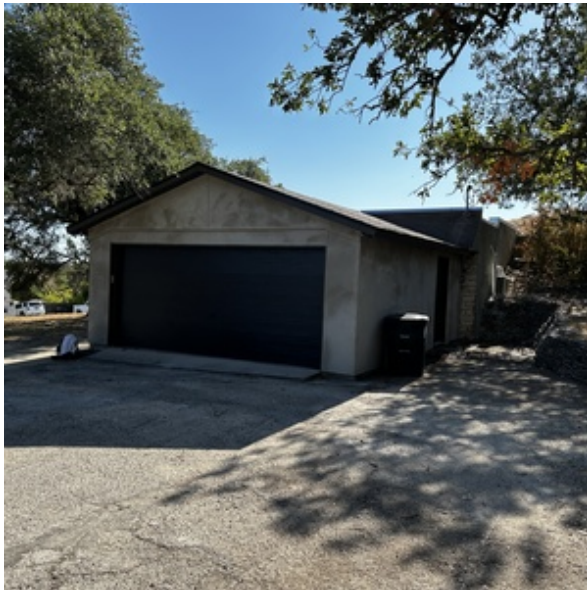
VARIOUS CLADDING TYPES

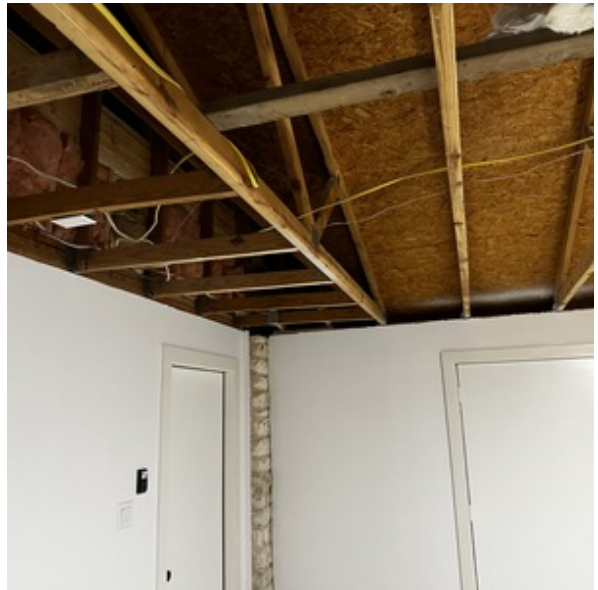
GARAGE: MISSING FIREWALLS

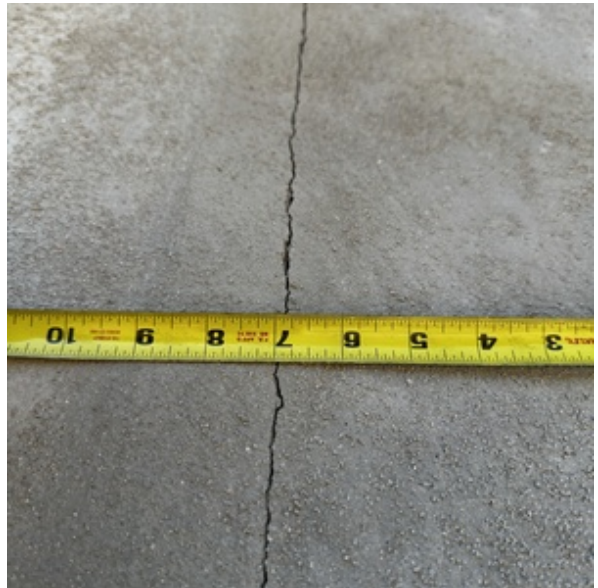
-The front facing, left side retaining wall has undergone shear stress, causing the wall to become unlevel, cracks have appeared at recently installed cladding (stucco type facade): Further stress damage would require repair and/or replacement

CRACKS AT RECENTLY INSTALLED CLADDING

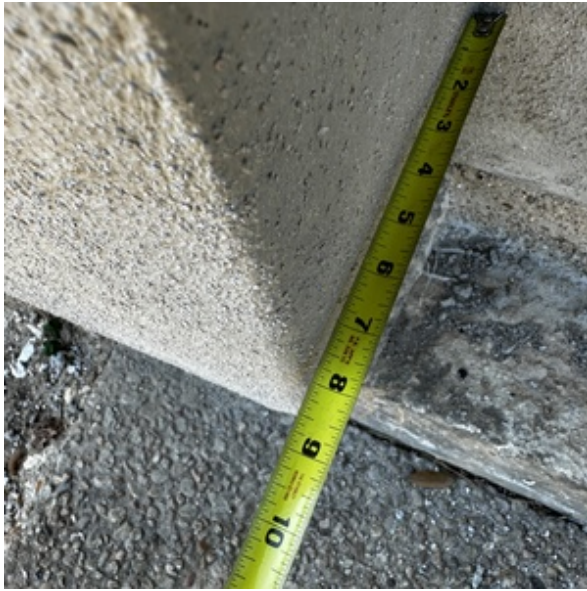
LOWER WALL: 8"

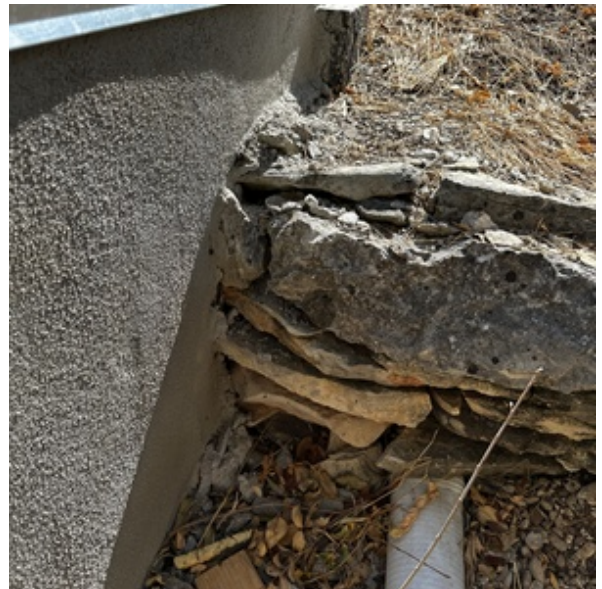
LOOSE STONE ABUTS STUCCO

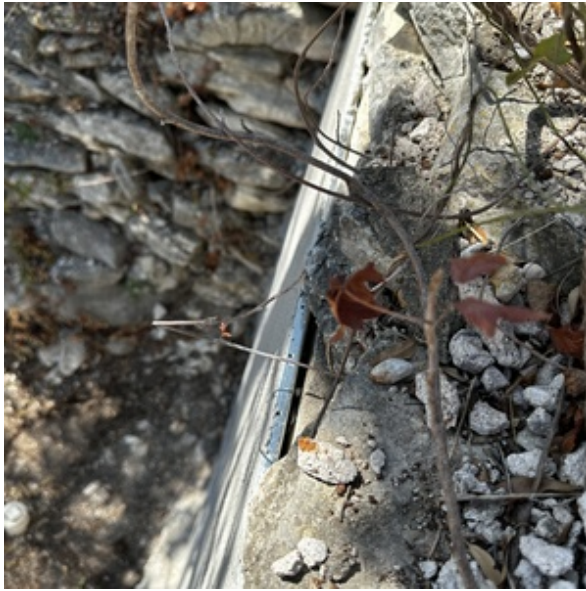
NO UPPER CLADDING FLASHING

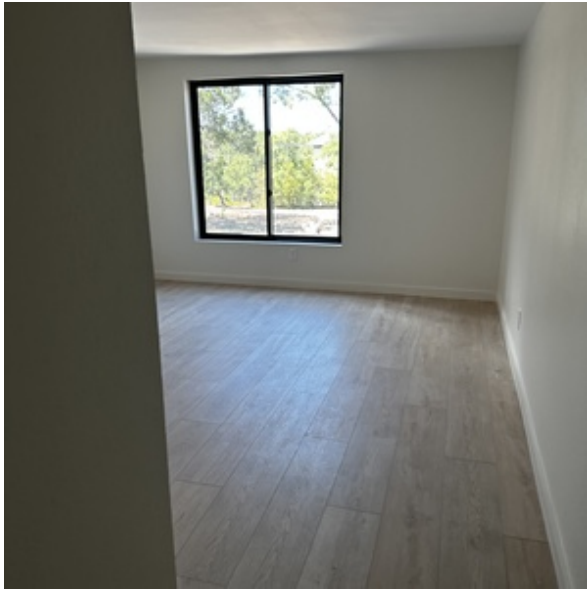
RECENT FLOORING UPDATES

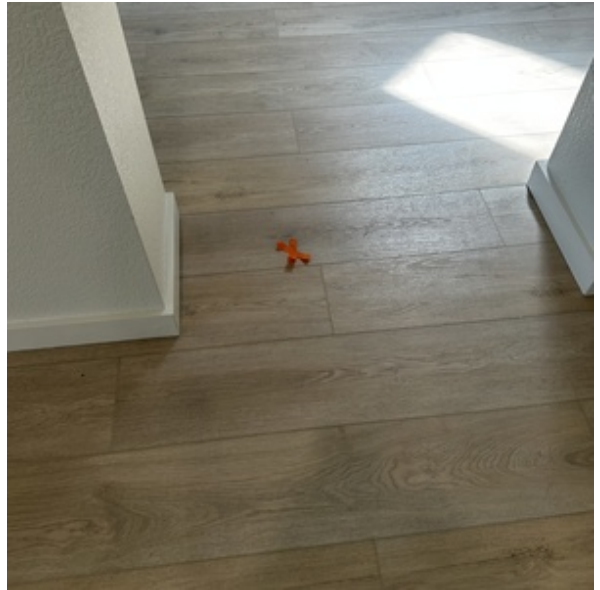
HOLLOW SPOT IN FLOORING

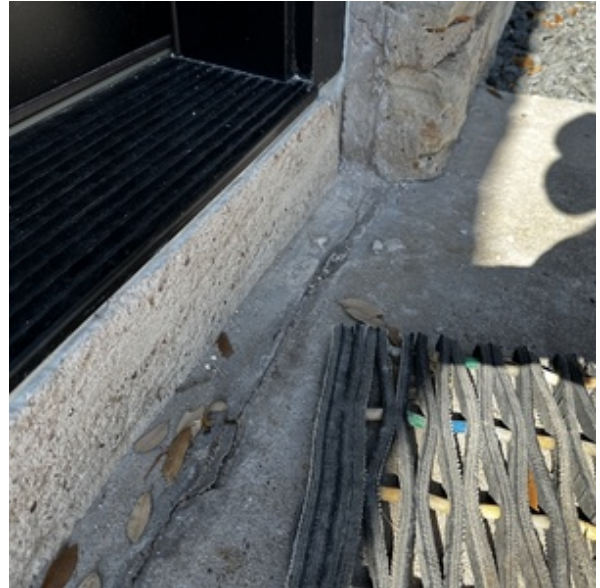
CRACKS AT ENTRY PORCH/LANDING

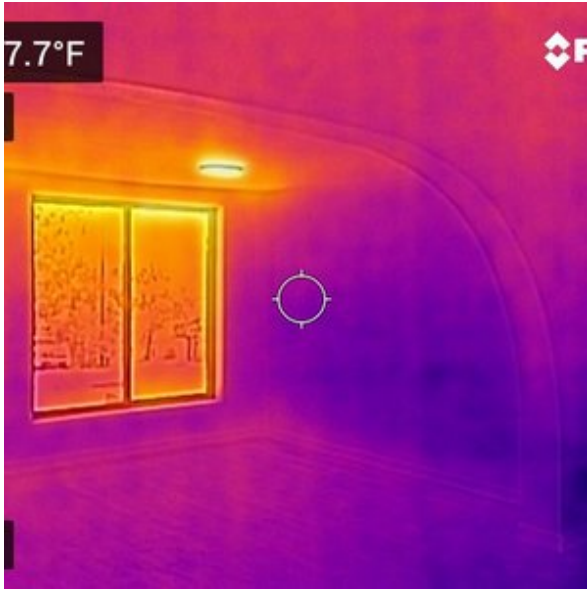
THERMAL CAMERA: NORMAL READINGS

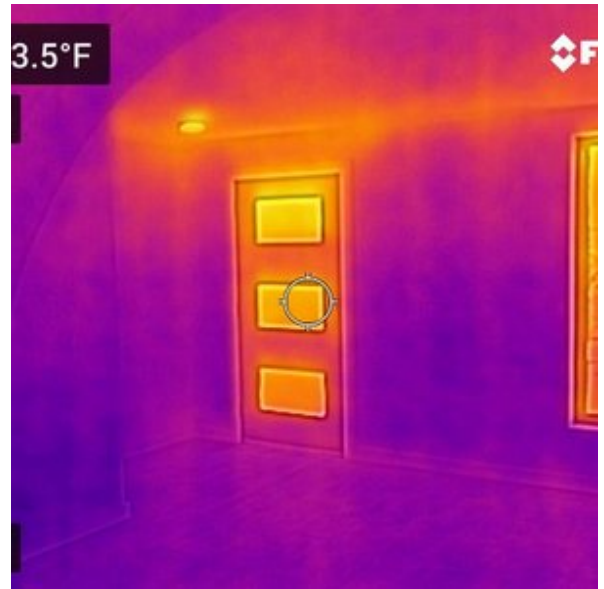
THERMAL CAMERA: NORMAL READINGS

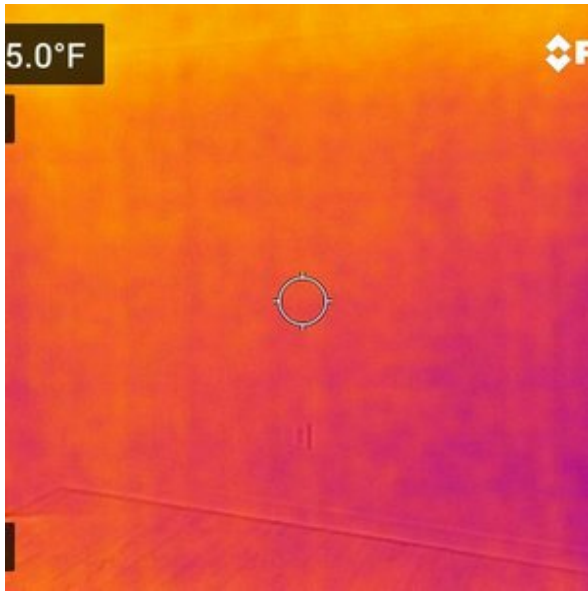
THERMAL CAMERA: NORMAL READINGS

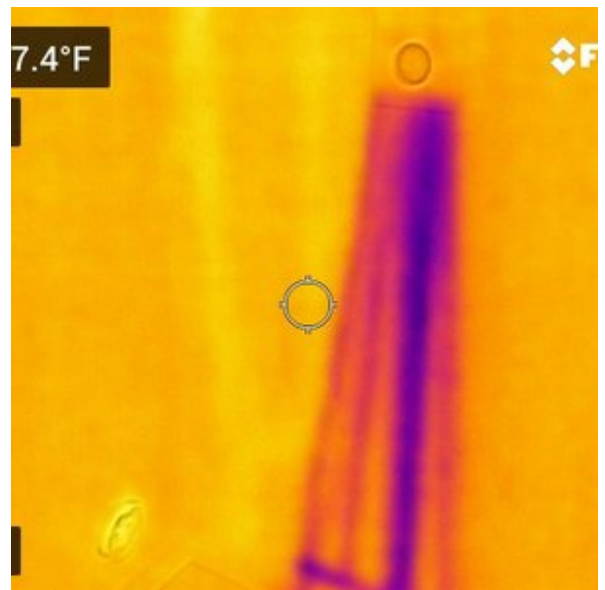
ADDRESS LEAK ISSUES

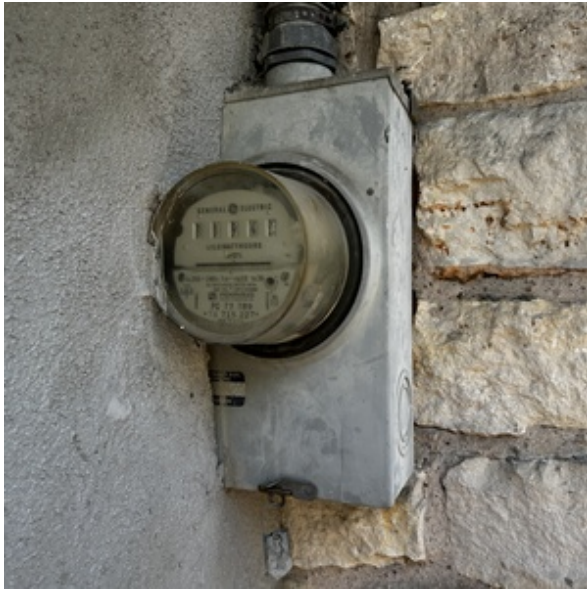
DATED METER CAN PARTIALLY COVERED

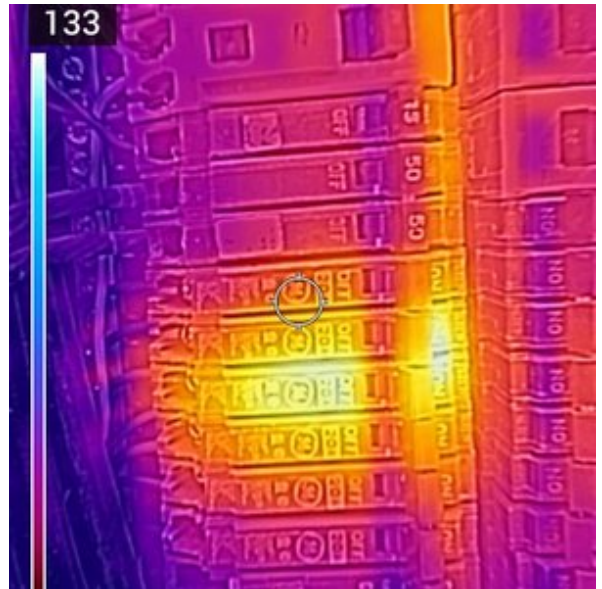
THERMAL CAMERA: NORMAL READINGS

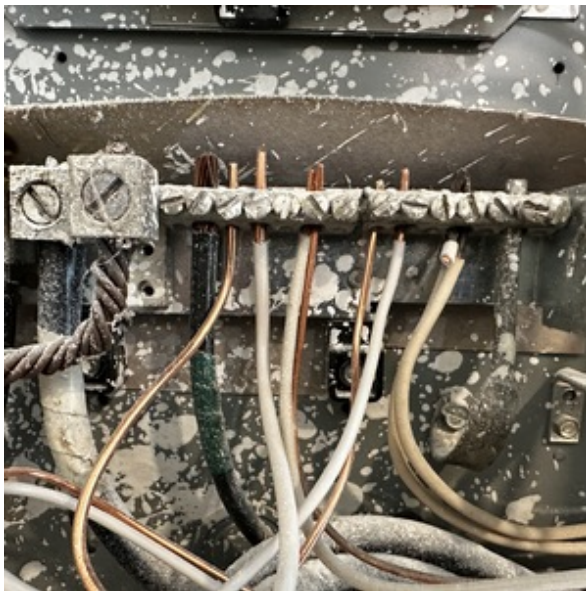
MINIMAL GROUND WIRES LUGGED

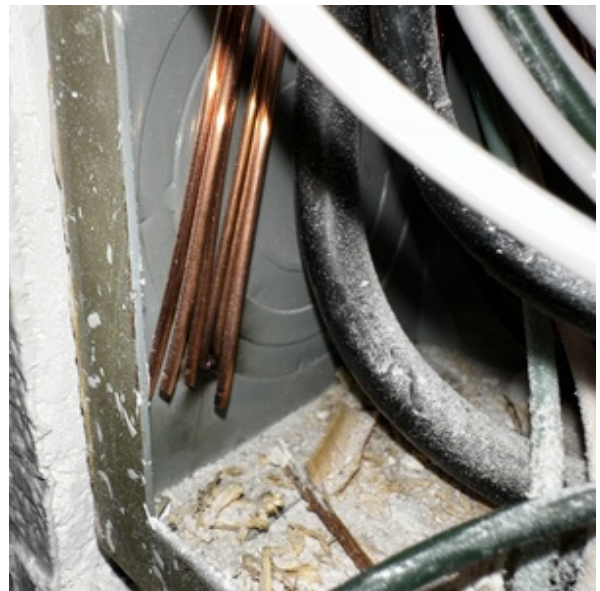
- ELEVATED SYSTEM ISSUES AND CONCERNS:  
Areas of elevated concern, possible safety hazards, and/or significant damage were discovered during the electrical inspection process. These issues should be addressed or further investigated by a licensed professional in a timely fashion to prevent continued damage or hazards to the system and structure as a whole. Areas in need of immediate repair or further investigation include, but are not limited to:  
-Improper circuit grounding noted at sub-panel (closet): Evidence of arcing/heat damage at neutral ends and panel walls

IMPROPER GROUNDING, ARC/HEAT DAMAGE

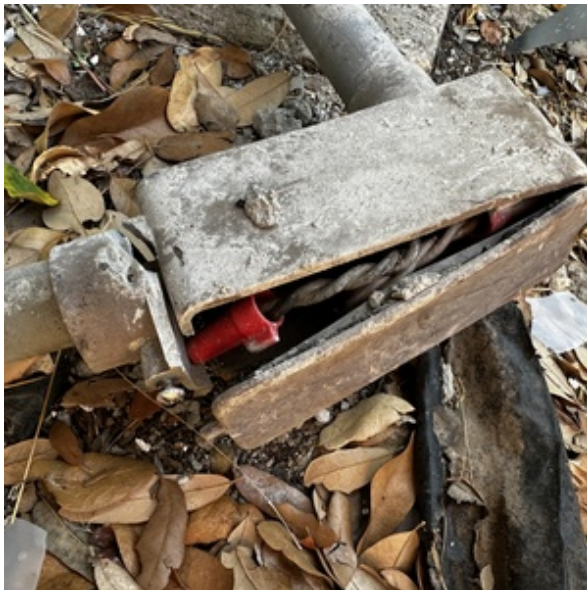
- OPEN JUNCTION BOXES, MISSING COVER PLATES, AND EXPOSED SPLICES:  
Open junction boxes, missing outlet/switch plates and exposed splices were noted. Properly capping and protecting the wiring is recommended to improve the overall safety of the system and reduce the likelihood of functionality issues. Ensure this common installation issues is professionally addressed at the next system servicing.
- EXPOSED/LOOSE DISTRIBUTION WIRING:  
Exposed distribution wiring was noted at exterior walls and/or various portions of the structure. By today's standards, all exposed wiring should be ran through enclosed portions of the structure (wall, attics, etc.) or placed in properly rated conduit. The wiring installation methods noted at the home were a common practice at the time of construction. Updates to exposed wiring would be considered a system and safety update.

OPEN/DAMAGED J-BOXES

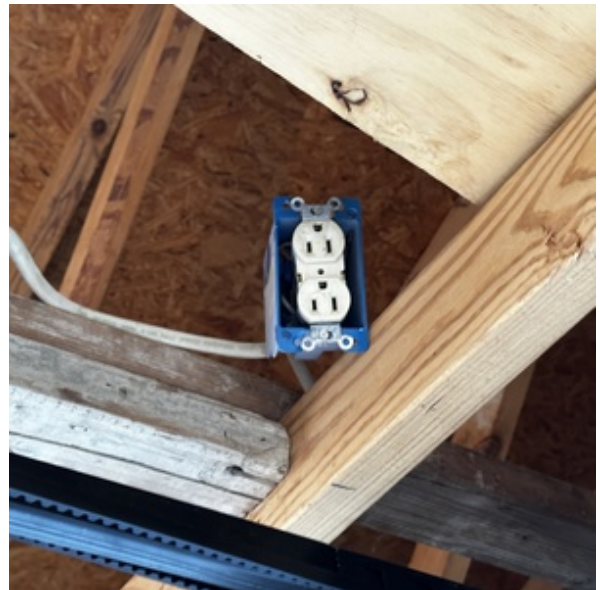
UNSECURED/EXPOSED J-BOXES

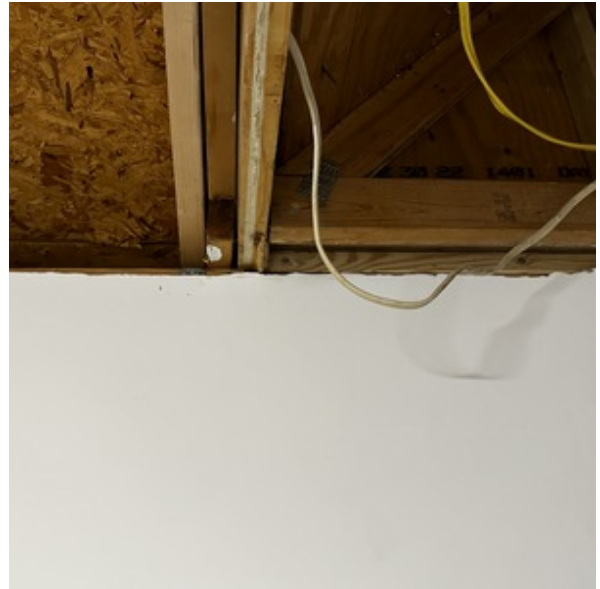
UNSECURED WIRING

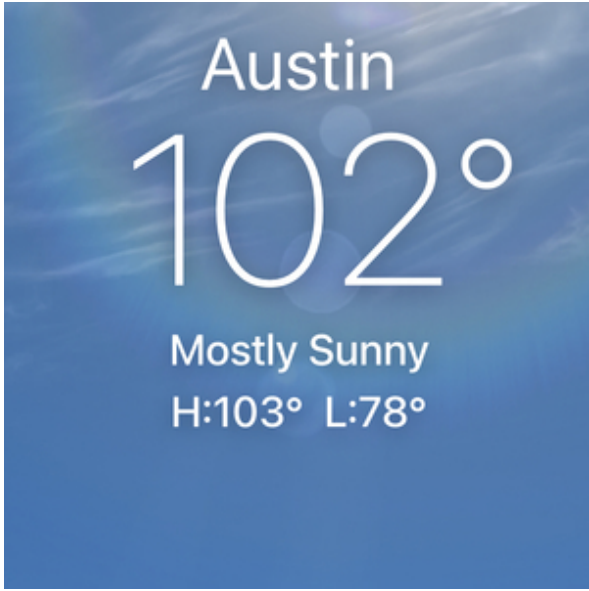
TEMP DURING TESTING: 102F

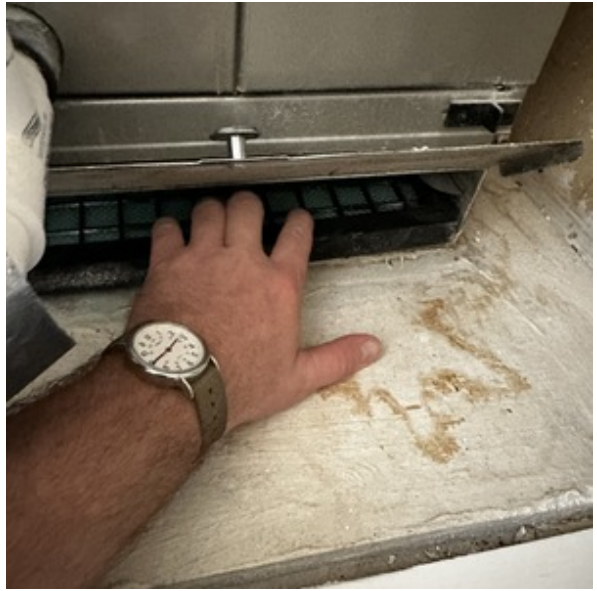
PREVIOUS HVAC LEAK

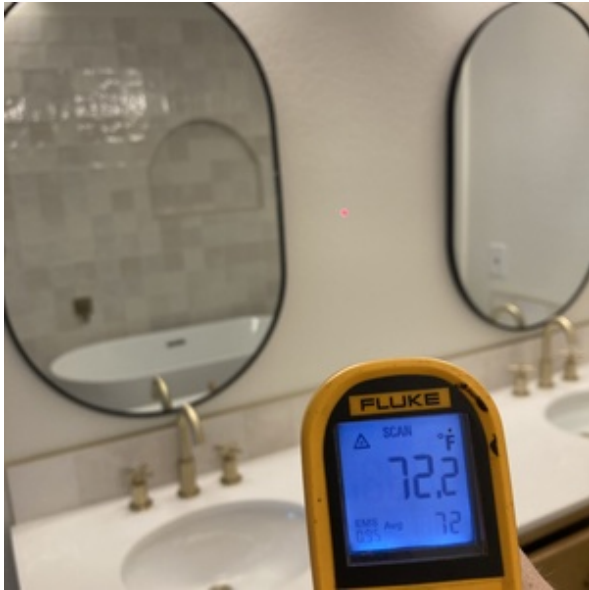
AVERAGE TEMP (BEDROOMS): 72-74F

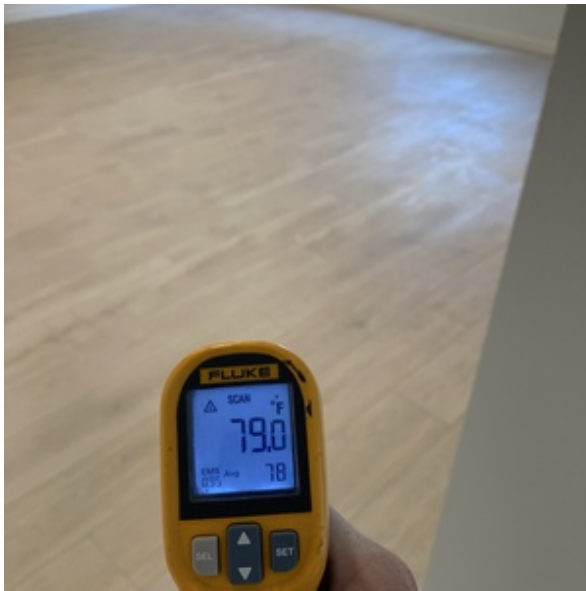
AVERAGE TEMP (COMMON AREA): 78-79F

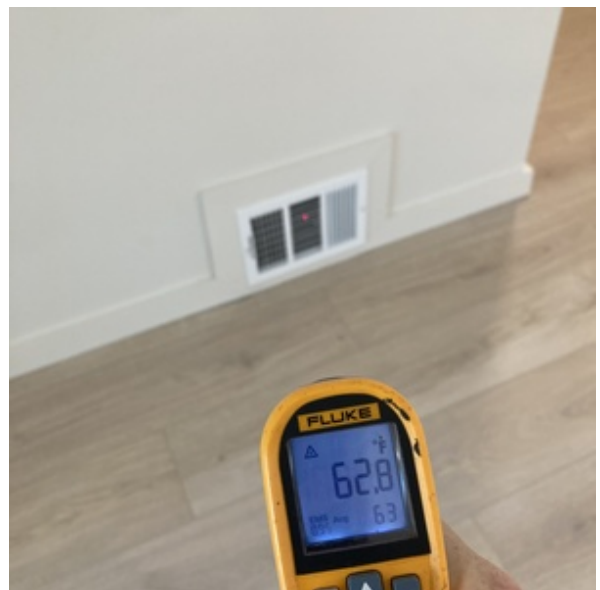
SUPPLY TEMP: 59-62F (MARGINAL)

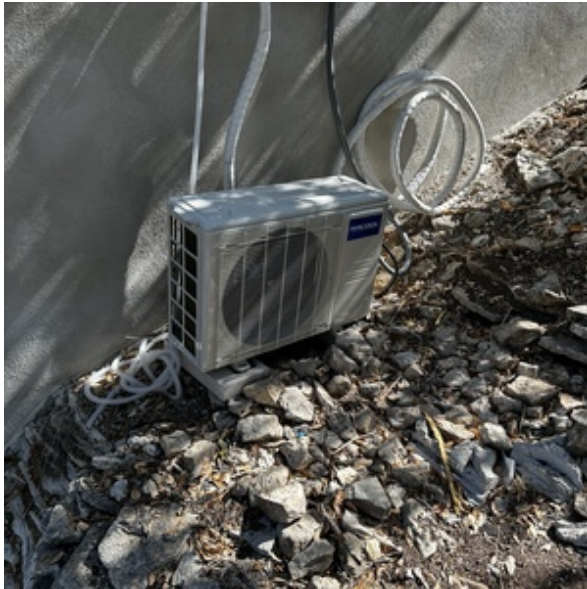
INSTALLATION AND FUNCTIONALITY ISSUES

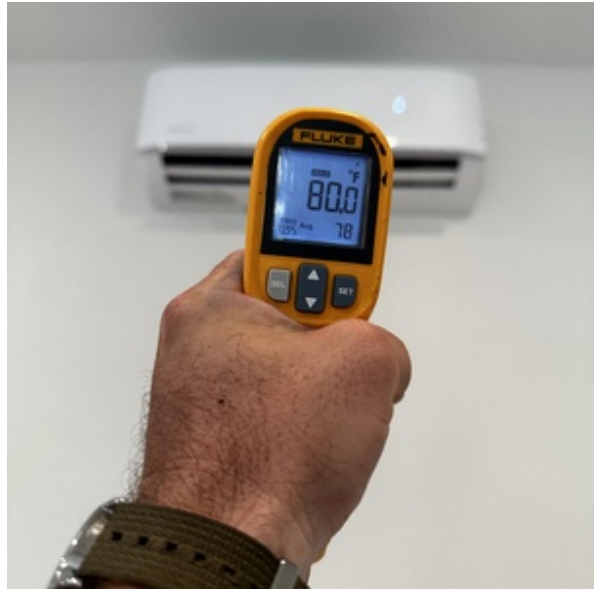
MINI-SPLIT FAILED TO COOL

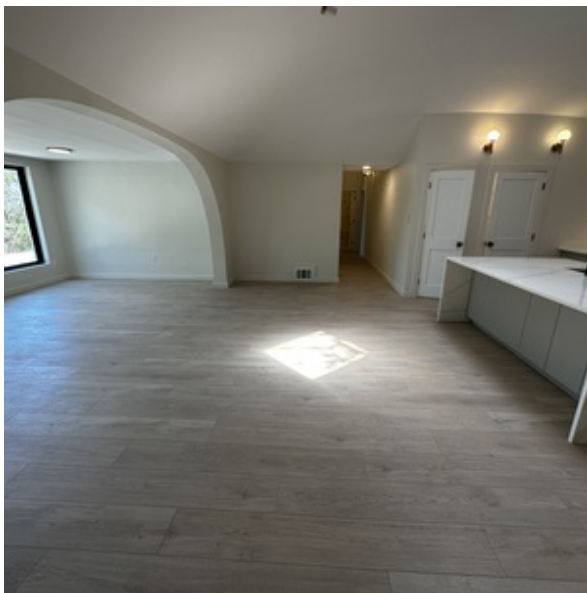
NOTE: A single air supply vent has been provided to condition a large room with multiple windows, high ceilings, and a skylight. Temperatures within the common area remained at appx 78-79F while temperatures within bedrooms dropped to appx. 72F.

1X VENT FOR LARGE SPACE

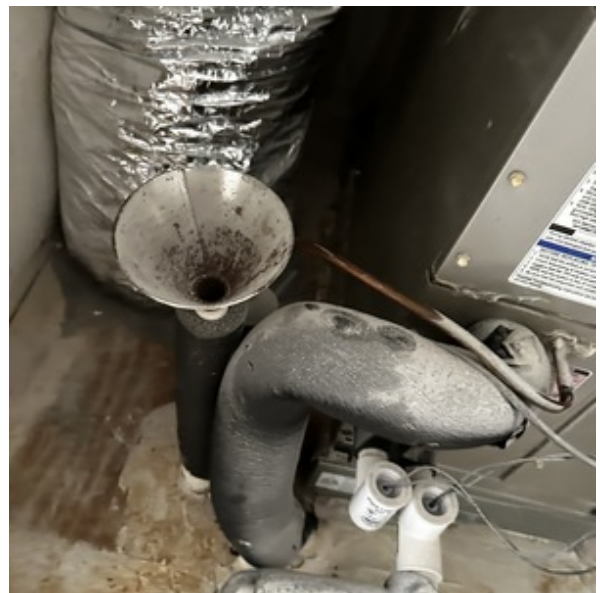
MYLAR FLEX DUCTING OBSERVED

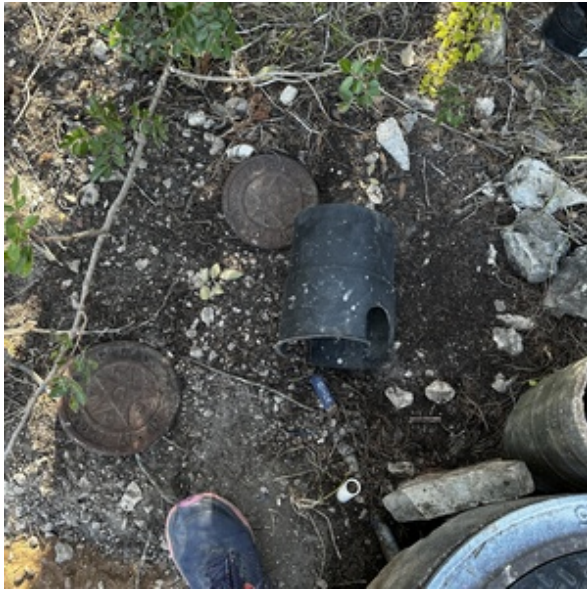
WATER METER RIGHT OF BLDG.

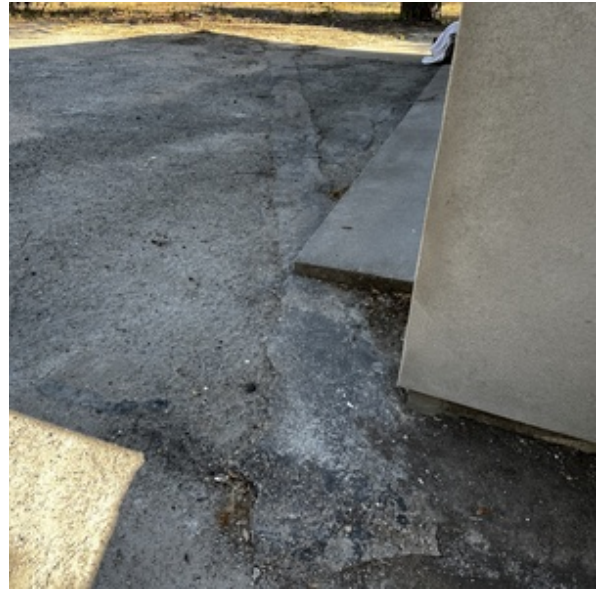
CUT/PATCH: PREVIOUS PIPE REPAIR

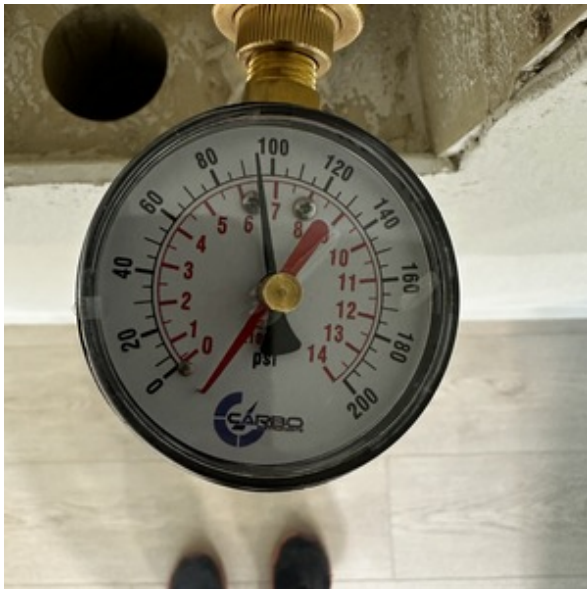
ELEVATED WATER PRESSURE
