**GREENBELT STRUCTURAL SERVICES**  
A DIVISION OF TAHI LLC

Property: 123 Sample Rd.  
Austin , TX 78736  
Client: Sample Report - Existing Building  
Inspector: Andy Jordan #9458  
Date: September 8, 2023

# PROPERTY INSPECTION REPORT

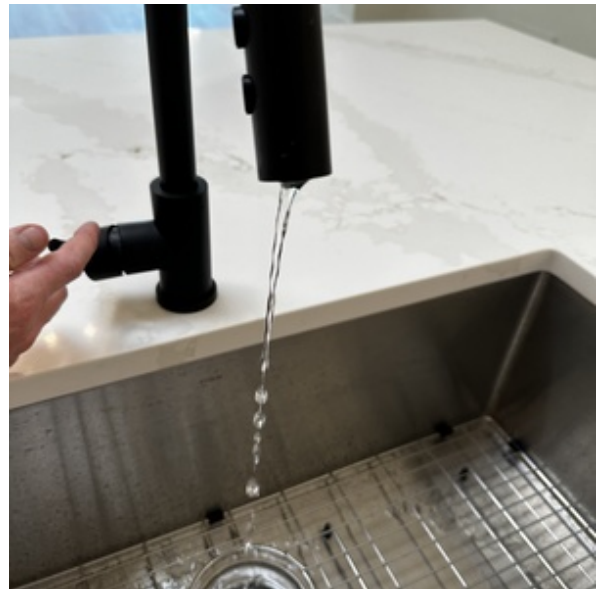
KIT. SINK: WEAK PRESSURE

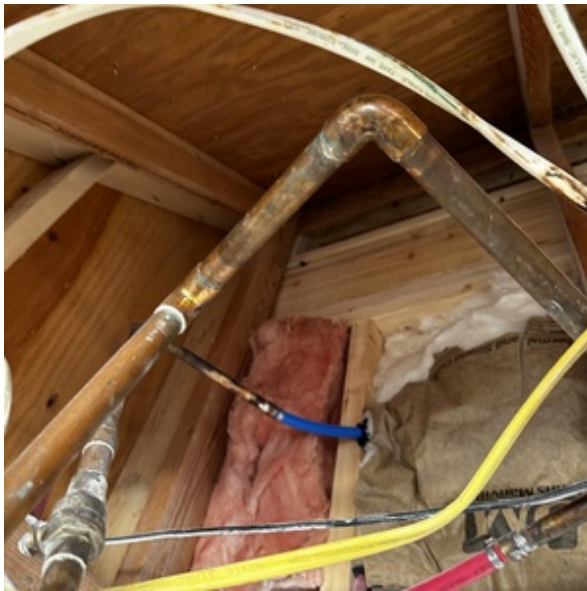
ATYPICAL PIPE CONFIGURATION

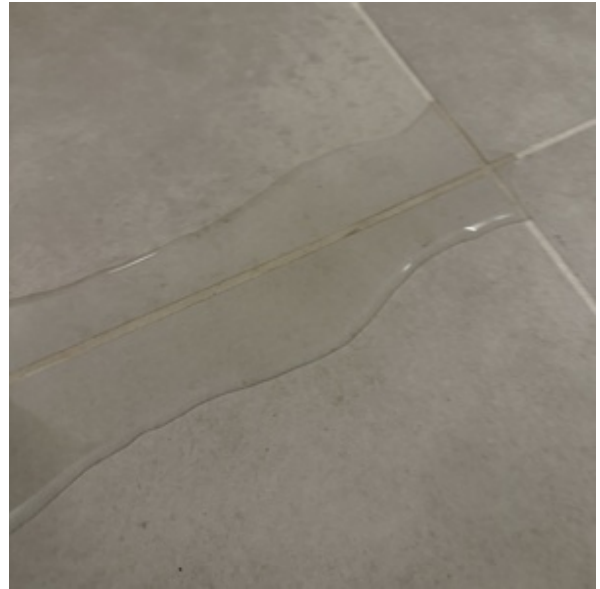
LEAK AT BEDROOM SINK

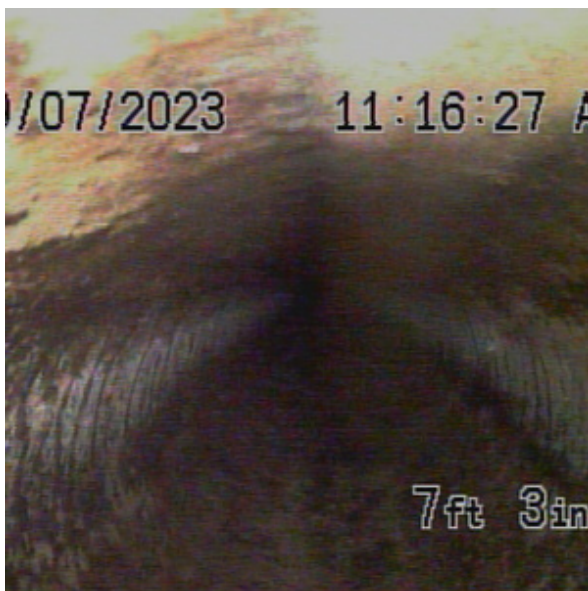
ENTRY INTO LATERAL

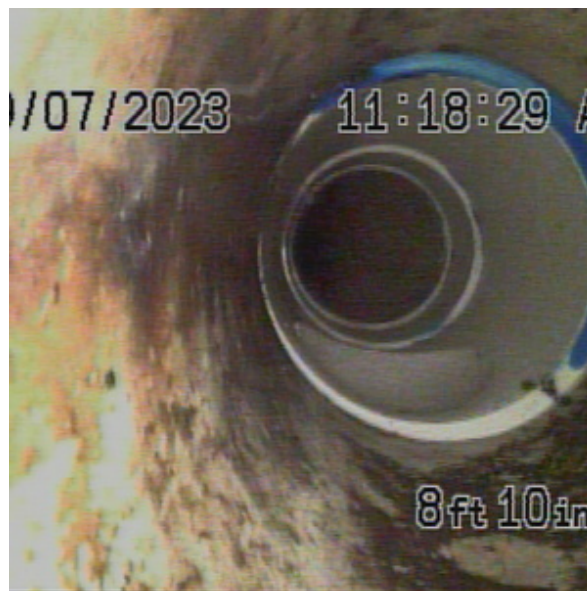
Multiple indicators of alterations or repairs at the main lateral pipe was noted. Common industry standards call for a passed hydrostatic test of the drain system following subgrade repairs. If a passed hydrostatic test can not be confirmed, retroactive testing is advised.

INDICATOR OF RECENT UPDATING

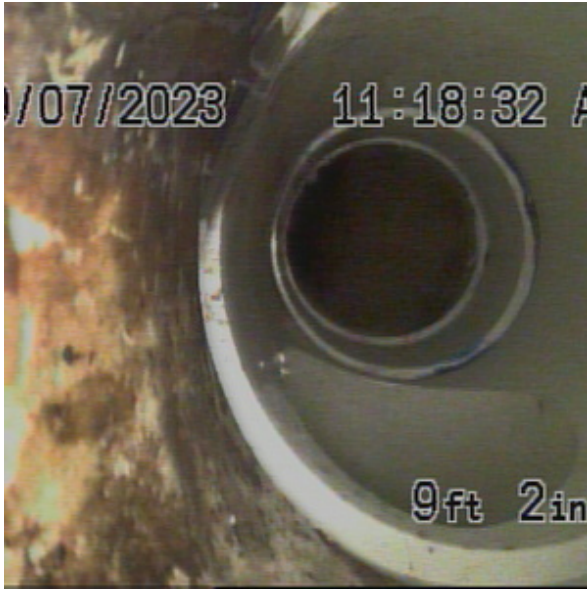
UPDATED BRANCH CONNECTION

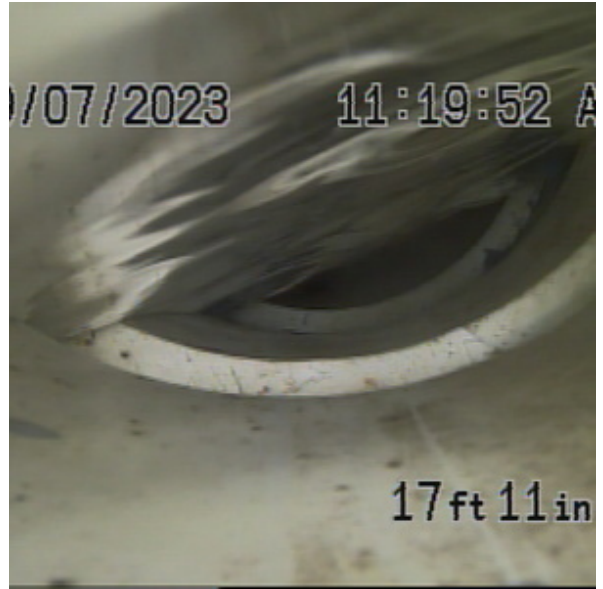
NORMAL DRAINAGE OBSERVED

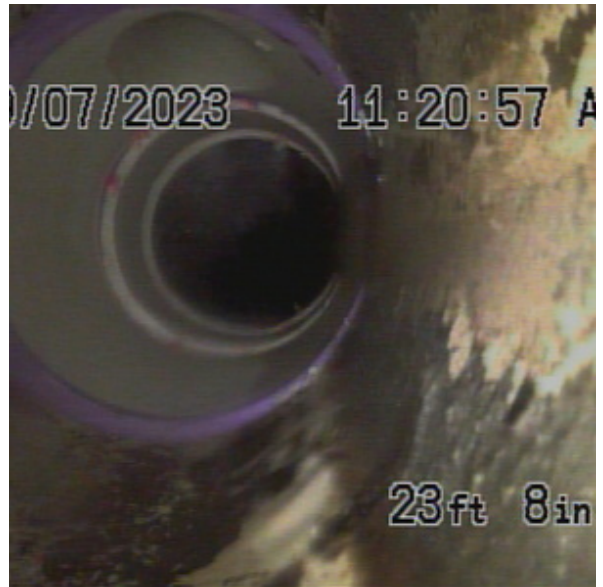
ADDITIONAL UPDATES OBSERVED
