Client: Inspector: Date: 2202 Sample Report Austin, Texas 78703 Sam Sample Andy Jordan #9458 April 9, 2019

# **PROPERTY INSPECTION REPORT**

<b>Prepared For:</b>	Sam Sample	
	(Name of Client)	
<b>Concerning:</b>	2202 Sample Report Austin, Texas 78703	
	(Address or Other Identification of Inspected	Property)
By:	Andy Jordan, Lic #9458	April 9, 2019
	(Name and License Number of Inspector)	(Date)
	(Name, License Number of Sponsoring Inspector)

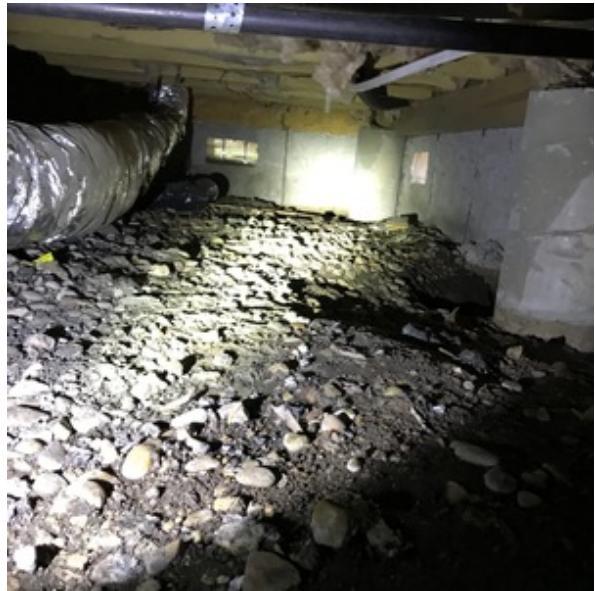
BACK RIGHT: IMPROVED SOIL ELEVATIONS

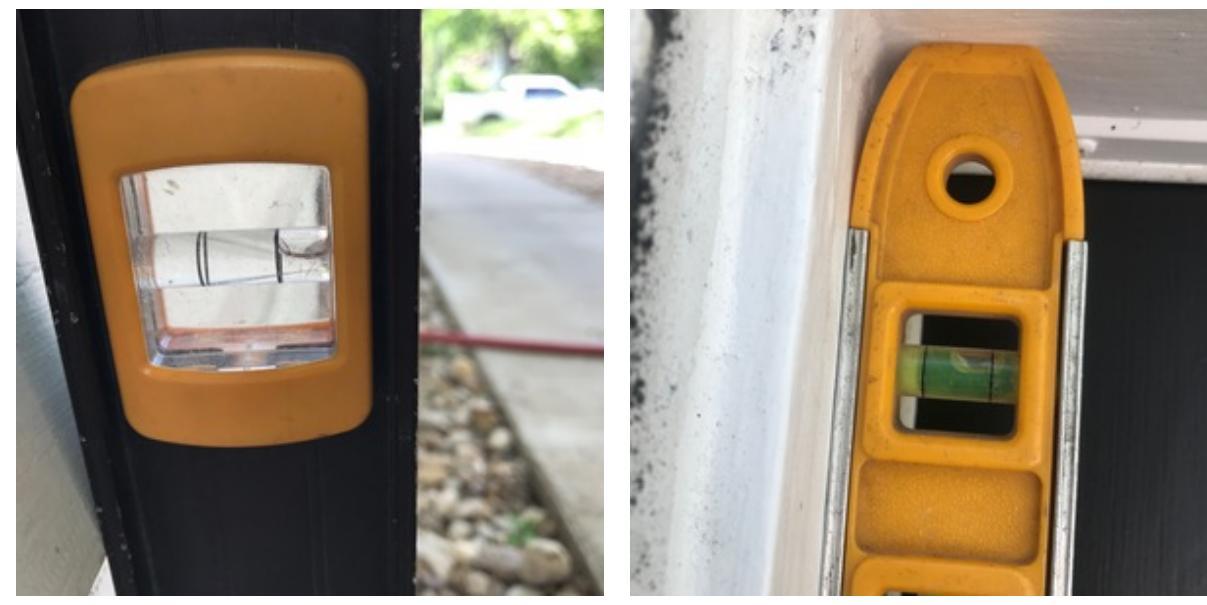
BOWING AT LEFT WALL

BACK DOOR FRAMING UNEVEN

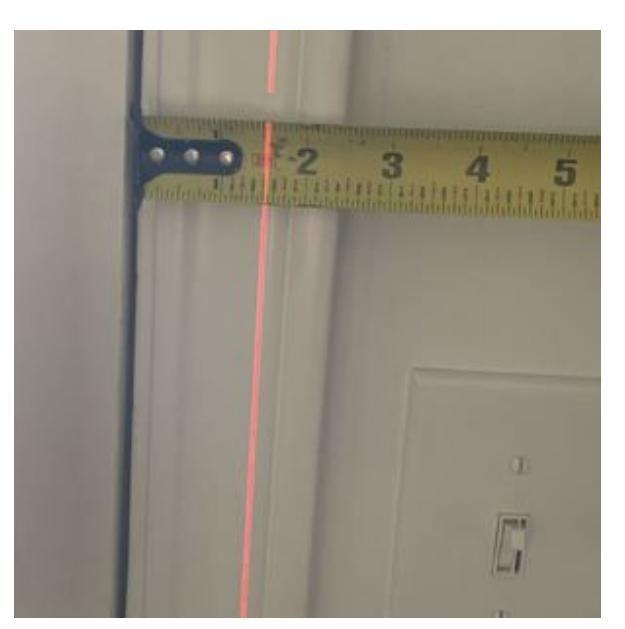
BACK DOOR FRAMING UNEVEN

-Back door framing uneven due to structural shifting: Monitor and update as needed

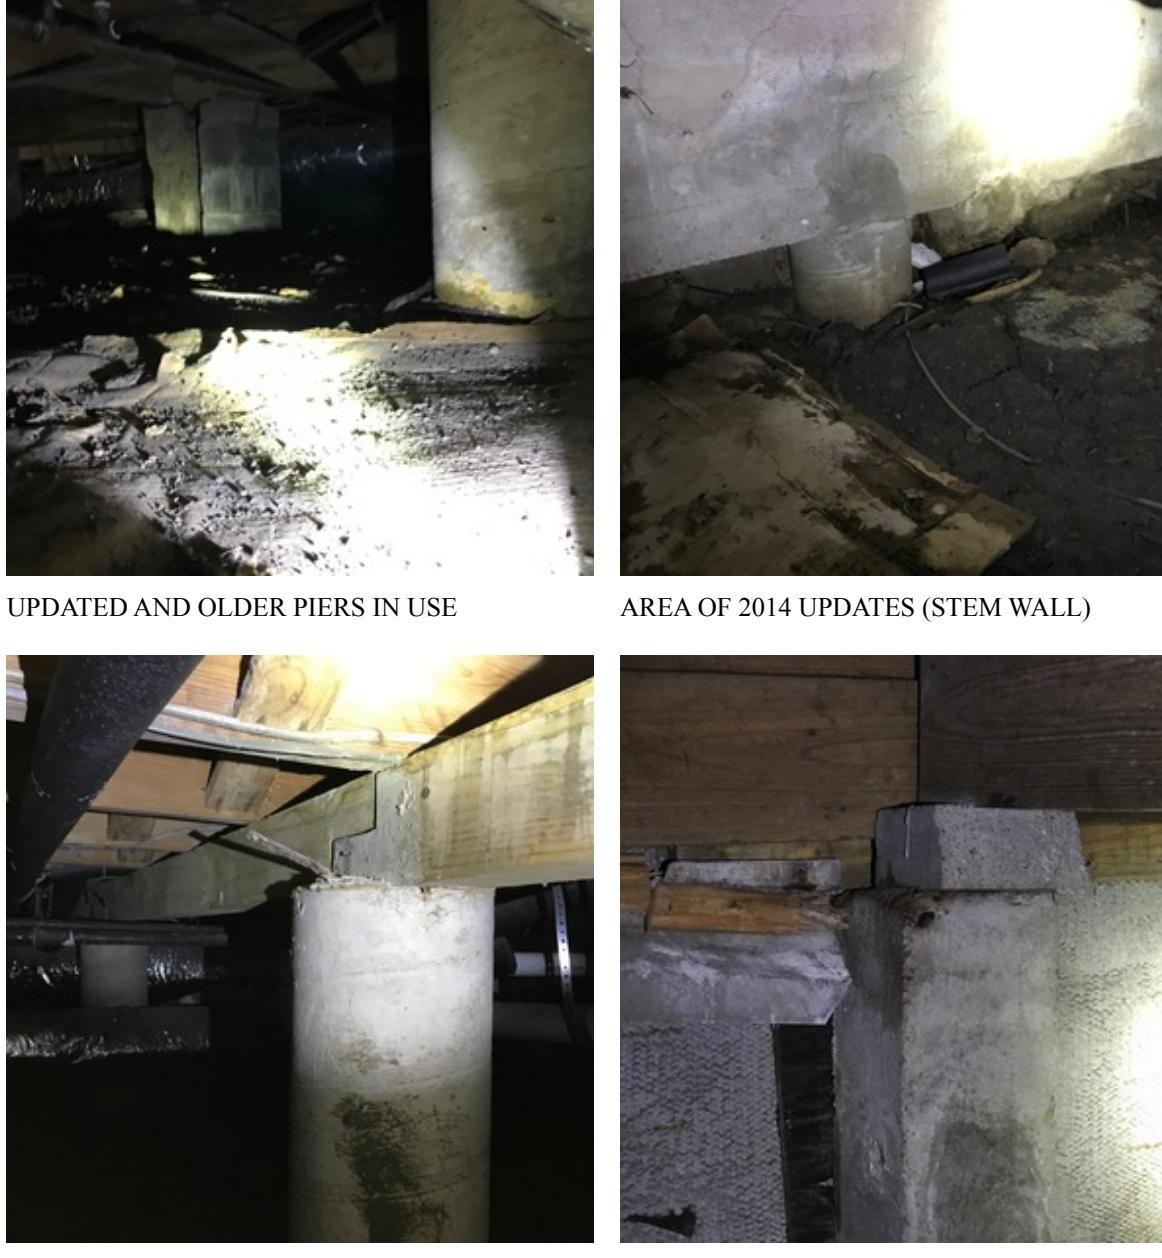
UNSECURED STRAPS AT UPDATED PIERS

WEAK PIER/BEAM CONNECTIONS

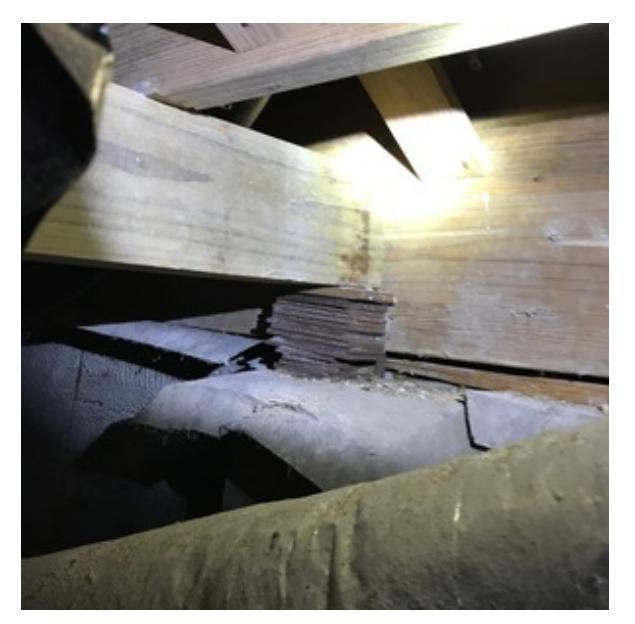
WEAK PIER/BEAM CONNECTIONS

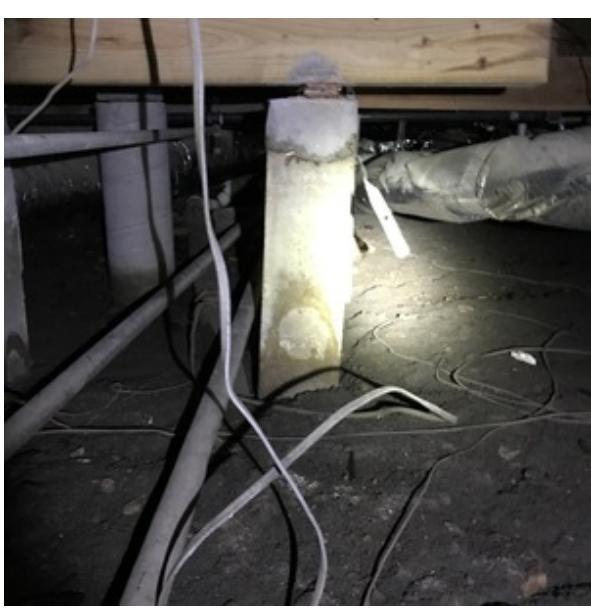
SOIL SATURATION THROUGHOUT

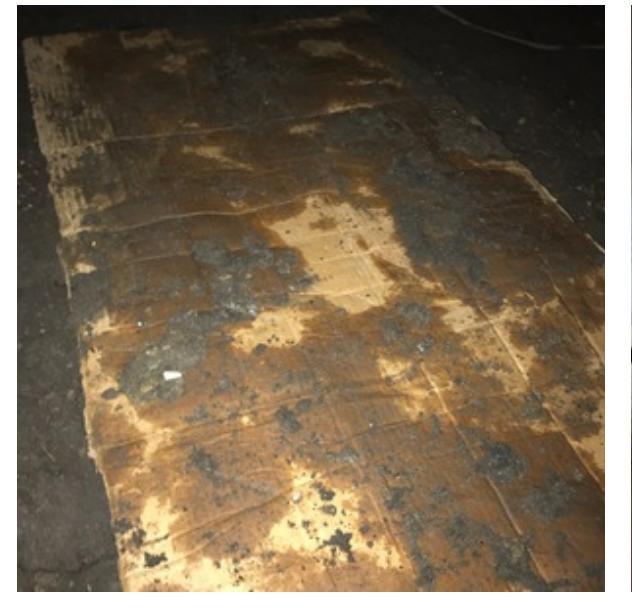
SOIL/MATERIAL SATURATION THROUGOUT

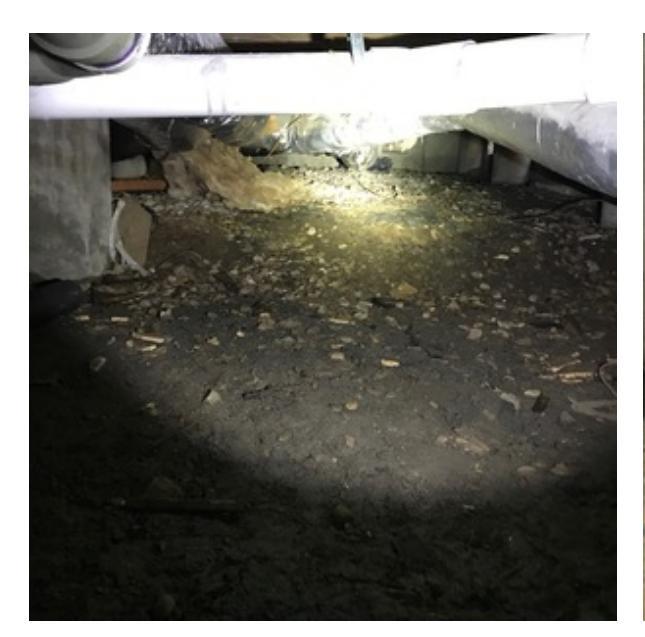
LOW AREAS: ELEVATED MOISTURE LEVELS

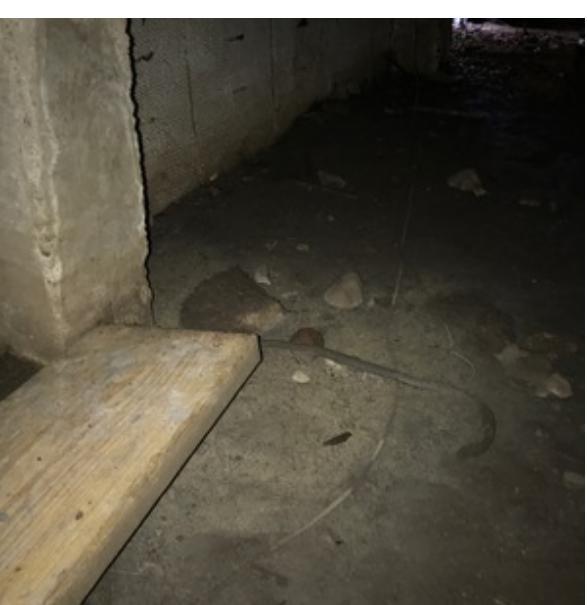
ELEVATED MOISTURE: FRONT RIGHT SIDE

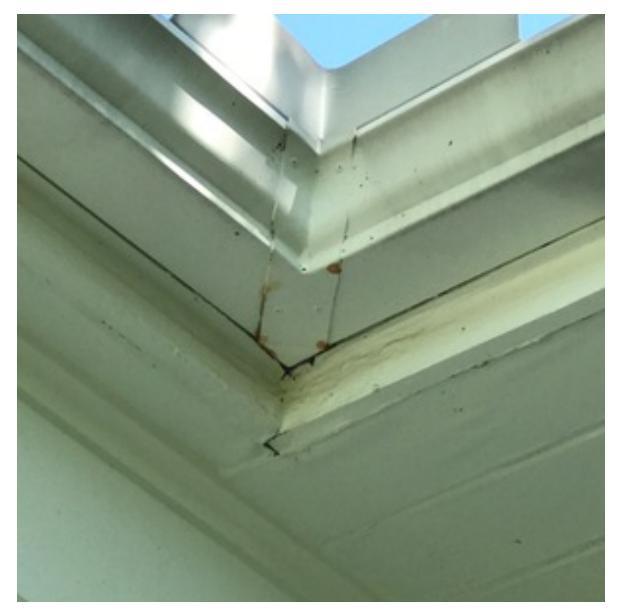
FRONT RIGHT: GUTTER LEAK

Servicing, repair, and/or replacement needs were discovered during the inspection process of the rain gutters and downspouts (debris buildup/loose material/leaks at joint connections/gutter exit update needs/etc.). Proper drainage and moisture diversion is essential to the overall protection of the structure as a whole. Contacting a rain gutter and grading/drainage specialist will aid in determining what improvement options are available and warranted.

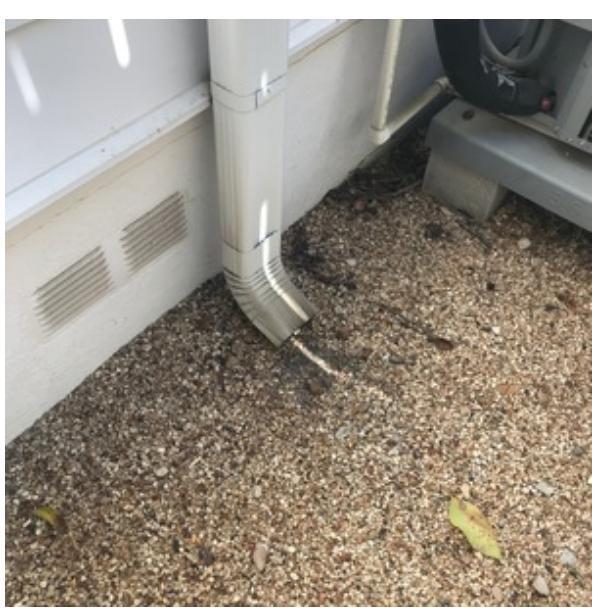
DOWNSPOUT EXTENSION NEEDS

Rain gutter exit points at various locations appear to release runoff water into areas of minimal grading/drainage. This issue can lead to excess moisture pooling at and around the structure. The installation of gutter exit extensions and/or general system updates (conducted by a gutter system specialist) is recommended to ensure proper moisture diversion away from the structure.

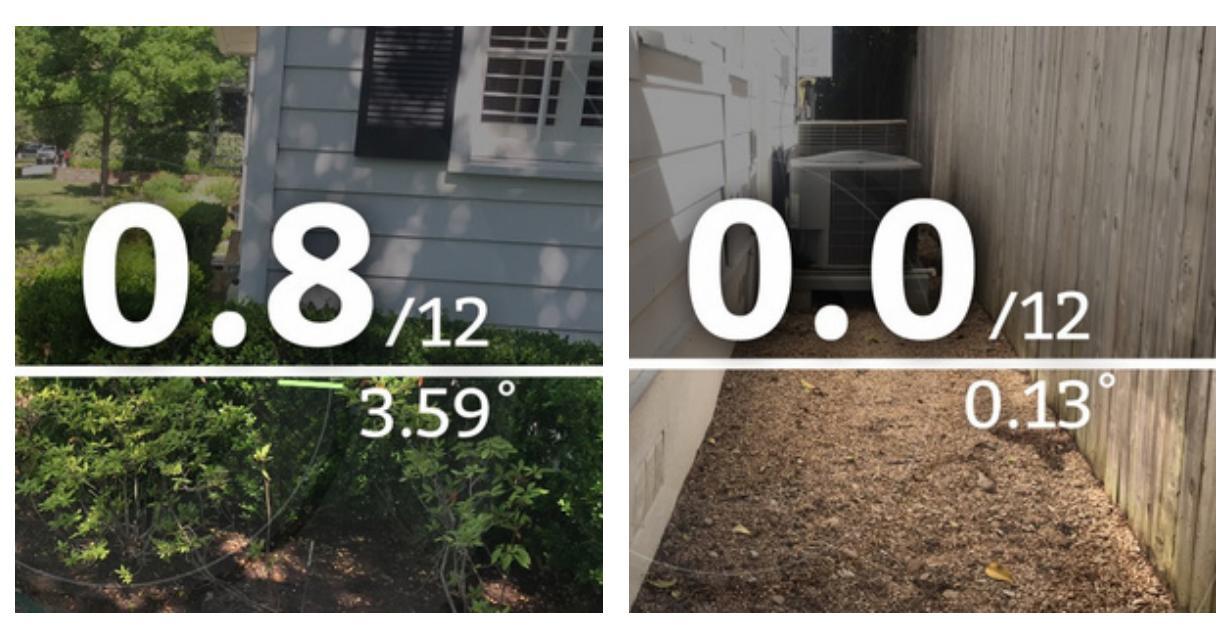
FRONT YARD: MARGINAL GRADE

RIGHT SIDE: MARGINAL GRADE

General grade slope, moisture diversion, and/or drainage concerns were noted at area/s surrounding the structure. Reduced moisture diversion can result in water penetration into the structure, damage to building material, insect intrusion (to include termites), and is a common contributing factor in foundation settlement issues. General standards call for no less that 3" of foundation wall to be visible above grade and a minimum 5% grade slope (6" drop per 10') away from the structure. Ensure all grading/drainage issues are professionally addressed as needed to meet minimum standards. If property limitations are present which prevent the ability to feasibly attain minimum grading/drainage standards, a landscaping/irrigation specialist should be contacted to determine what improvement options are available and warranted.

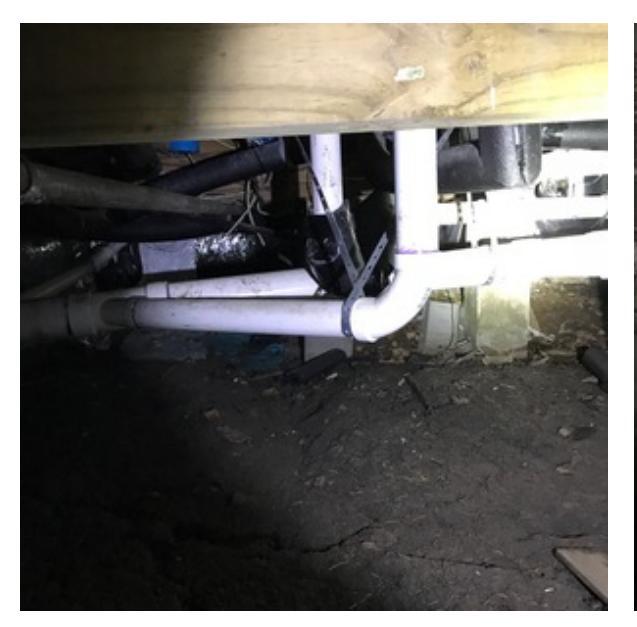
EXCESS MOISTURE IN CRAWLSPACE

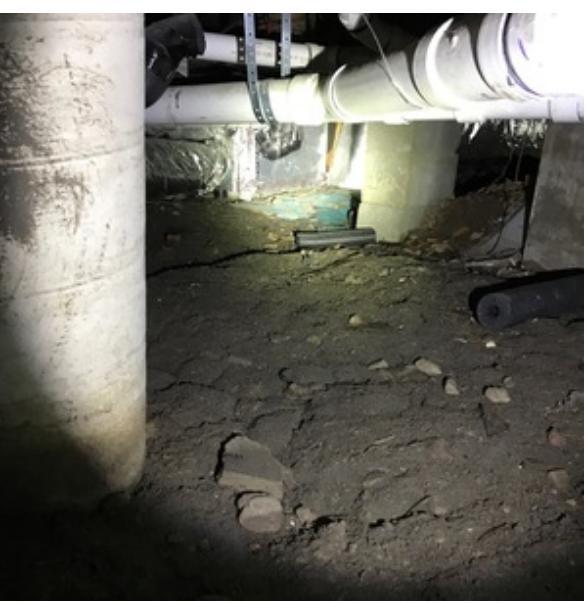
EXCESS MOISTURE IN CRAWLSPACE

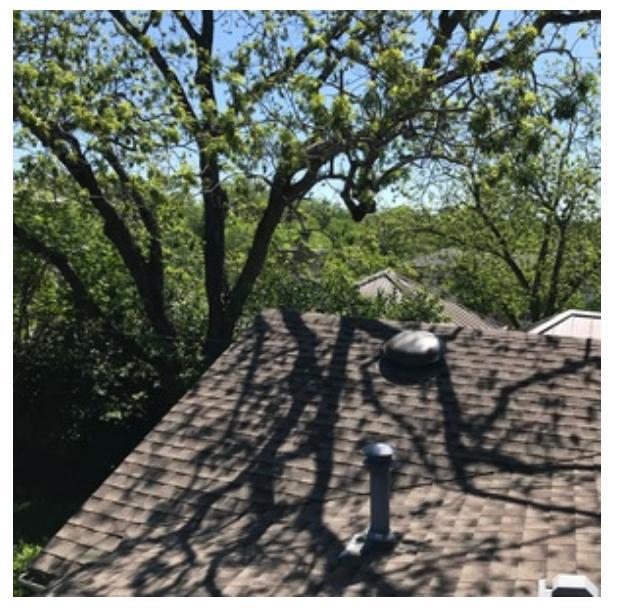
BRANCHES OVERHANGING ROOF

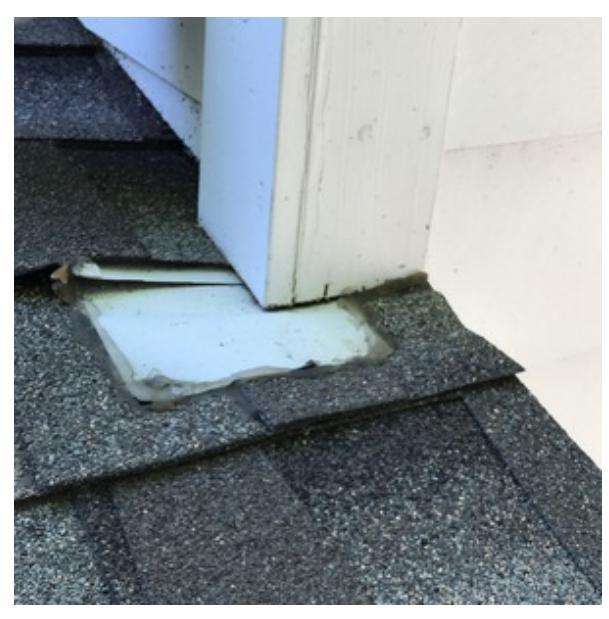
MISSING/IMPROPER FLASHING

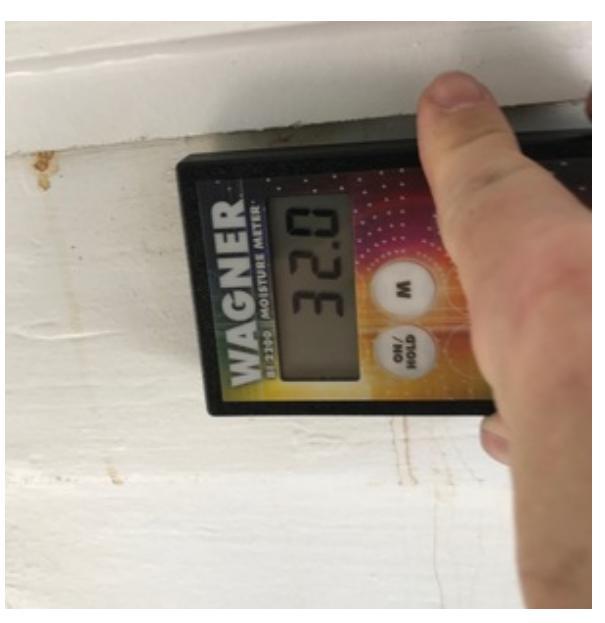
ELEVATED MOISTURE AT RIGHT WALL

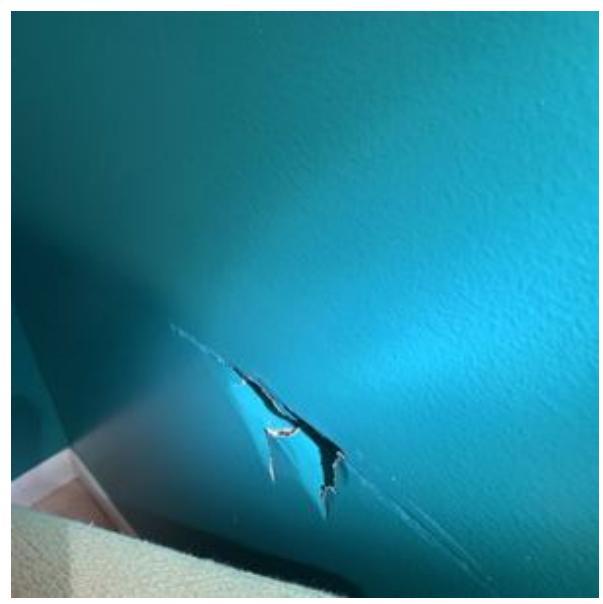
COMMON WEAR/TEAR

SETTLEMENT CRACKING / REPAIRS

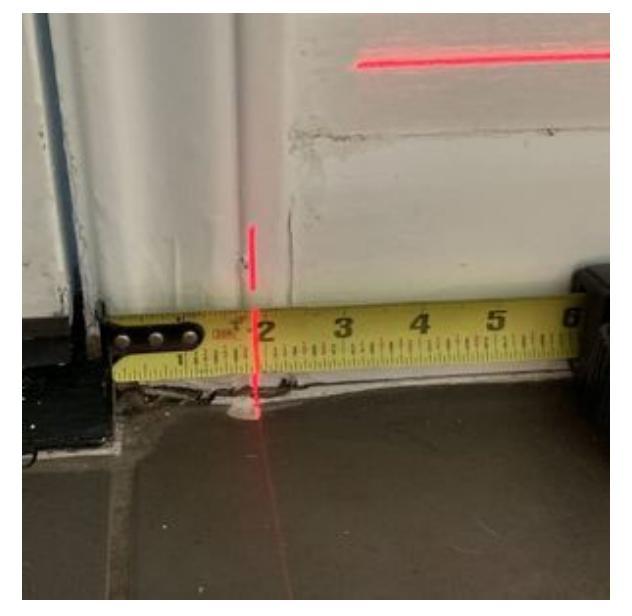
LASER LEVEL: LOWER BACK DOOR JAMB

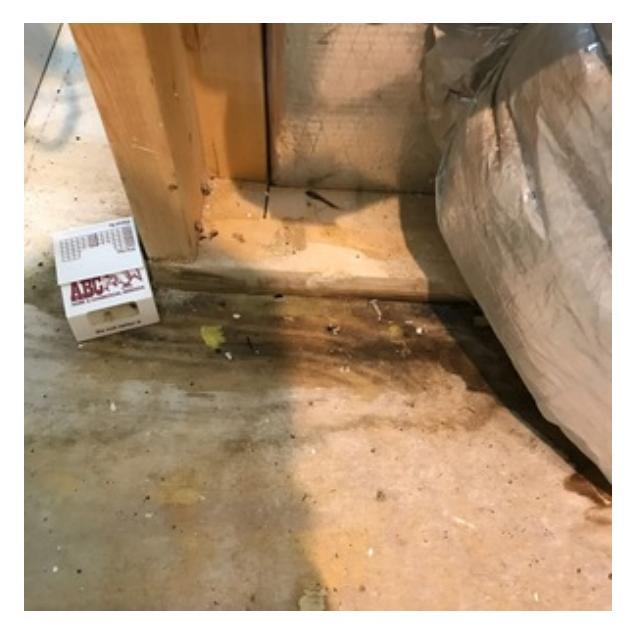
PREVIOUS LEAK ISSUES: HVAC CLOSET

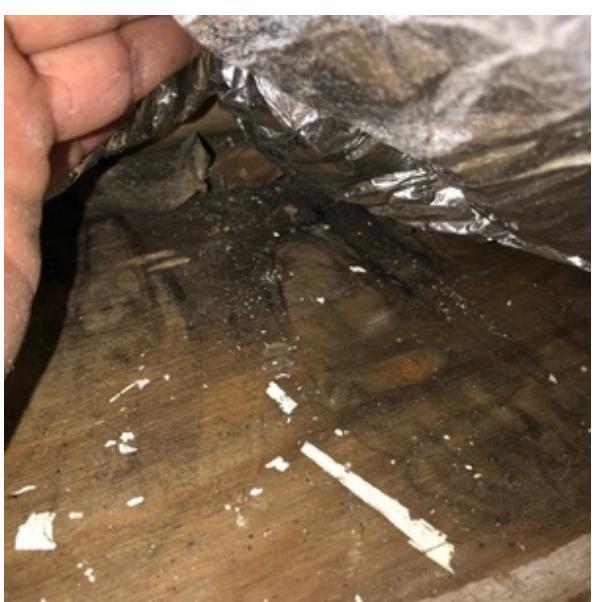
PREVIOUS LEAK ISSUES: HVAC CLOSET

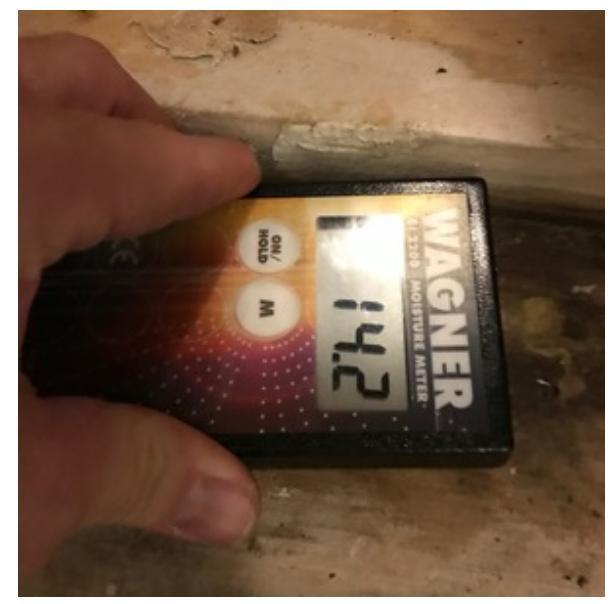
MINOR RISE IN MOISTURE LEVELS

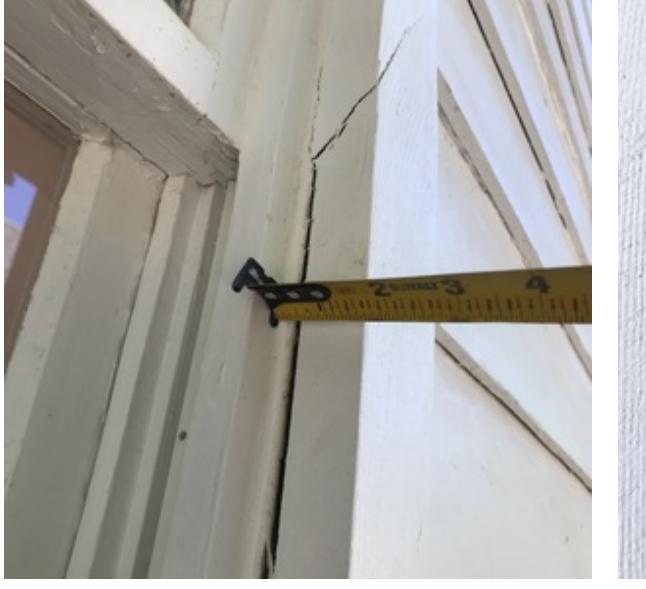
GENERAL MAINTENANCE NEEDS

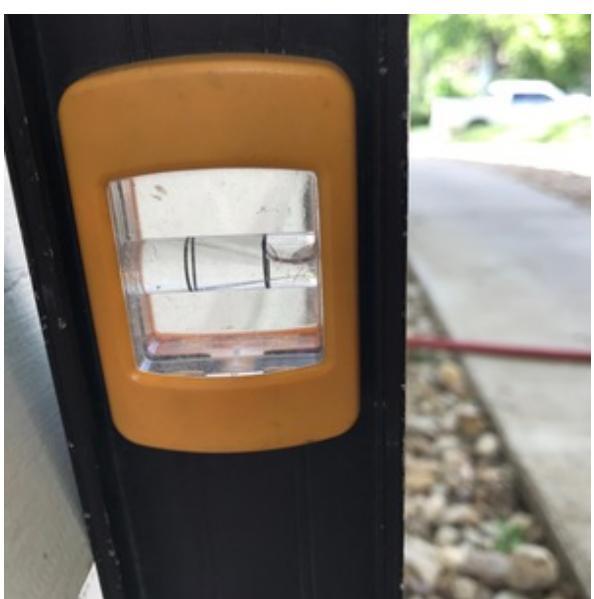
LEFT WALL STRESS / BOWING

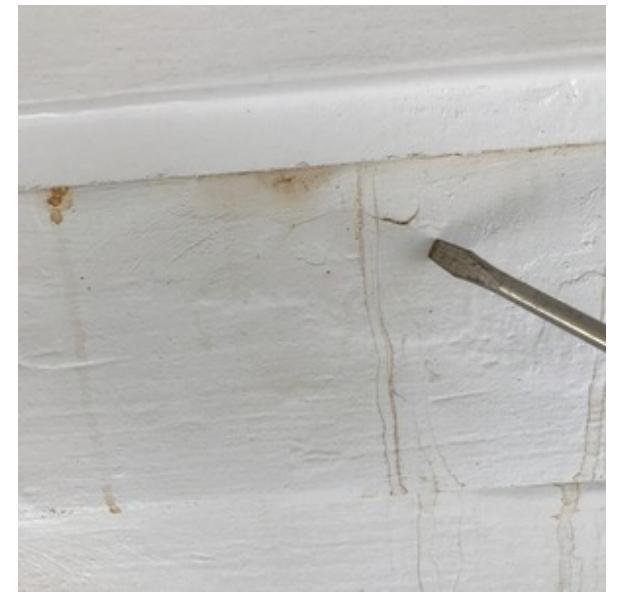
ROOF LEAK ISSUE: LEFT SIDE

-Active leak and wood rot at siding near left side wall eave: Address leak issue and repair/replace damaged siding as needed

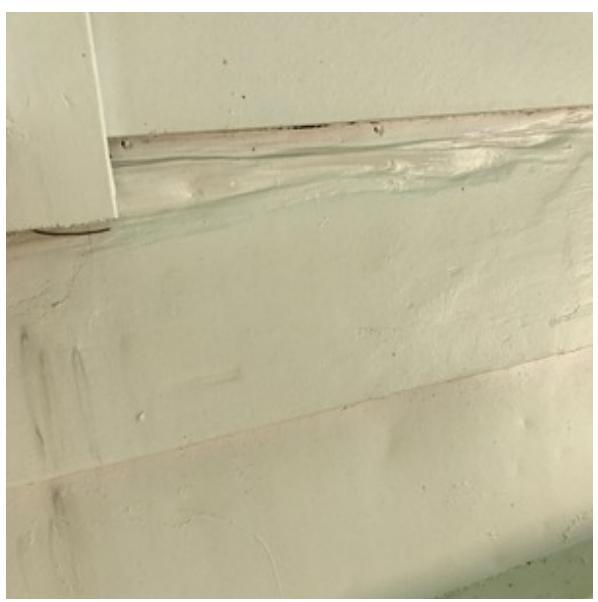
LEAK DAMAGE / WOOD ROT

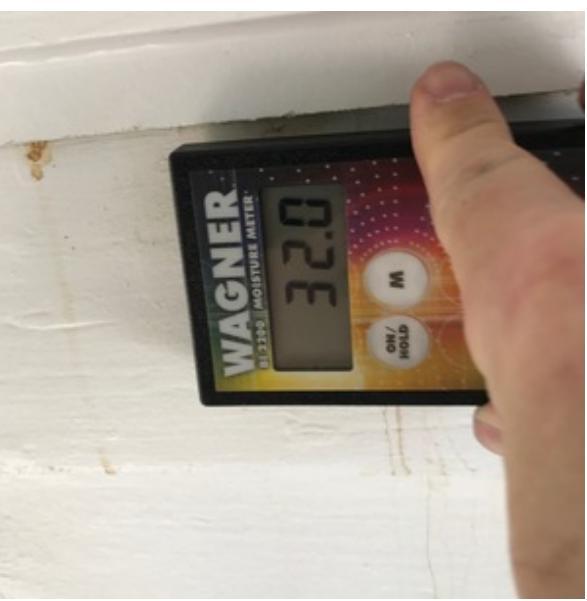
ELEVATED MOISTURE AT LEAK POINT

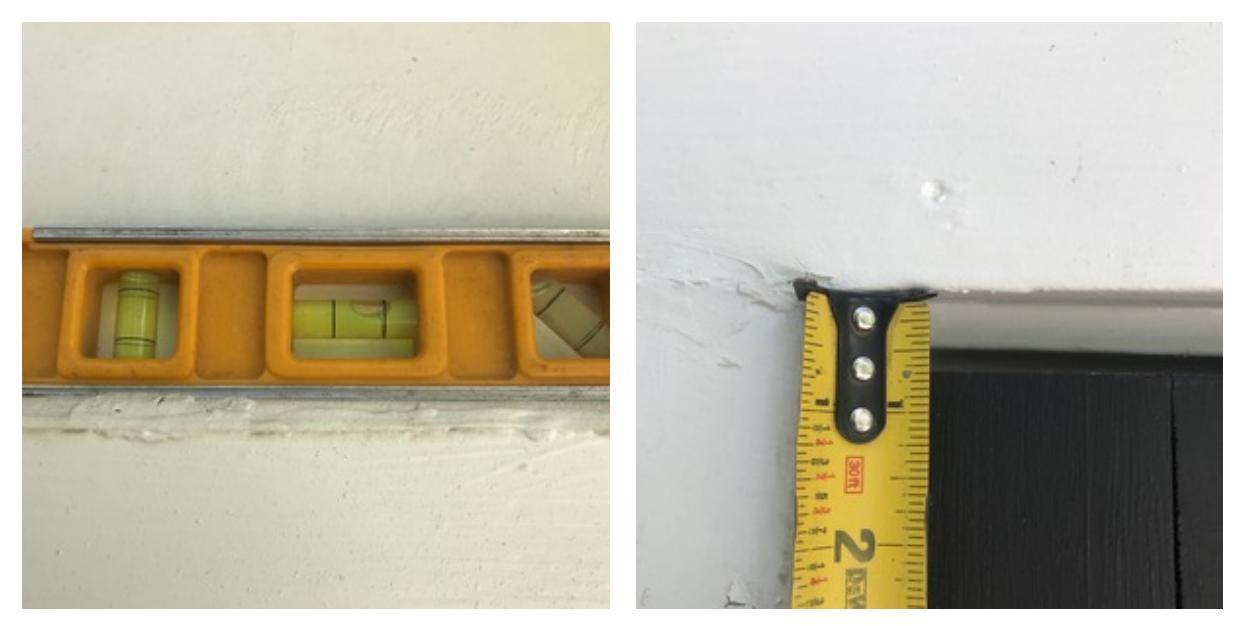
BACK DOOR UN-PLUMB

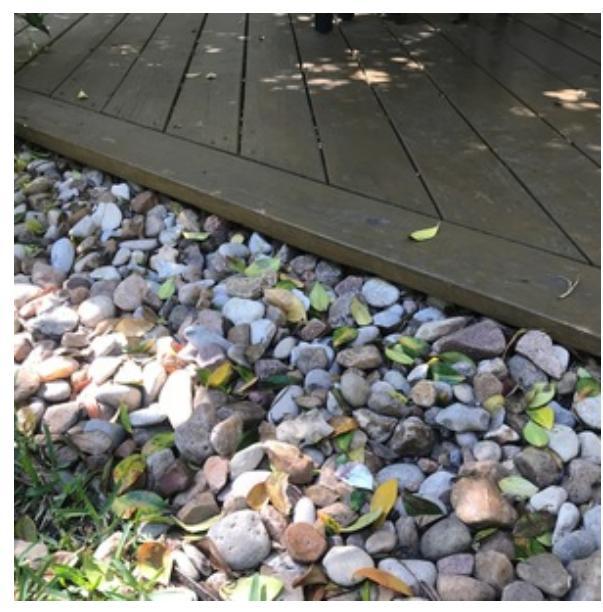
GENERAL FENCE DAMAGE

WOOD / SOIL CONTACT

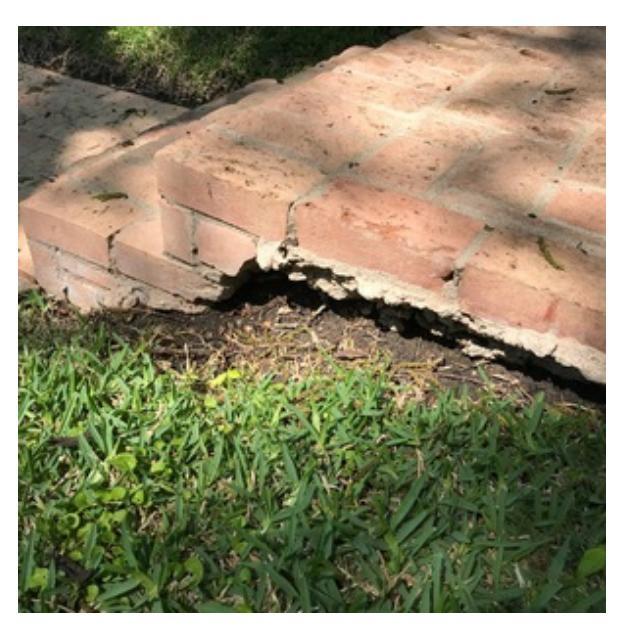
-Cracks and erosion issues at front walkway and porch (brick)

EROSION AT WALKWAY STEPS

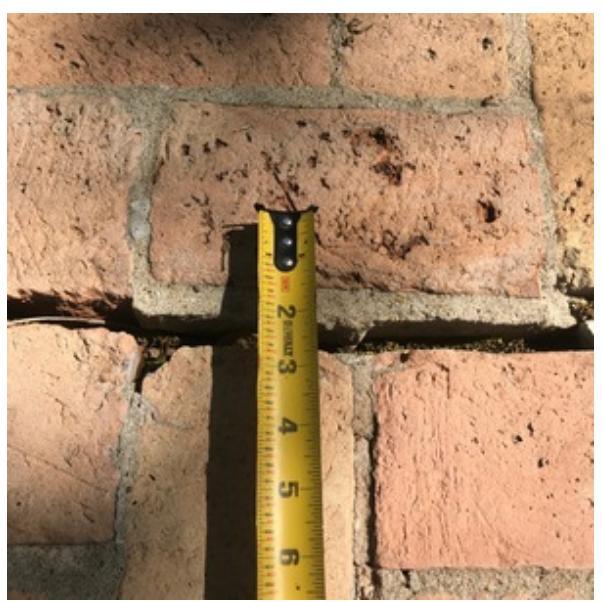
FRACTURES AT WALKWAY

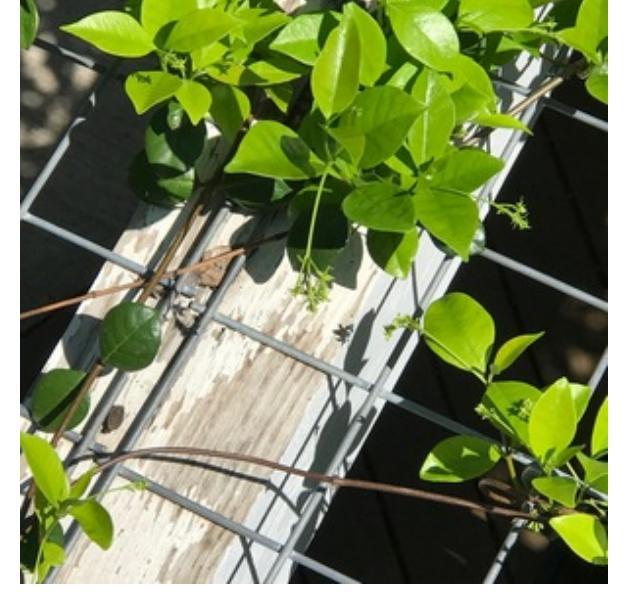
PAINT FAILING AT UPPER PERGOLA

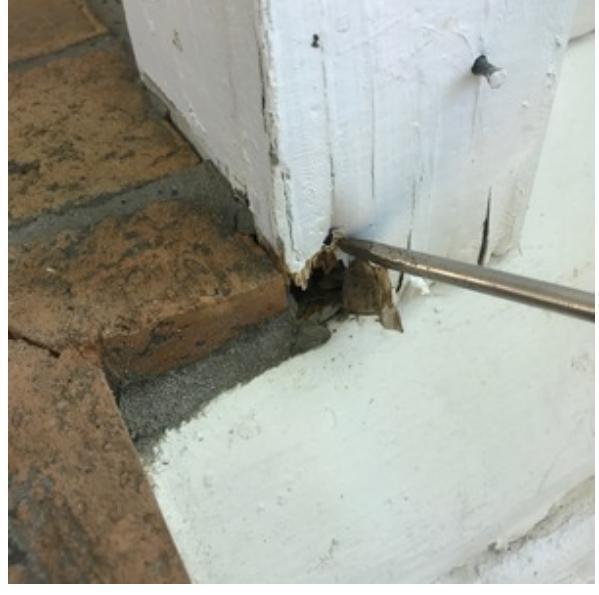
PORCH BRICK COVERS WALL

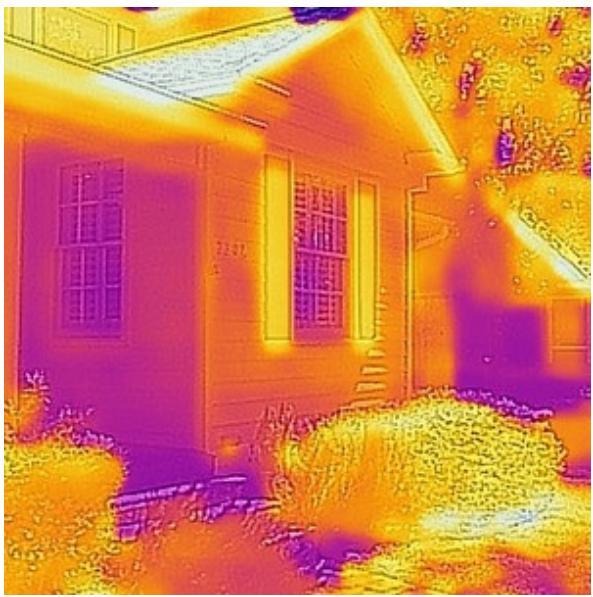
ENERGY LOSS AT SINGLE PANE WINDOWS

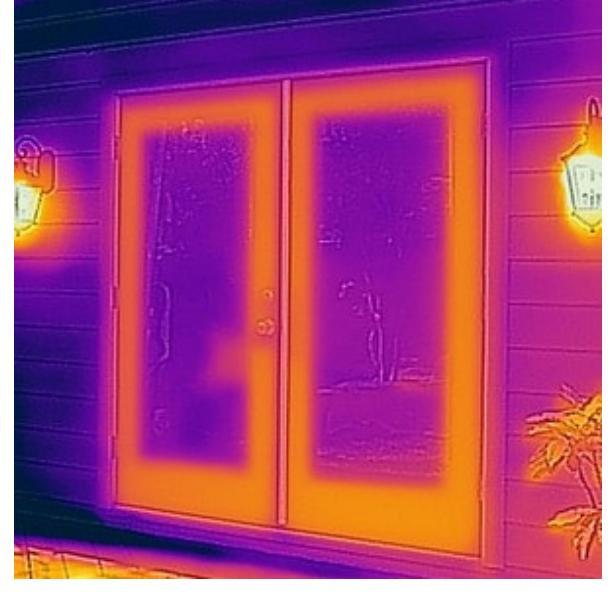
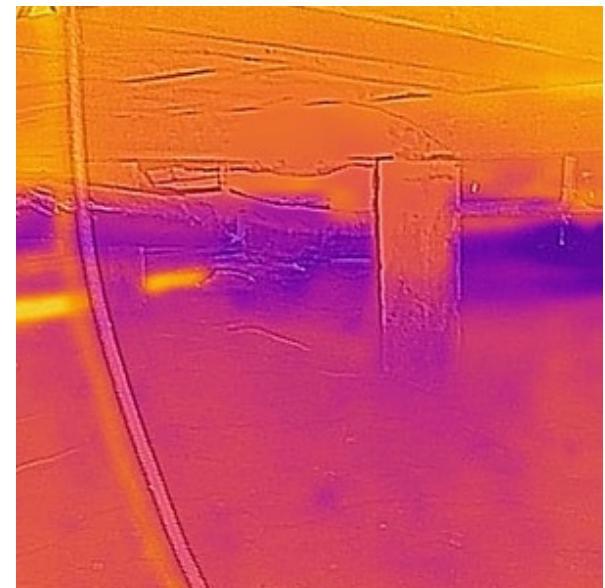
ENERGY LOSS AT SINGLE PANE WINDOWS

EXCESS MOISTURE / AIR LOSS AT DUCTS

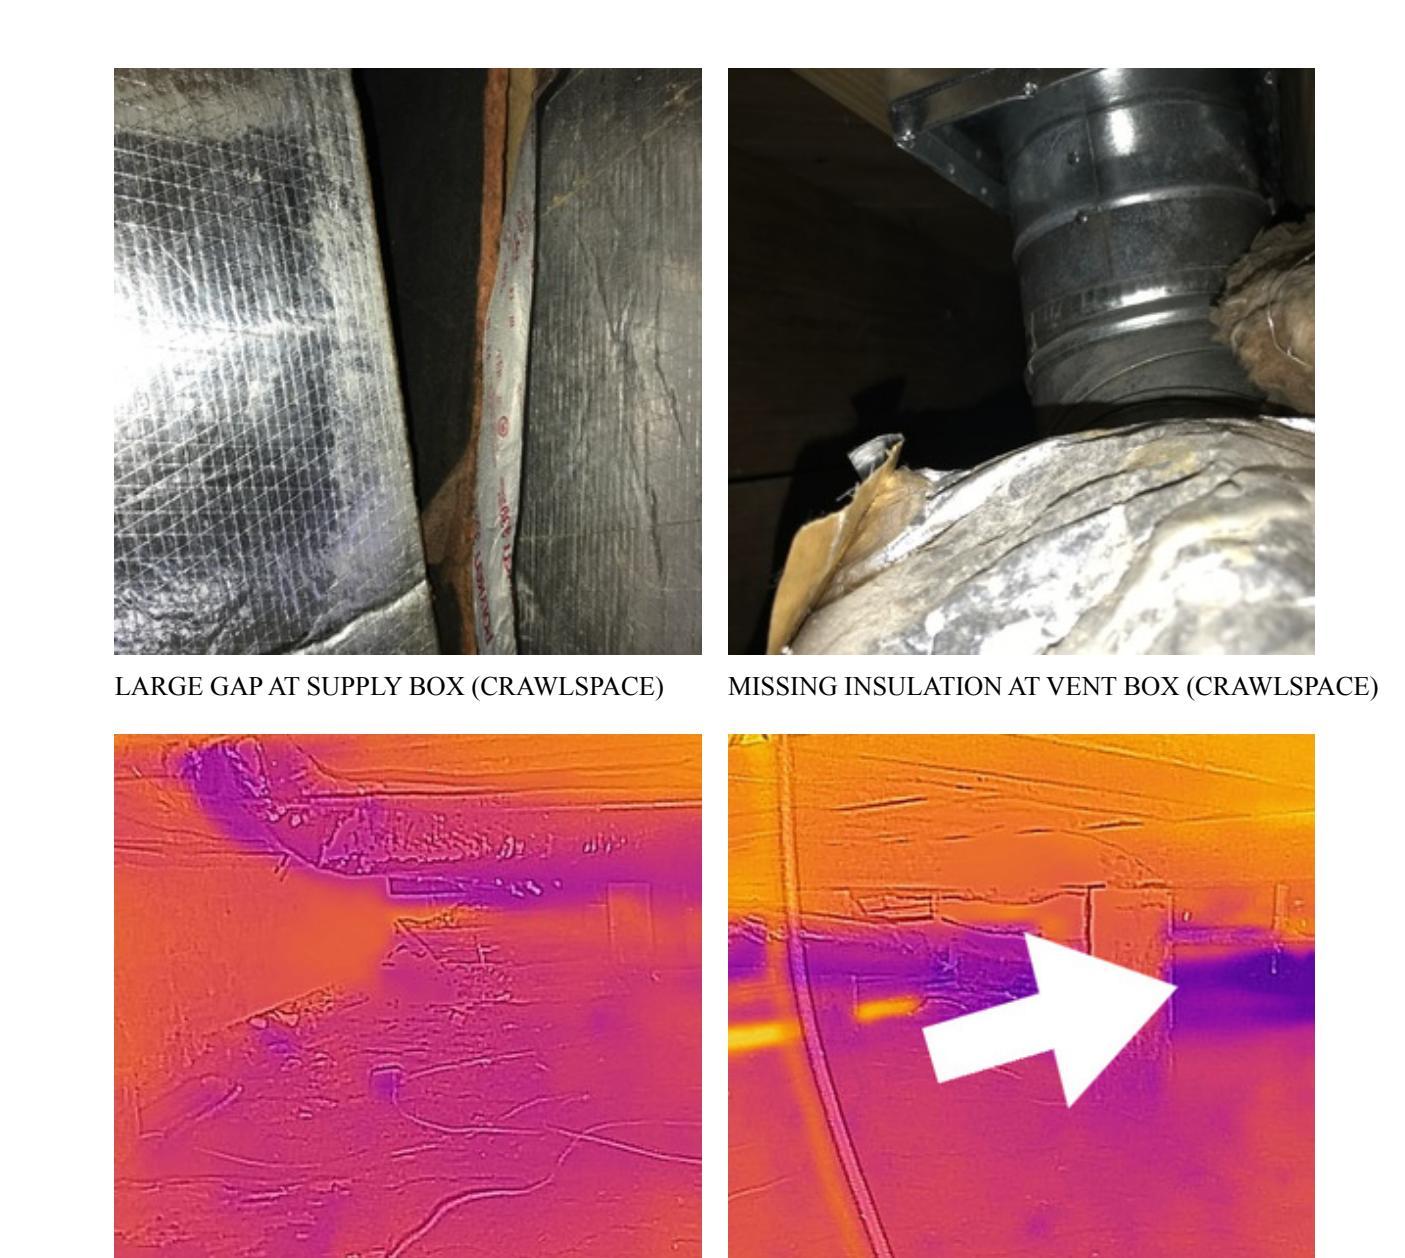
- ELEVATED DUCT ISSU	JES DISCOVERED:	
	Areas of elevated concer	n, possible safety hazards, s	ignificant damage, or issues that may be causing
	further investigated in a	timely fashion to eliminate t	he concerns noted below. Areas in need of immediate repair
	or further investigation b	y a subject matter expert in	clude, but are not limited to:
	-Large gap, failed foil tap	be at supply box located in o	rawlspace: Update as needed to prevent air loss, air quality
	issues	· · · · · · · · · · · · · · · · · · ·	and in the second se
	soil	pace. Address excess moist	ite issues in crawispace, elevate all ducts in direct contact with
	5011

AIR LOSS AT DAMAGED DUCT

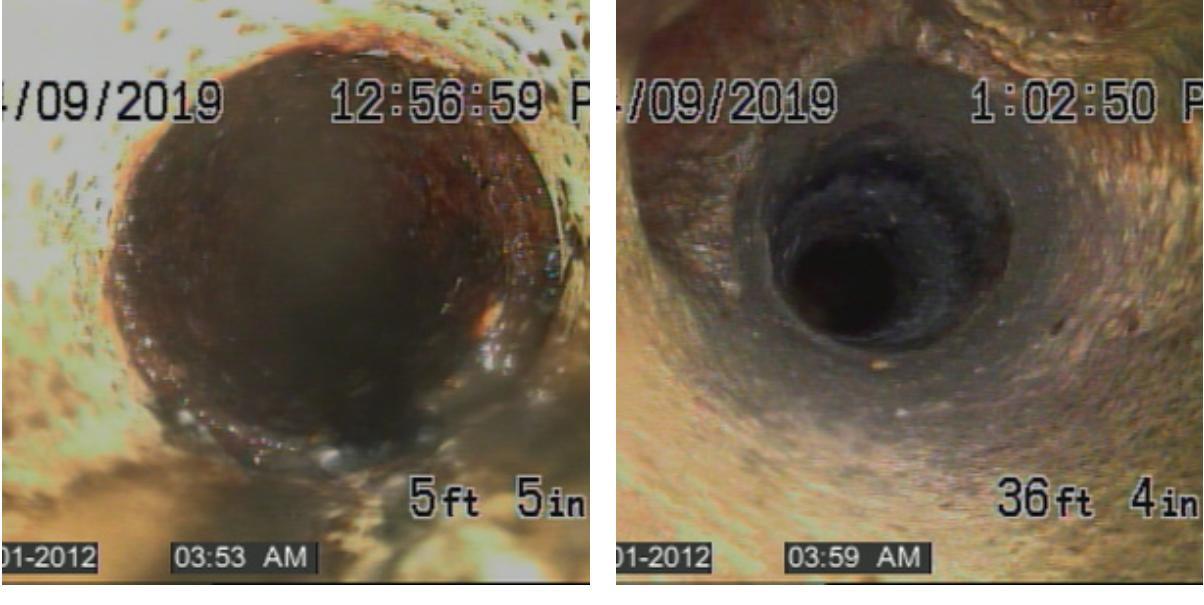
PVC / CAST IRON CONNECTION

CAST IRON BRANCH CONNECTION

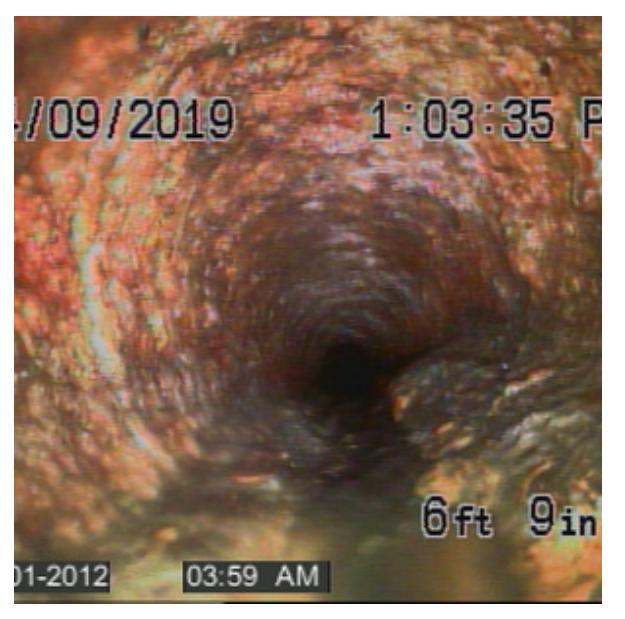
PIPE CHANNELLING / DETERIORATION

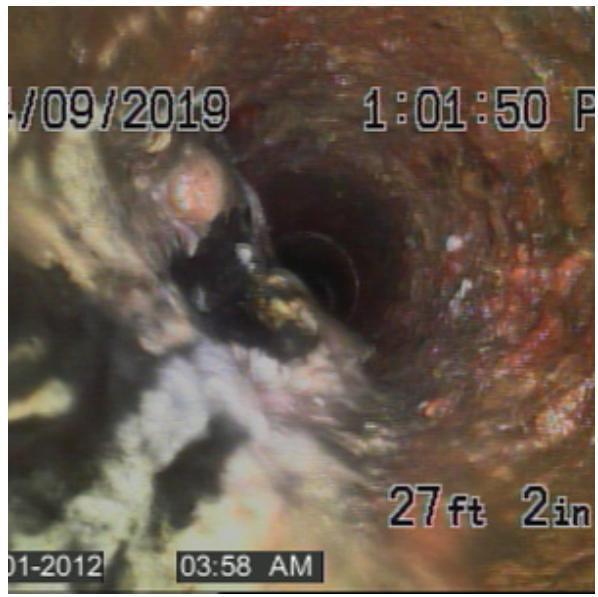
DEFORMATION AT CAST IRON

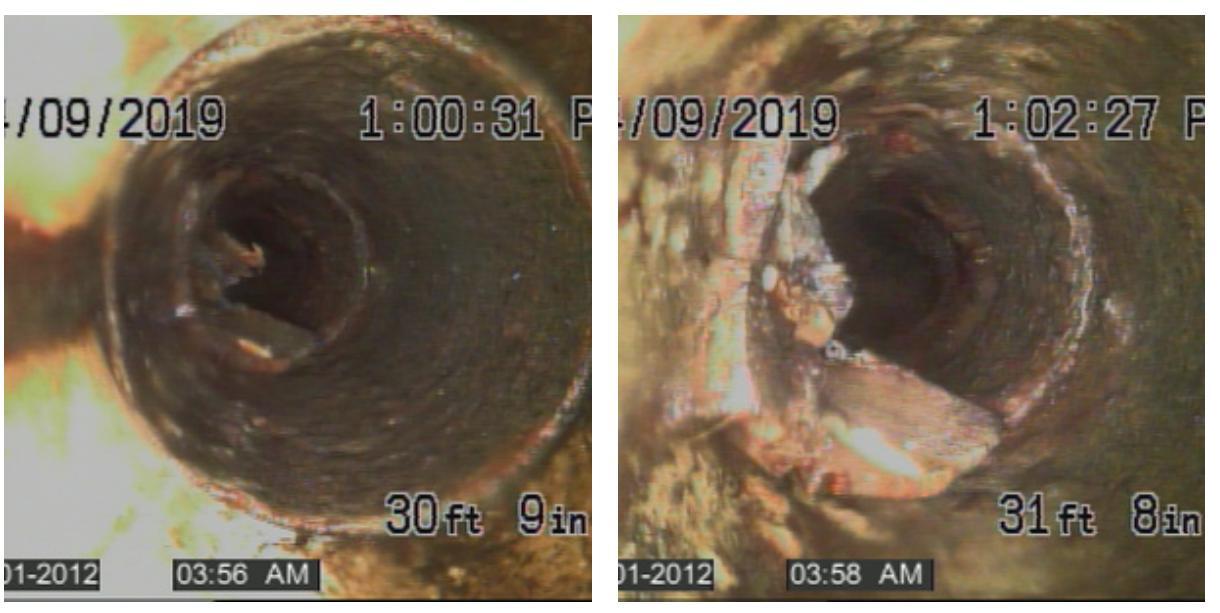
DEBRIS, POSSIBLE PIPE DAMAGE

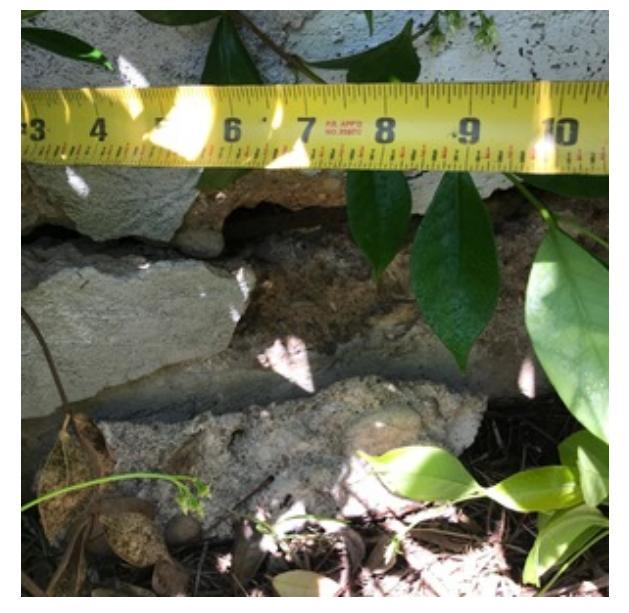
FRACTURED FOOTER WALL

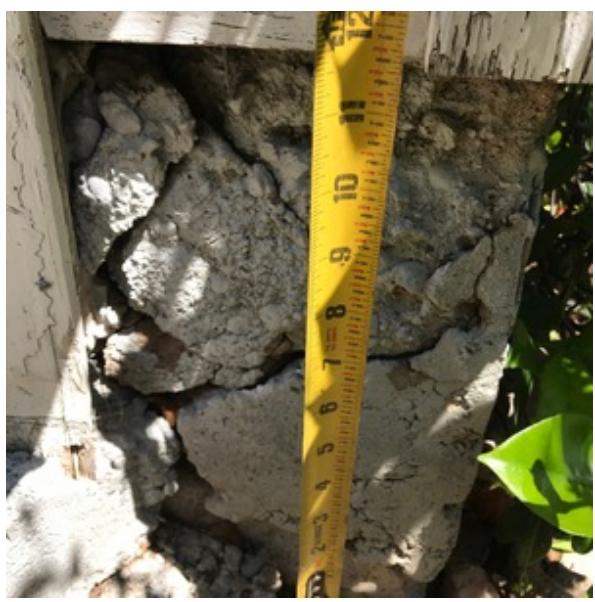
FRACTURES FOOTER WALL

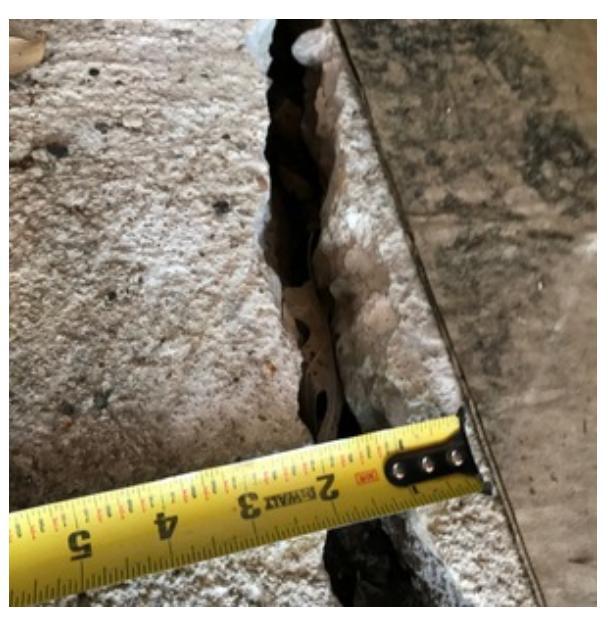
FAILED FOUNDATION

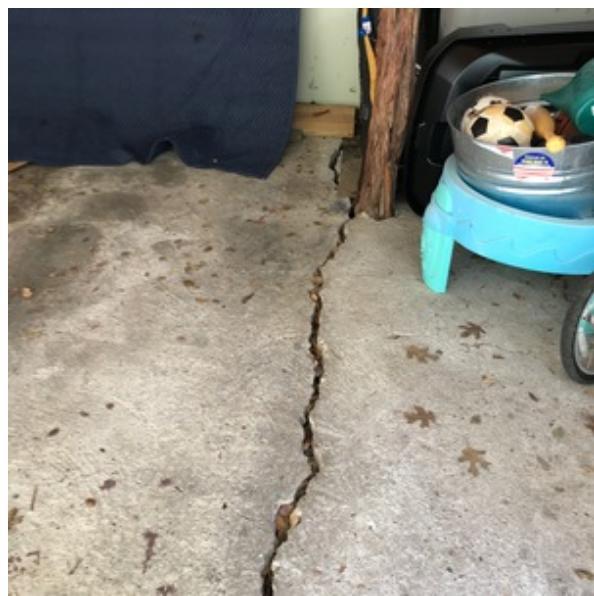
FAILED FOUNDATION

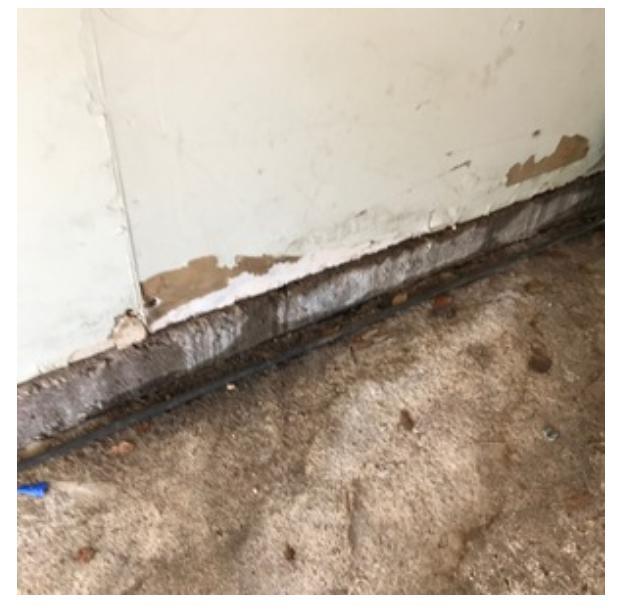
MOISTURE PENETRATION / DAMAGE

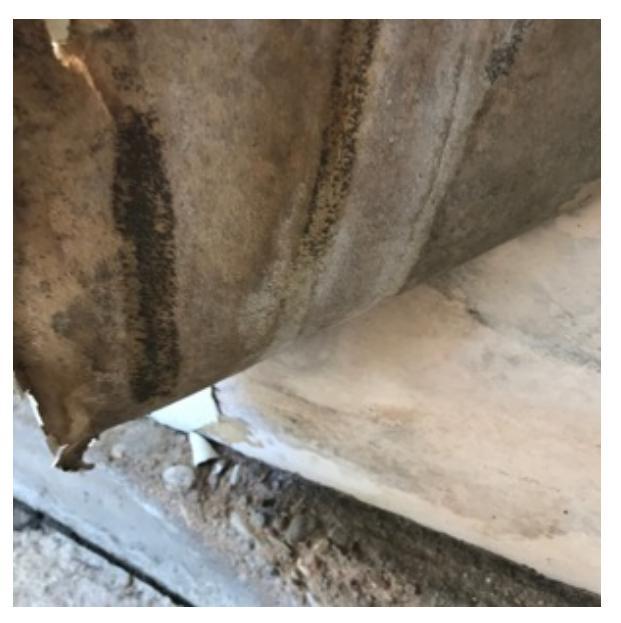
SATURATED / DAMAGED DRYWALL
