Client: Inspector: Date: 2202 Sample Report Austin, Texas 78703 Sam Sample Andy Jordan #9458 April 9, 2019

# **PROPERTY INSPECTION REPORT**

<b>Prepared For:</b>	Sam Sample	
	(Name of Client)	
<b>Concerning:</b>	2202 Sample Report Austin, Texas 78703	
	(Address or Other Identification of Inspected	Property)
By:	Andy Jordan, Lic #9458	April 9, 2019
	(Name and License Number of Inspector)	(Date)
	(Name, License Number of Sponsoring Inspector)

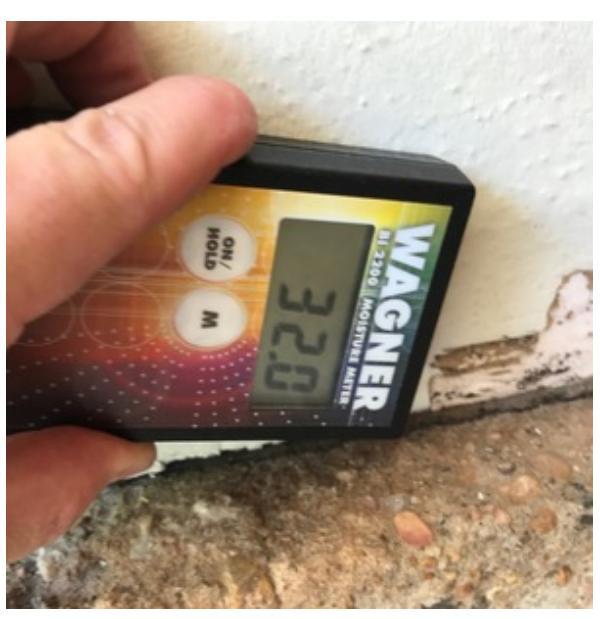
SATURATED DRYWALL

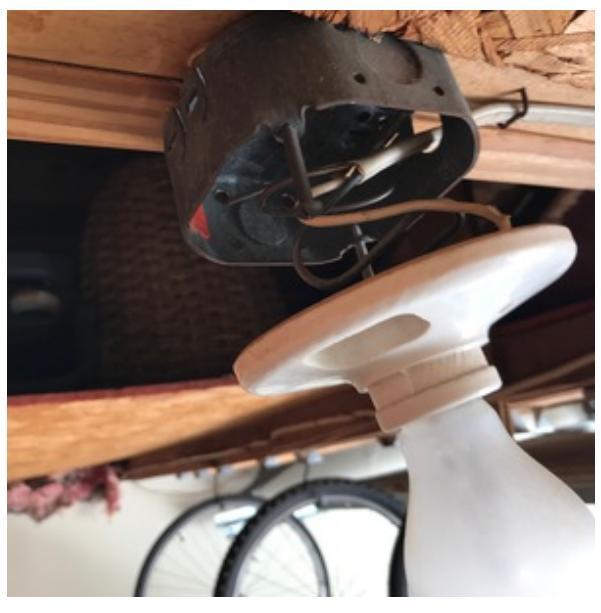
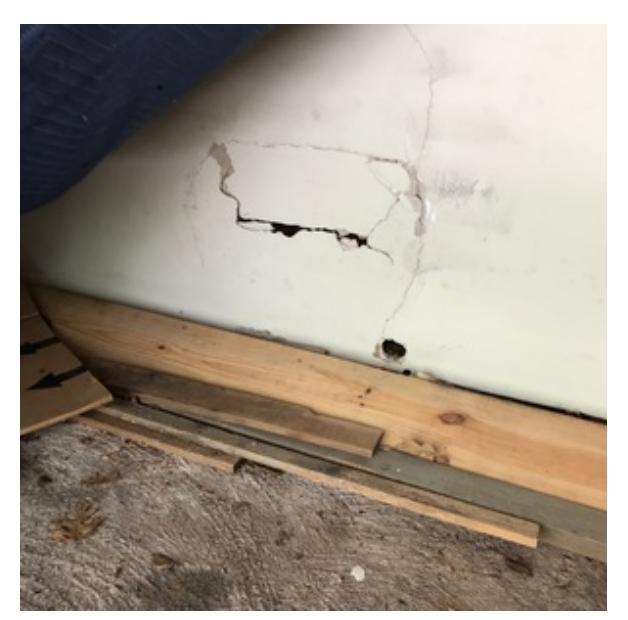
WIRING ISSUES

WALL DAMAGE / VERMIN ACTIVITY
