GREENBELT STRUCTURAL SERVICES
A DIVISION OF TAHI LLC

Assessment Type: Residential

Inspection Date/Time: 6/8/2023 at 1:00 PM

PROPERTY INSPECTION REPORT FORM

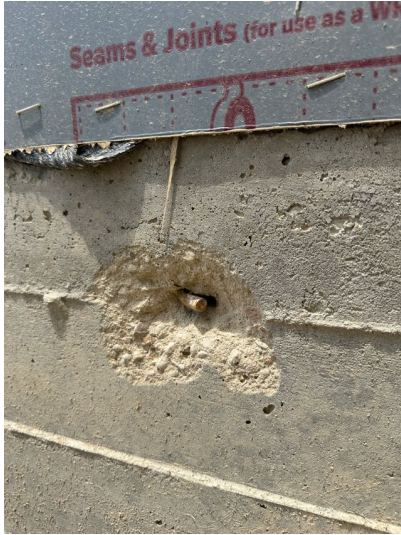
Exposed metal was present on the foundation wall or slabs (rebar, steel, slab reinforcement material, or fasteners). All exposed metal component should be rust treated and properly covered with concrete or parge coat to prevent rusting/expansion and damage to foundation.

EXPOSED METAL

- Remove all form debris prior to landscaping and sod install (wood material)
- Remove/trim any exposed rebar and cover to prevent rusting (foundation wall)
- Conduct finish work (parging/sand coat) if included in builder/buyer agreement
- Ensure all low spots and areas of utility trenches are properly backfilled and compacted prior to landscaping
- Ensure proper grading and drainage features are provided to adequately divert moisture away from the structure (to be inspected at final)

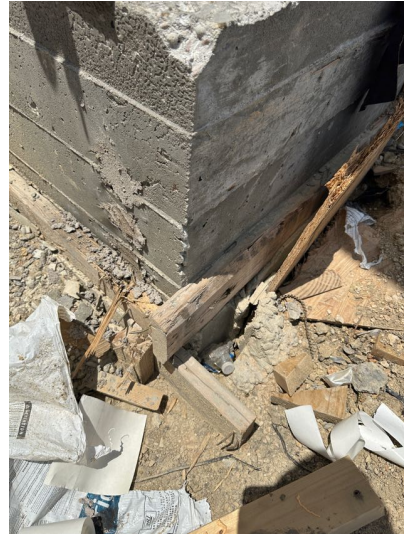
Form boards were observed in isolated areas. Form boards are used to shape concrete (slabs/skirting/wall openings) and are sometimes left in place after construction. In general, it is recommended that form boards be

removed to eliminate conducive conditions for wood destroying organisms.

FORM BOARDS LEFT IN PLACE

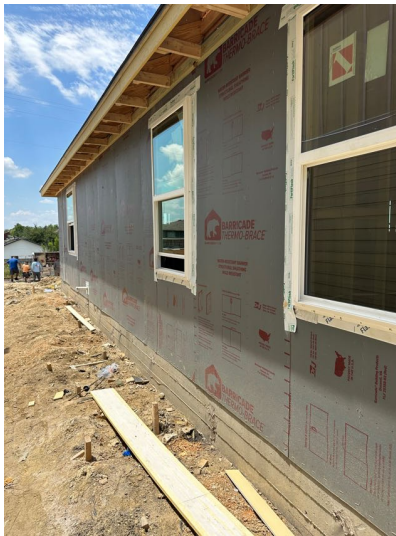
INSTALL PARGE COAT

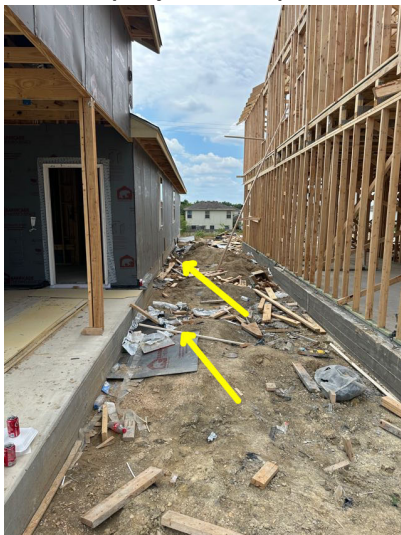
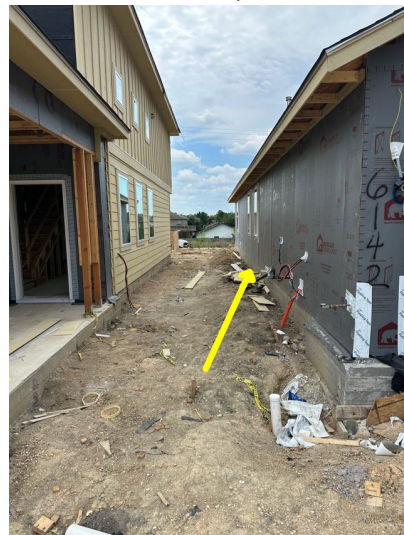
REMOVE DEBRIS

- Remove any construction debris around structure/yards prior to landscaping and sod install (wood/metal/glass etc)
- Ensure proper slope is achieved at areas with neutral/negative grading prior to project completion and landscaping (to be assessed at final)

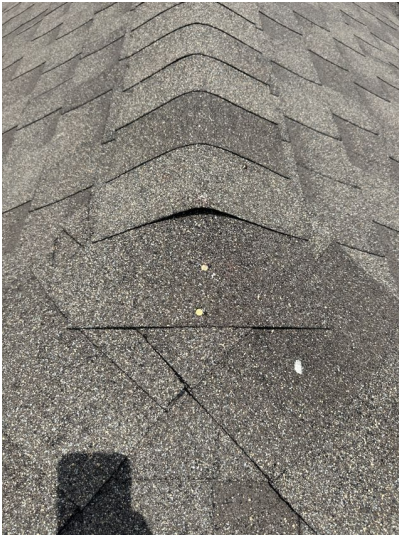
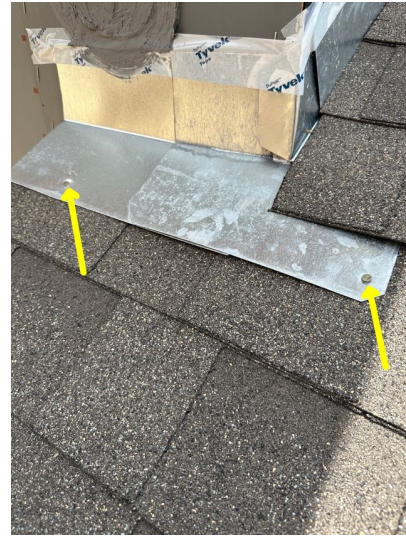
FASTENERS NOT SEALED

<p>-Seal all exposed fasteners -Adhere shingle at ridge</p> <p>Roof penetrations missing paint</p>
Page 10 Item: 4	Roof Structure and Attics	<p>- NOTED ISSUES -</p> <p>COMMON ISSUES PRESENT AT ROOF STRUCTURE/ATTICS: Common issues were observed at the roof structure and attics. The roof/attics were inspected for adequate ventilation/ducting, framing, moisture penetration, vermin activity and plumbing/electrical runs. Any notable issues will be listed in the report and should be addressed before final inspection.</p> <p>NOTE - DESIGN INFO AND INSPECTION LIMITATIONS: Roofs/attics are most commonly framed using a manufactured truss systems or conventional framing (rafters, perlin, vertical bracing, and collar ties). Roof framing should never be cut or structurally altered without first consulting a structural engineer. Using the interior attic framing area for storage may also place improper structural loads on supports not designed for applied loads. Inspection of the attic is limited by various factors including duct/framing layout, plumbing and electrical lines, insulation, and other factors. A good faith effort is made to examine all areas but some issues may be present that are not listed in the report as a result of limited safe access.</p> <p>DECKING ISSUES AND CONCERNS: Areas of decking material deflection and damage were observed in the attic. In their current state, it is important that these areas be avoided when walking on the roof. Although no immediate indicators of roof failure were observed, weak decking is susceptible to vertical forces from above which may affect the future roof performance if not corrected. The structure does not appear to be currently unstable but getting options/costs for reinforcement by a roofing and framing expert are recommended for future budgeting.</p> <p>GAPS AND CRACKS BETWEEN ROOF EAVE COMPONENTS: Gaps were present between segments of the fascia, trim, and soffit. Updating these areas with proper sealant/finishing is recommended to prevent moisture, insect, and vermin intrusion / damage.</p>

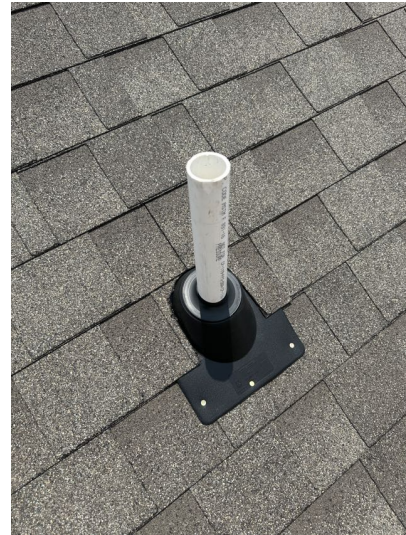
Roof penetrations missing paint

PAINT VENTS

- Uniform installation of roof covering material
- Adequate installation of flashing
- Proper caulking and sealing
- Proper adhesion of shingles
- Proper paint protecting of PVC pipe stacks
- General assessment for workman damage and isolated issues

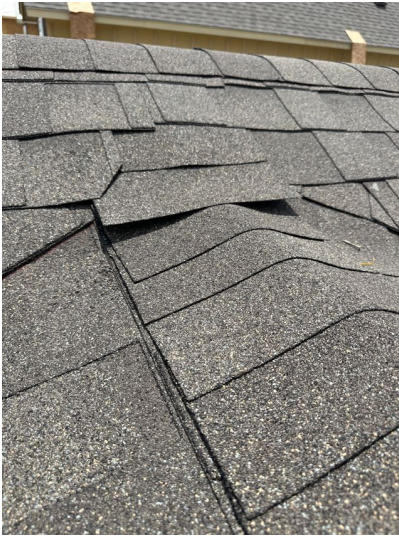
ADHEAR SHINGLE

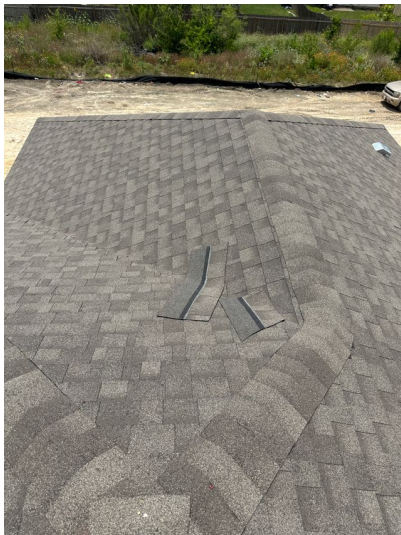
DEBRIS ON ROOF

Page 7 Item: 3	Roof Covering Materials	<p>COMMON RECOMMENDATIONS AND CONCERNS - INCOMPLETE INSTALLATION: Roofing material installation was incomplete at the time of the framing assessment. A full evaluation of the roofing system should take place at project completion (final inspection). Areas of common flaws, adjustment needs, and/or general concern were discovered during the property assessment. Ensure all recommendations and concerns are professionally addressed per the builder/buyer agreement. Areas of concern noted at the time of inspection include, but are not limited to:</p> <ul style="list-style-type: none"> -Ensure all vents and flashings are painted with uv protective paint prior to completion -Cut shingle at ridge -Remove debris from roof

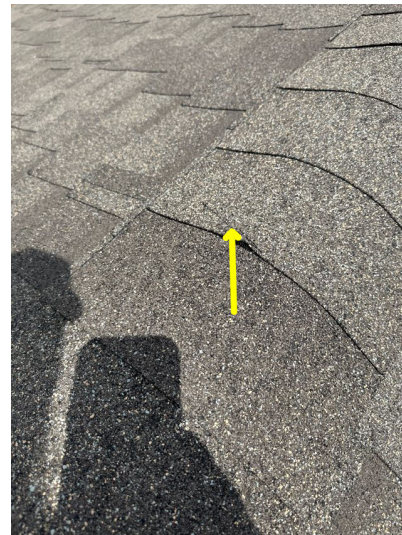
CUT SHINGLE

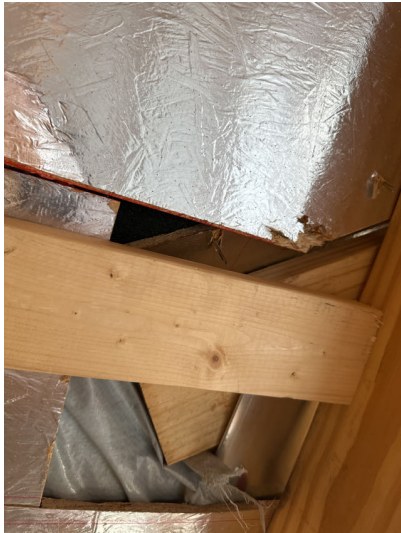
Areas of decking material deflection and damage were observed in the attic. In their current state, it is important that these areas be avoided when walking on the roof. Although no immediate indicators of roof failure were observed, weak decking is susceptible to vertical forces from above which may affect the future roof performance if not corrected. The structure does not appear to be currently unstable but getting options/costs for reinforcement by a roofing and framing expert are recommended for future budgeting.

DECKING ISSUES ABOVE GARAGE

Areas of common flaws, adjustment needs, and/or general concern were discovered the during property assessment. Ensure all recommendations and concerns are professionally addressed per the builder/buyer agreement. Areas of concern noted at the time of inspection include, but are not limited to:
 -Improve roof decking support at weak points and areas susceptible to damage

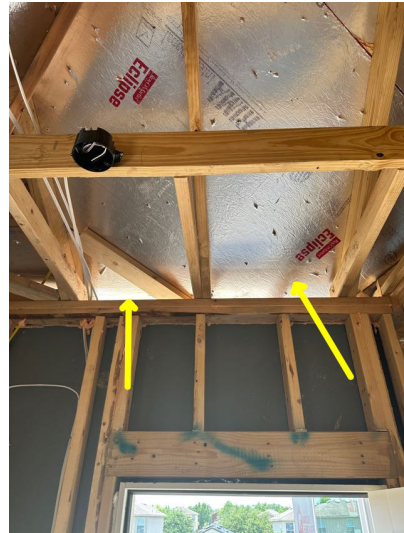
GAPS AND CRACKS BETWEEN ROOF EAVE COMPONENTS:
Gaps were present between segments of the fascia, trim, and soffit.
Updating these areas with proper sealant/finishing is recommended to prevent moisture, insect, and vermin intrusion / damage.

GAPS AND CRACKS BETWEEN WALL AND EAVE

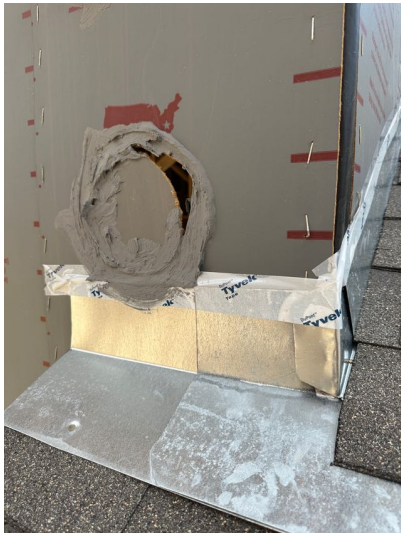
SEAL HOLES COMPLETELY

- Improve sections of house wrap / barrier with inadequate/improper coverage (missing, torn, loose, improperly installed materials)
- Ensure all wall penetration points are properly sealed to reduce the likelihood of future moisture entry (pipe, wire, exhaust penetrations etc)

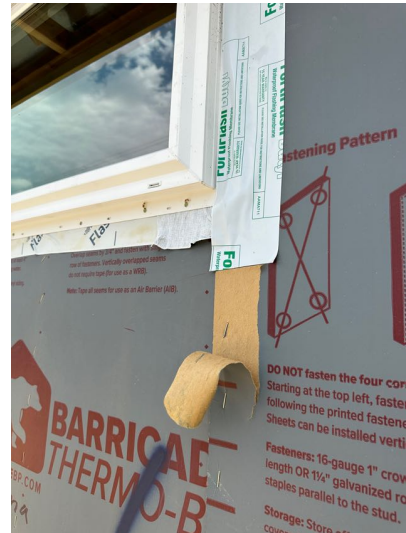
REPAIR MOISTURE BARRIER

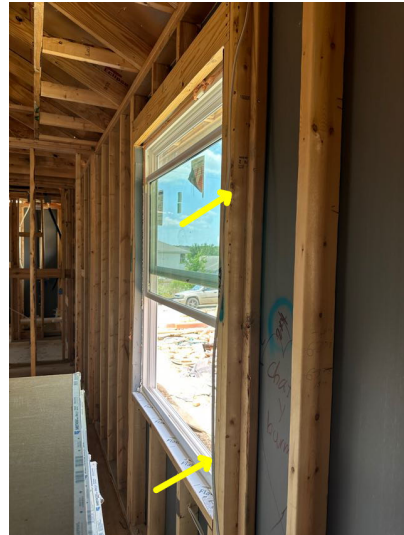
Common issues were observed with branch circuits and fixtures at the time of inspection. Notable problems will be listed in the report. Having a professional or specialist address the noted issues is recommended. Loose wire near window in living space.

SECURE LOOSE WIRE

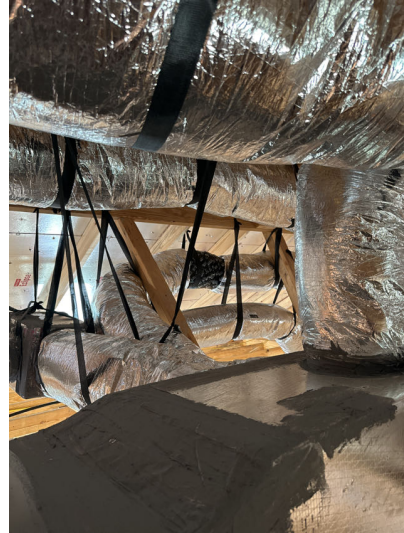
DUCT REPAIRED
