GREENBELT STRUCTURAL SERVICES
A DIVISION OF TAHI LLC

TAHI Services and Greenbelt Structural performed a limited assessment at the above noted property. The purpose of the site visit was to conduct a structural investigation to determine current condition and provide additional recommendations with regards to foundation repairs.

PROJECT REVIEWER

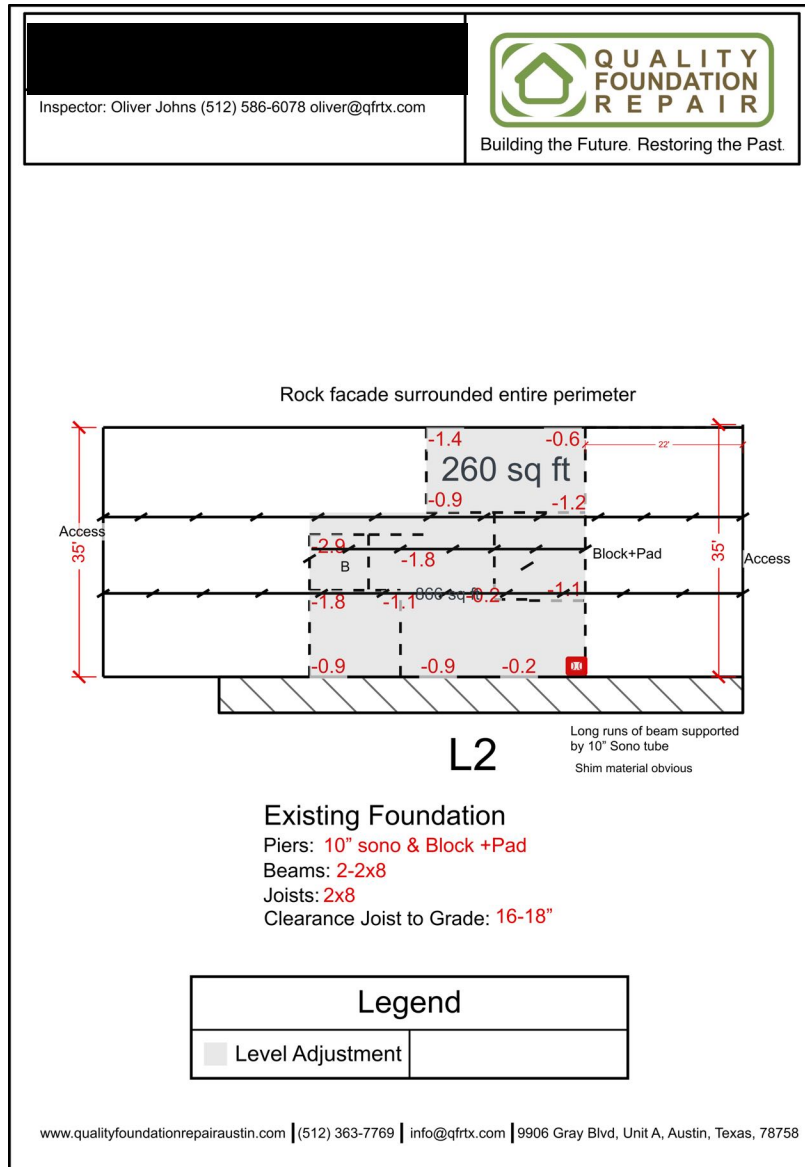
FOUNDATION LEVELNESS SURVEYS

The following foundation levelness survey is measured to the nearest 1/10th inch. All readings are the variances from the 0.0 in the read boxes. The surveys showed the overall variances in the levelness of the foundations to be larger than normal parameters for a foundation of this size. Larger than normal variances were also found in relatively short distances between some of the check points.

The drawing is not to scale but is a reasonable facsimile of the building foundation. This drawing should only be used as reference tools:

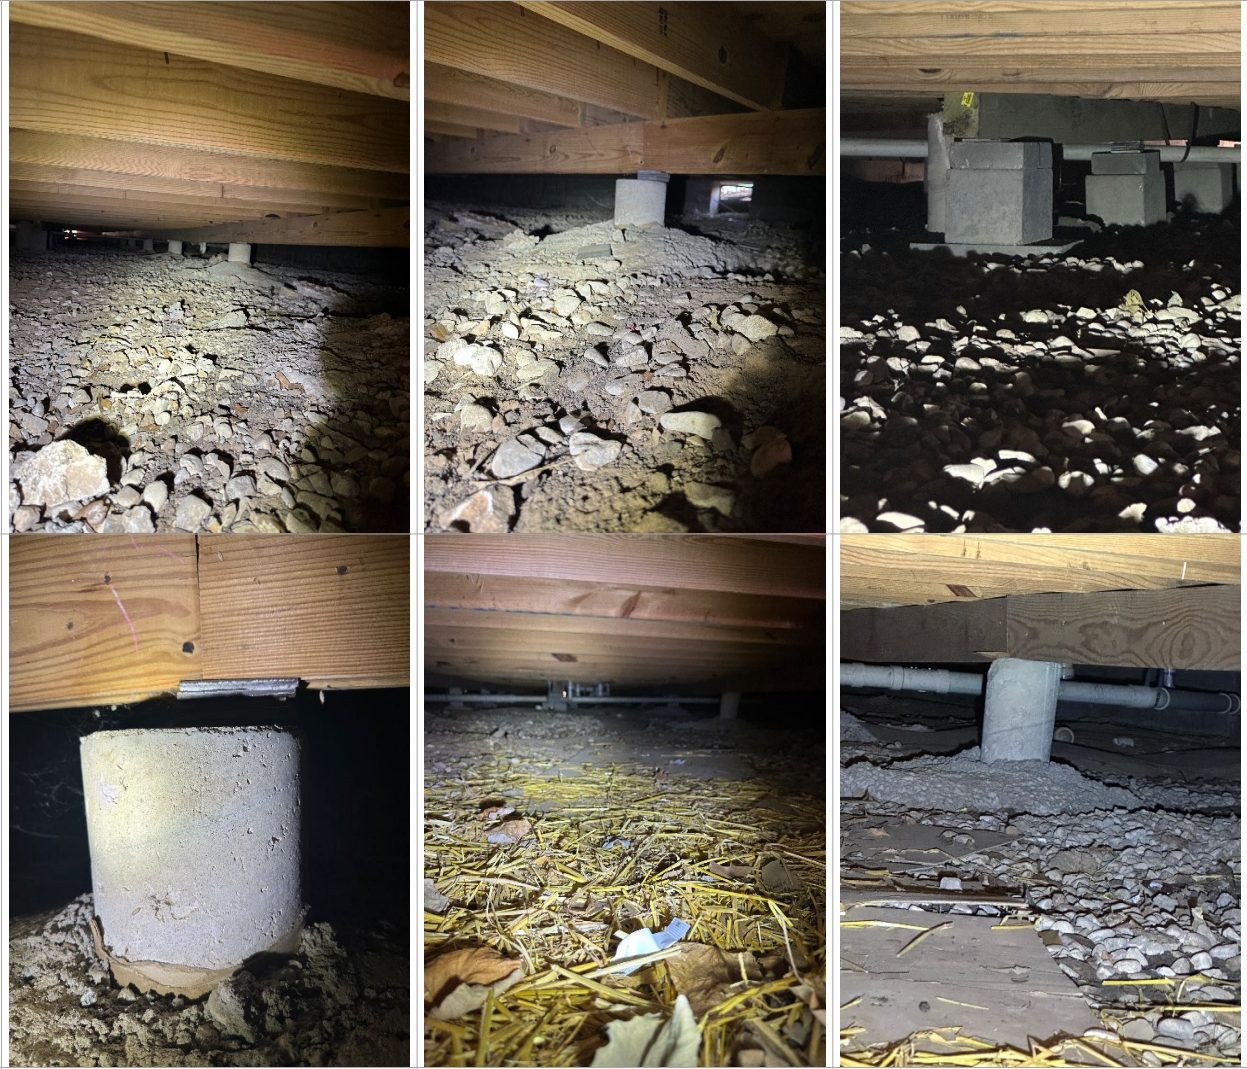
SILL PLATE UPLIFT

Upon entry at the right side of the building, we observed substantial lifting of the sill plate. The inside edge of the sill was lifted by up to 1 1/2". From our vantage, we did not observe any anchors or other method of connection between the sill and perimeter beam wall. No steel straps or other common connectors were present at interior piers and beams. Evidence of previous shimming and repair/improvements at interior piers and beams was noted. The installation of an additional pier/beam system was present at the mid/center portion of the crawlspace.

Observations from the right side entry point revealed similar conditions, however, sill uplift at the right side was less pronounced. Vertical load stress at various pier/beam intersections was observed at several locations with the most visibly obvious areas being at the front most interior beam near plumbing termination points. Visible deflection of the beam spans was also noted in these areas.
