Property: 123 Sample Rd.
Austin , TX 78703
Client: Sample Report - New Construction
Inspector: Andy Jordan #9458
Date: October 18, 2023

PROPERTY INSPECTION REPORT

Concerning: 123 Sample Rd. Austin, TX 78703
(Address or Other Identification of Inspected Property)

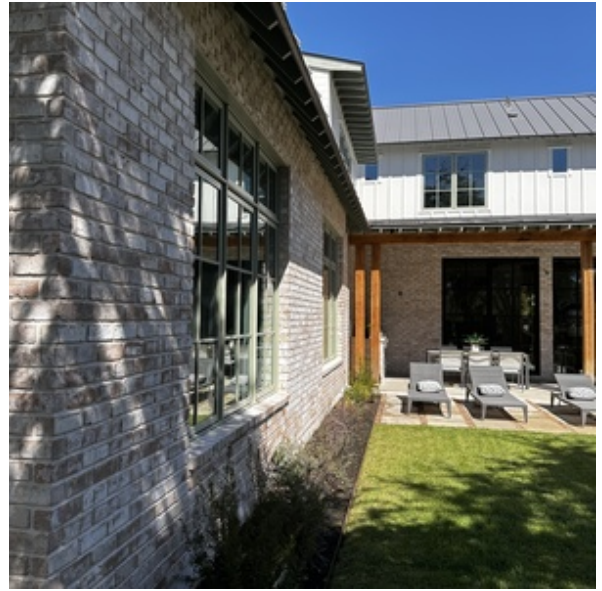
RAIN GUTTERS NOT PROVIDED

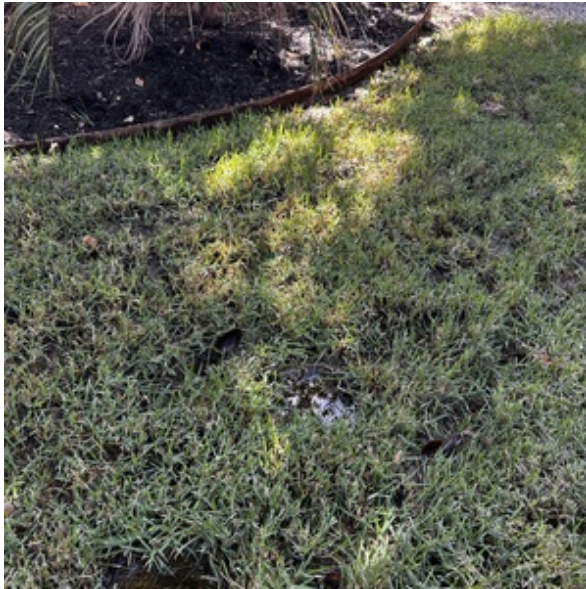
At the time of inspection, portions of the front yard were saturated (possibly due to an irrigation leak). Supply side plumbing pressure testing indicated slow water loss was occurring. Further investigation is required to identify possible points of water loss. If the soil saturation at the front yard is not irrigation leak related, steps should be taken to identify additional issues and ensure the irrigation system meets standards noted in the engineering report.

FRONT YARD: SOIL SATURATION

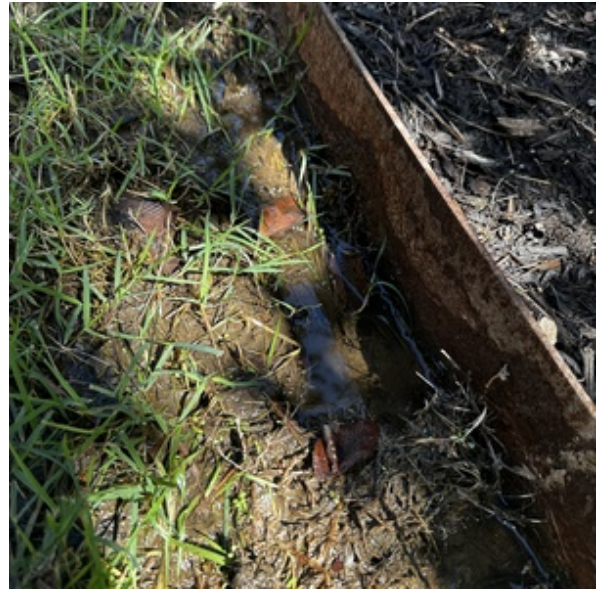
FRONT YARD: SOIL SATURATION

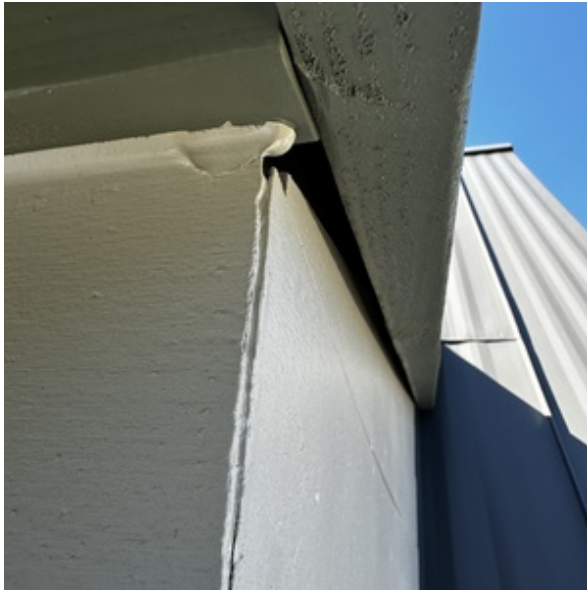
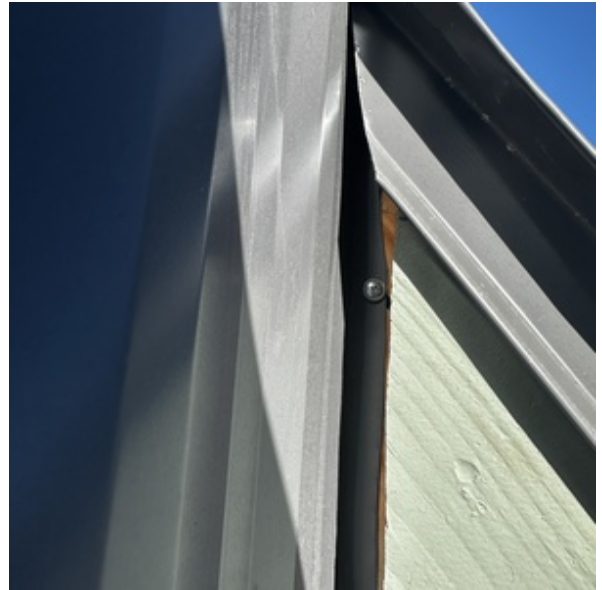
- Additional flashing or sealant required at fascia areas of dormer/s: Small gaps and exposed underlayment/OSB observed at front dormer

SEAL GAPS AT FASCIA AREAS

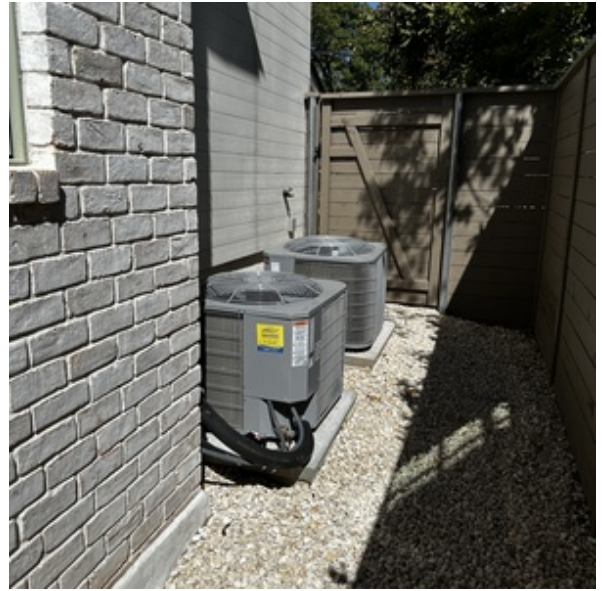
EQUIP. UNDER FLAT ROOF DRAIN POINT

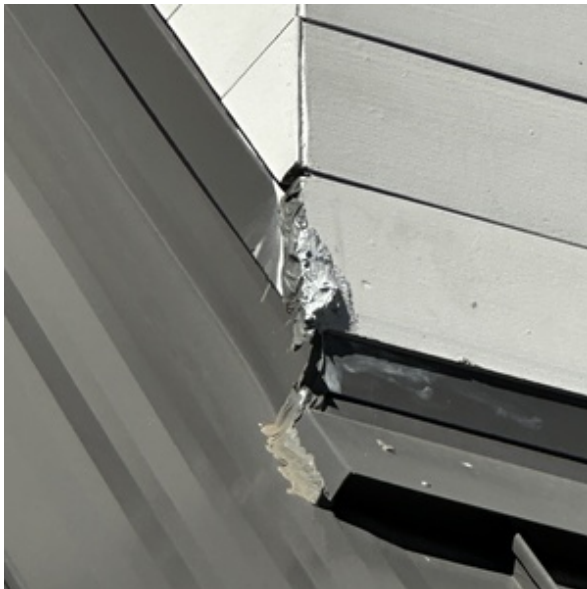
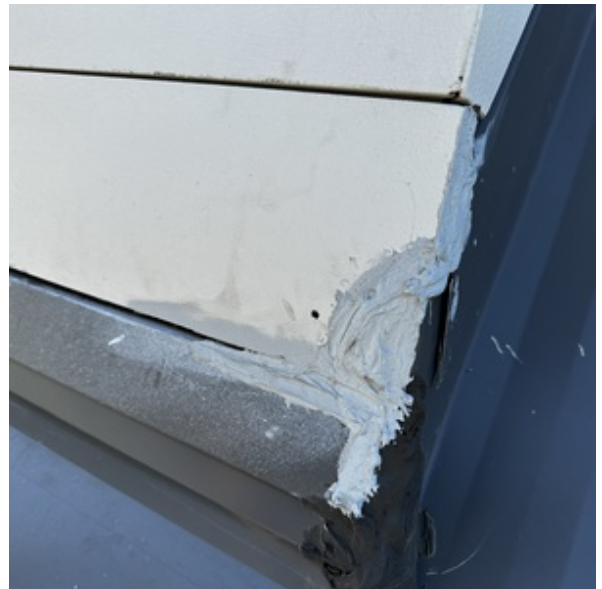
POSSIBLE CAULK DEPENDENT FLASHING

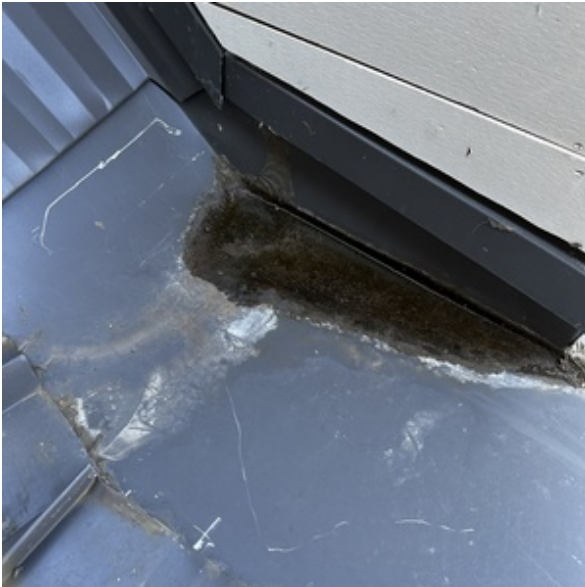
- Area of improper drain slope at flash pan of lower roof near front dormer (pooling water observed in valley flash pan)
- Recommend roofer further inspect pitch transitions at dormer areas: Pitch break/transition flashing not installed (panels bent and may be notched to make transition), further assess to ensure bending/notching does not create potential moisture entry points

POOLING WATER AT FLASH PAN

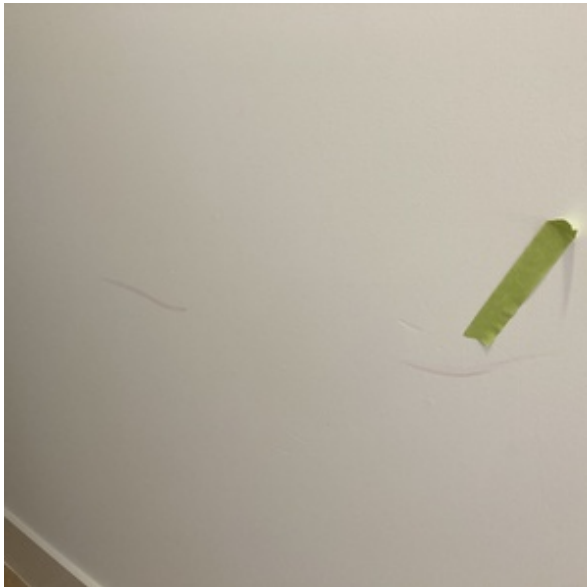
MINOR FLAWS MARKED ON SITE

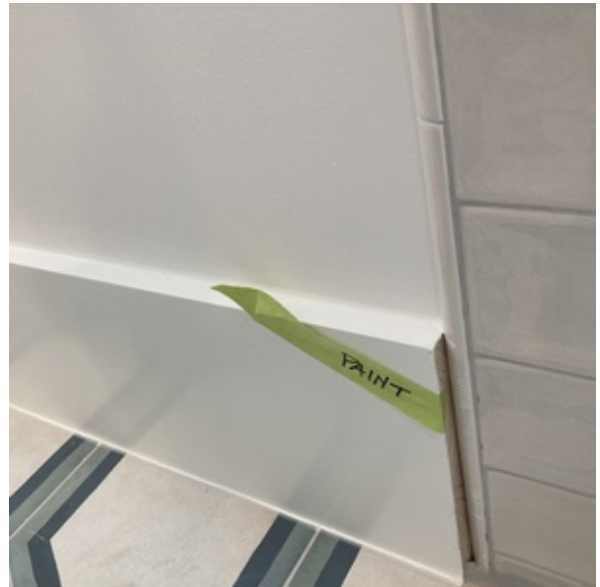
MINOR FLAWS MARKED ON SITE

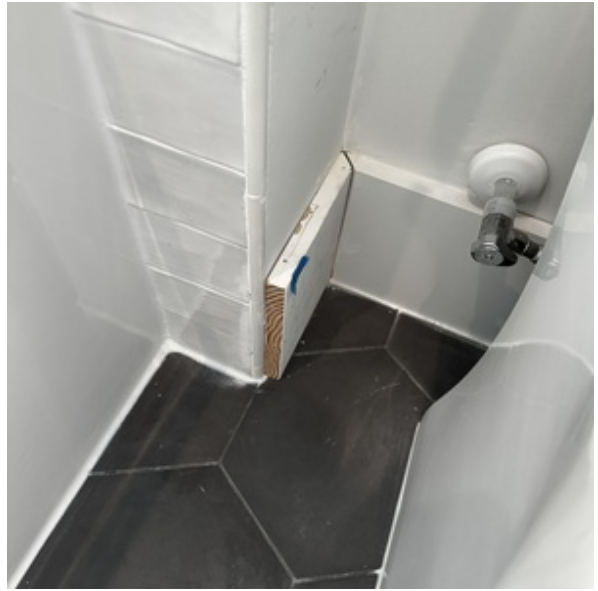
INCOMPLETE TRIM WORK (BATHROOM)

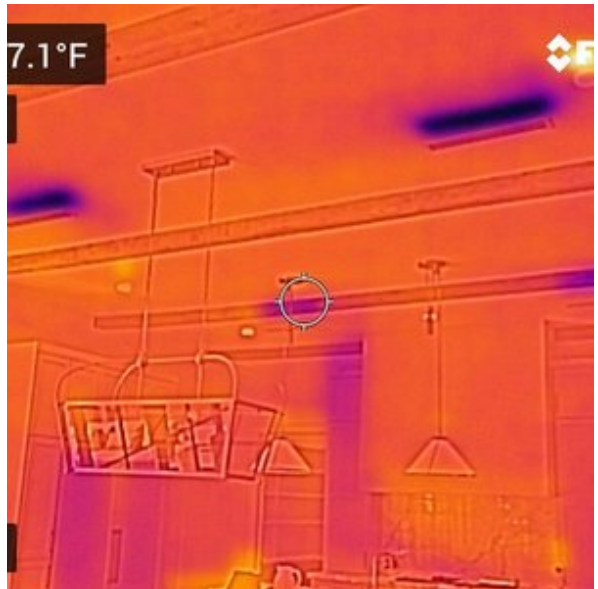
THERMAL CAMERA - NORMAL READINGS

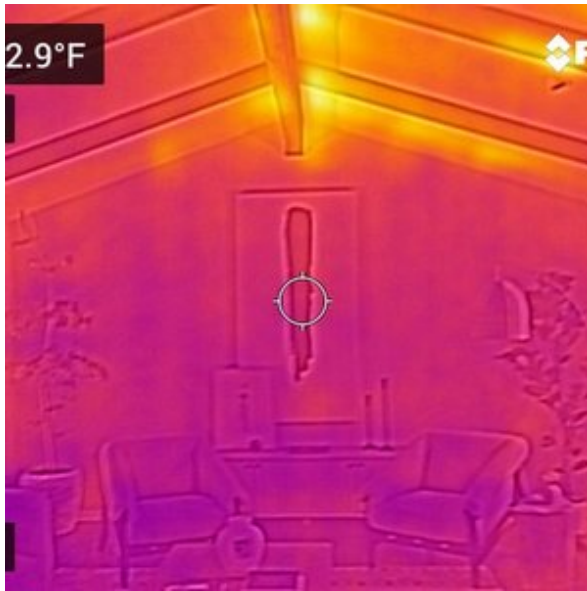
THERMAL CAMERA - NORMAL READINGS

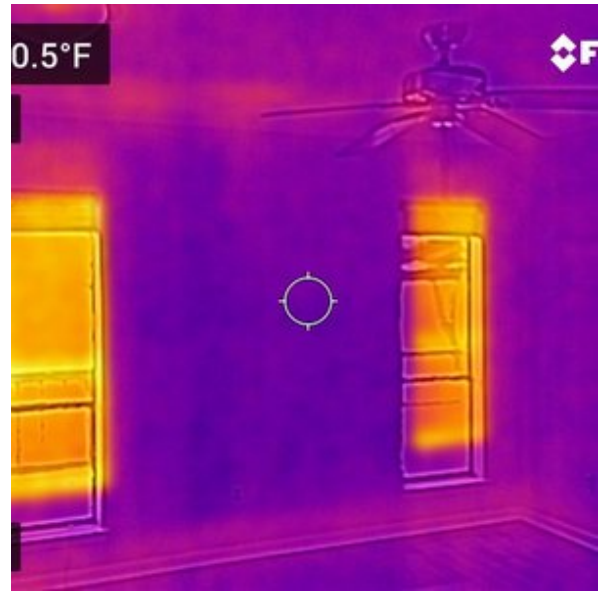
THERMAL CAMERA - NORMAL READINGS

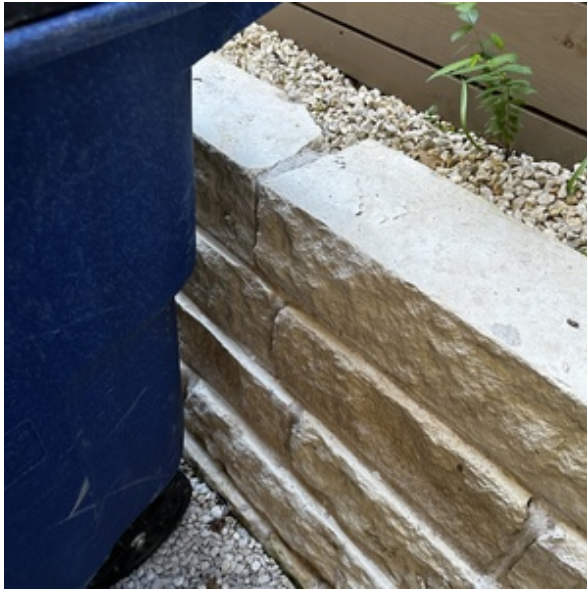
RETAINING WALL PROVIDED

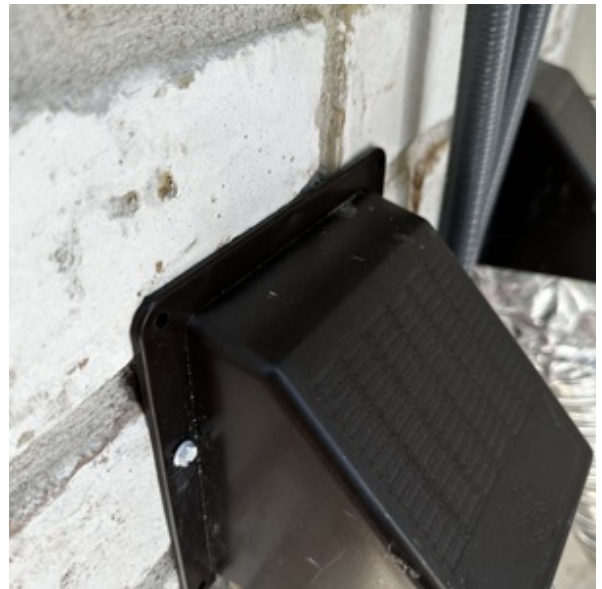
CAULK/SEAL AT HVAC LINE CAP

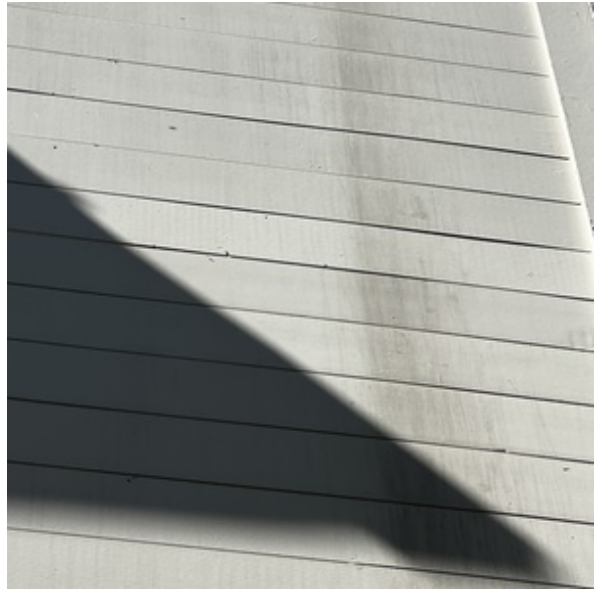
- See notes on roof run-off concern under flat roof (Roof Covering chapter): Improve moisture diversion and/or ensure cladding is well sealed/protected, ensure bowing wood panels in area are not redirecting water (address as needed)

AREA OF ROOF RUN-OFF

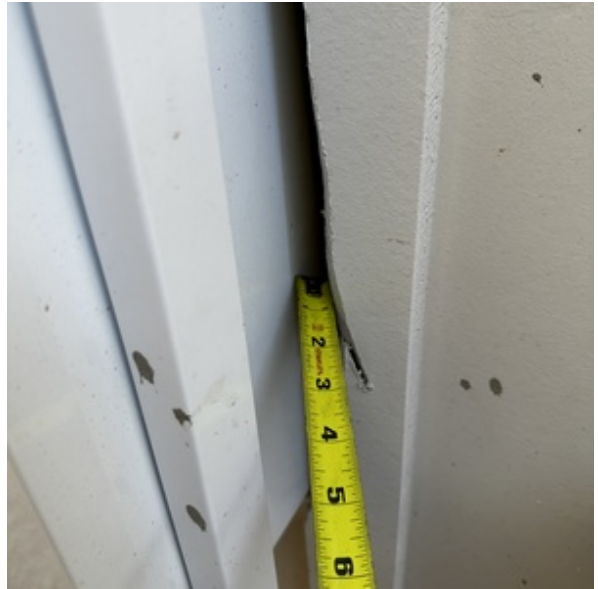
- Incomplete flashing and finish work at water heater installation area (right ext wall, cuts suggest water heaters placed after cladding installed): Inset water heaters at exteriors pass through barrier material, ensure area is provided long term protection from moisture penetration

GAP/CUTS SURROUNDING W/H

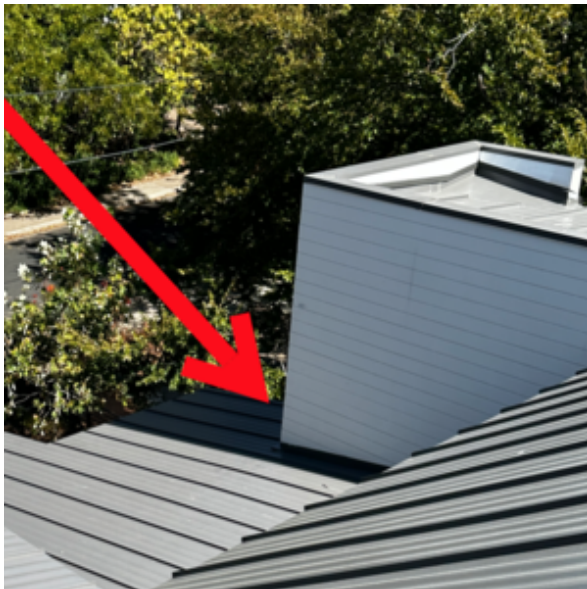
- A cladding gap/flaw and torn barrier wrap was noted at the front facing right wall corner under the flat roof (torn barrier viewed from gap w/ flashlight): Updates are advised to eliminate this potential moisture entry point

AREA OF GAP/BARRIER FLAW

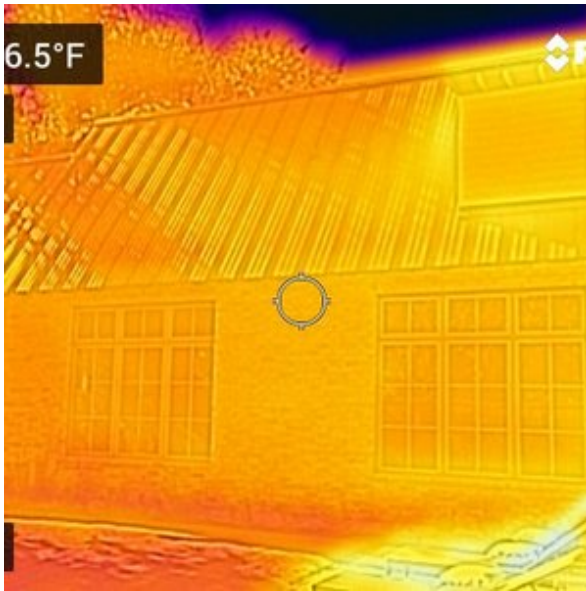
THERMAL CAMERA - NORMAL READINGS

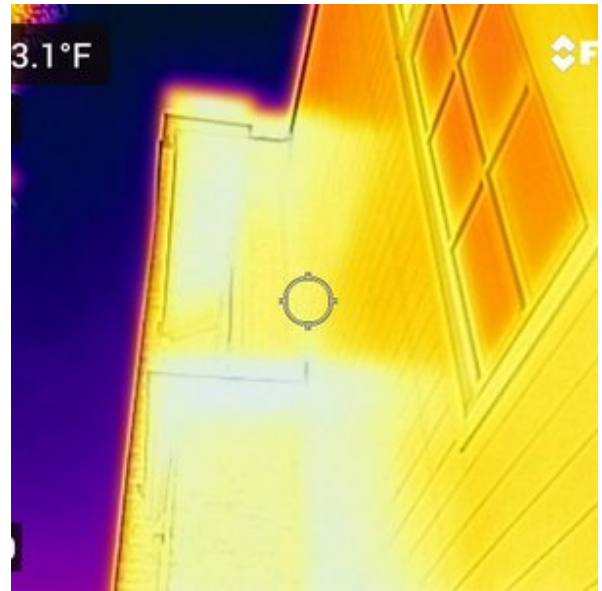
THERMAL CAMERA - NORMAL READINGS

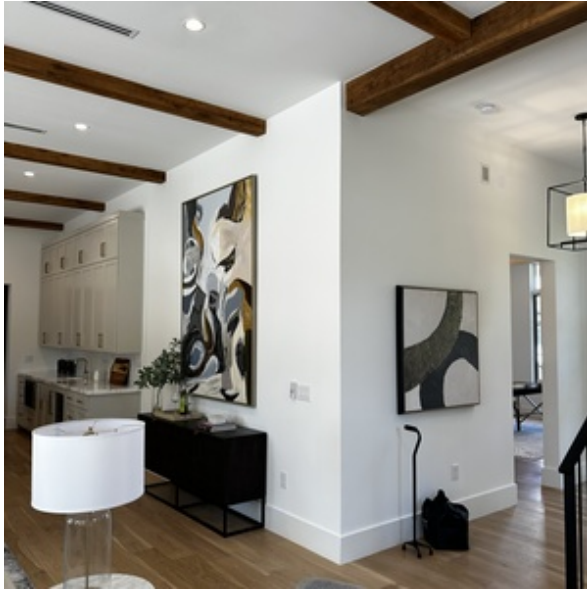
OVERALL GOOD CONDITION

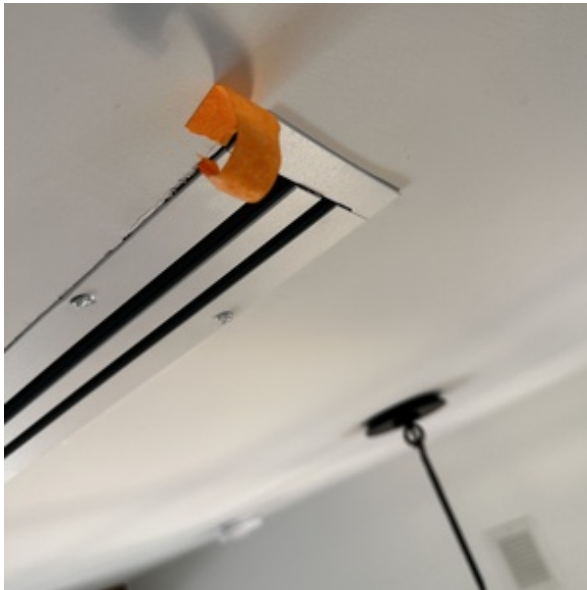
MINOR FLAWS MARKED ON SITE

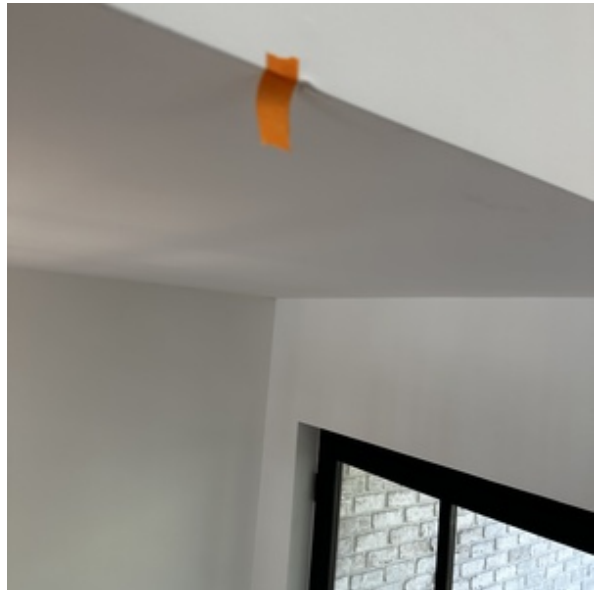
MINOR FLAWS MARKED ON SITE

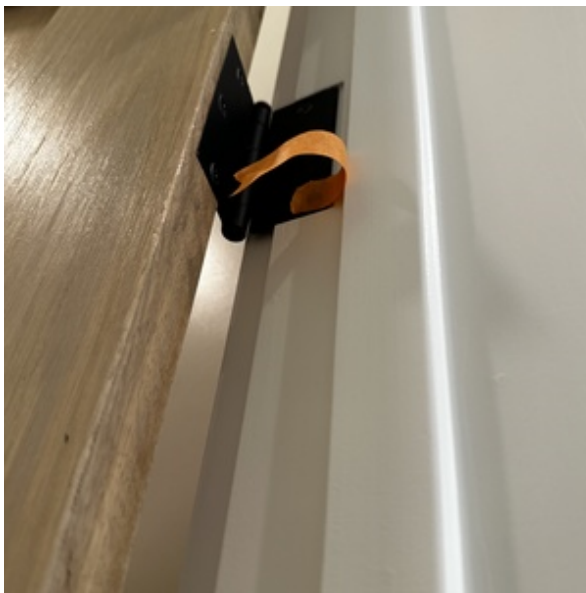
COMMON FLAWS MARKED ON SITE

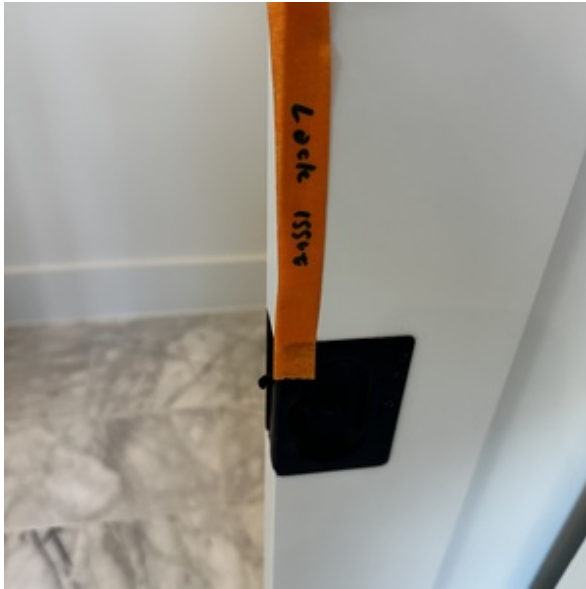
LOCKING ISSUES AT DOORS

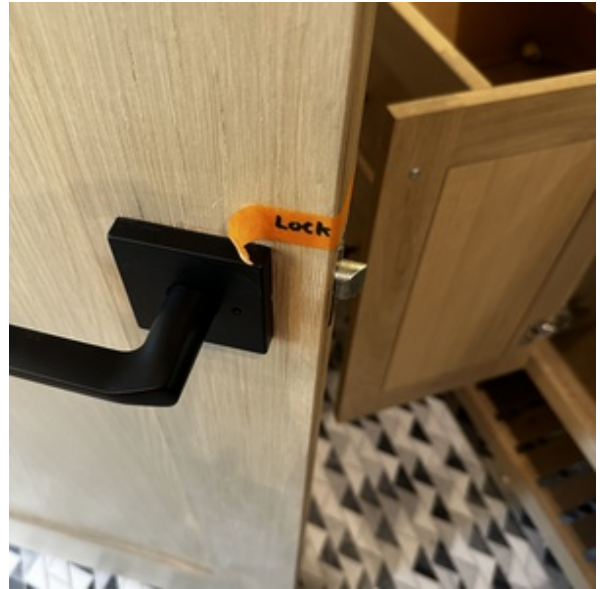
LOCKING ISSUES AT DOORS

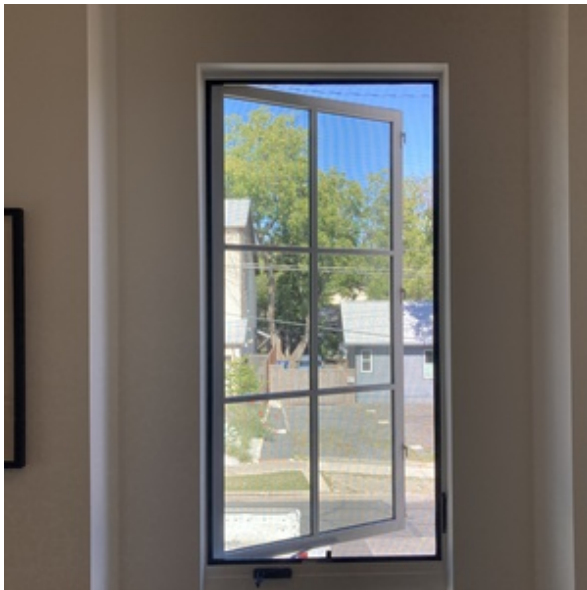
WOOD FRAMED WINDOWS PRESENT

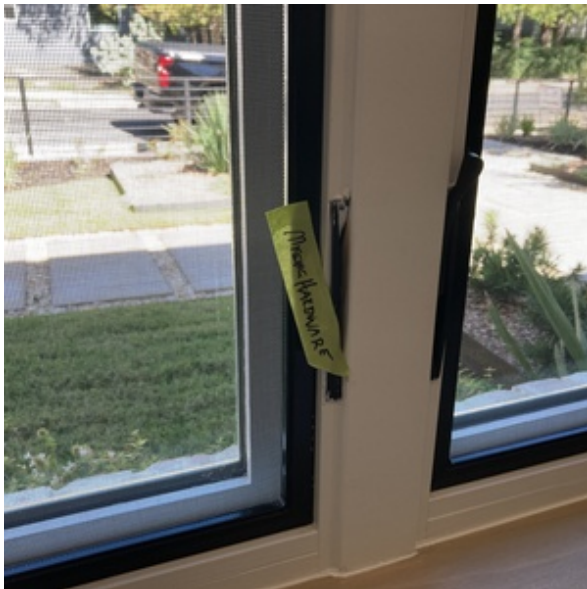
COMMON ISSUES MARKED ON SITE

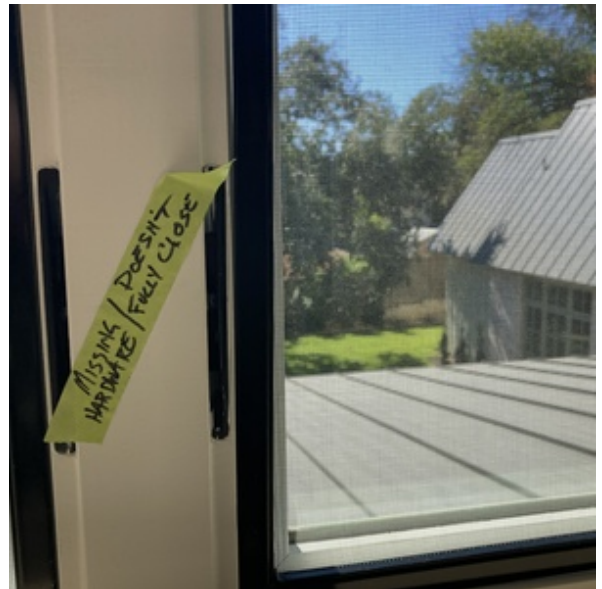
COMMON ISSUES MARKED ON SITE

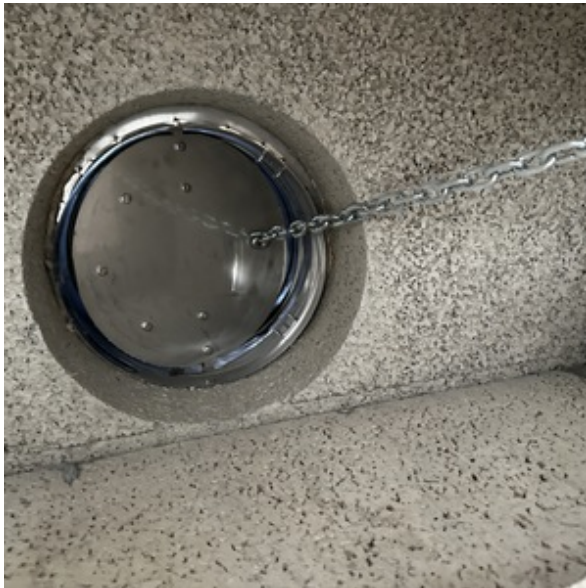
FLUE DAMPER PROVIDED

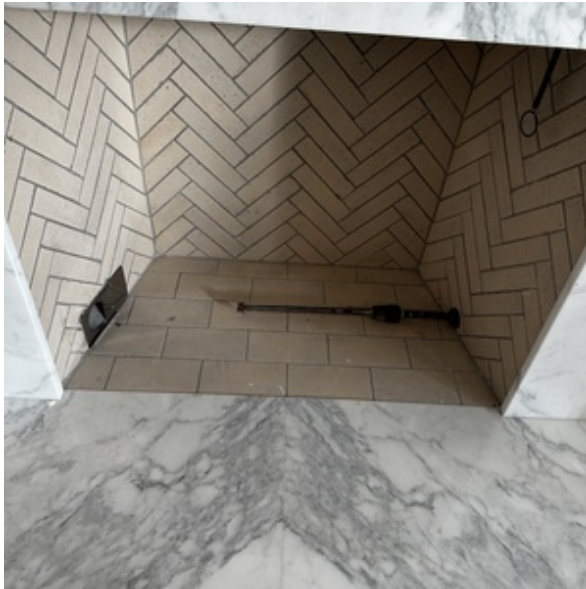
FIREWALL IN GOOD CONDITION

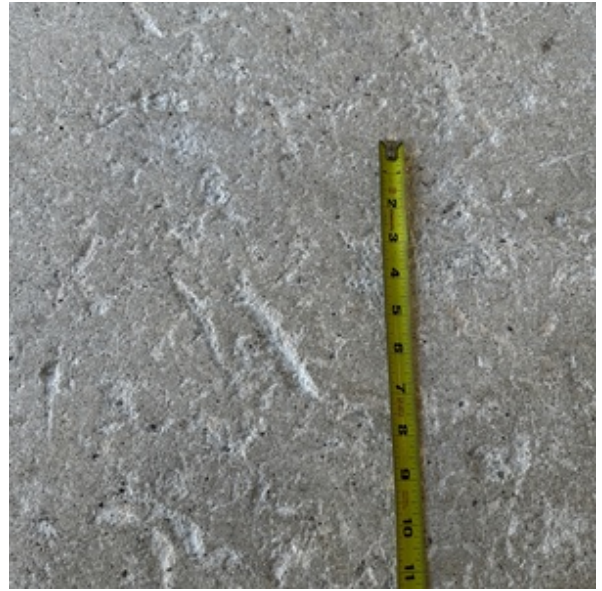
GARAGE SURFACE FLAWS

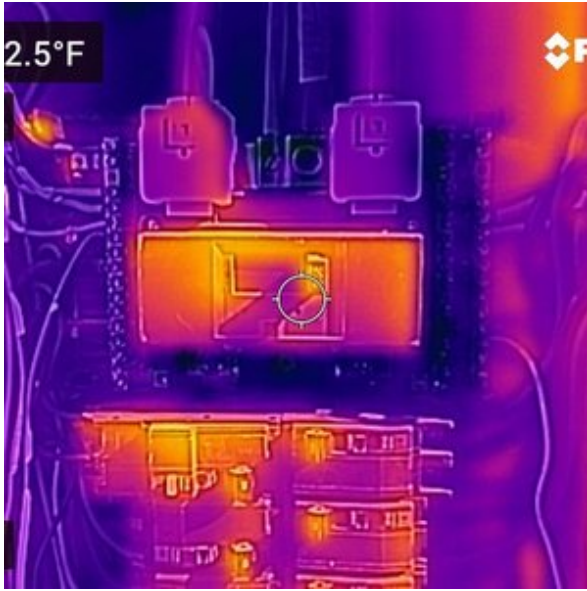
THERMAL CAMERA - NORMAL READINGS

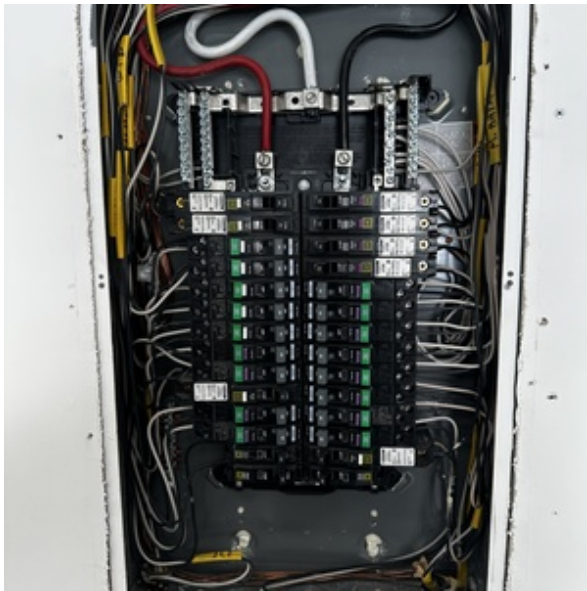
SUB PANEL IN GARAGE

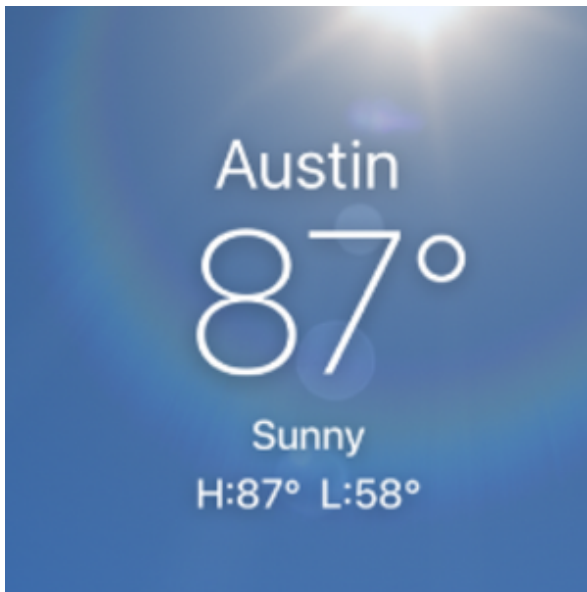
87-90F DURING TESTING

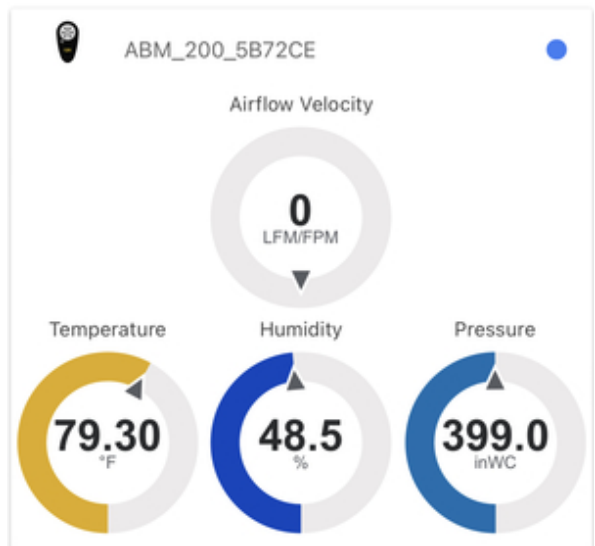
ATTIC: NORMAL CONDITIONS

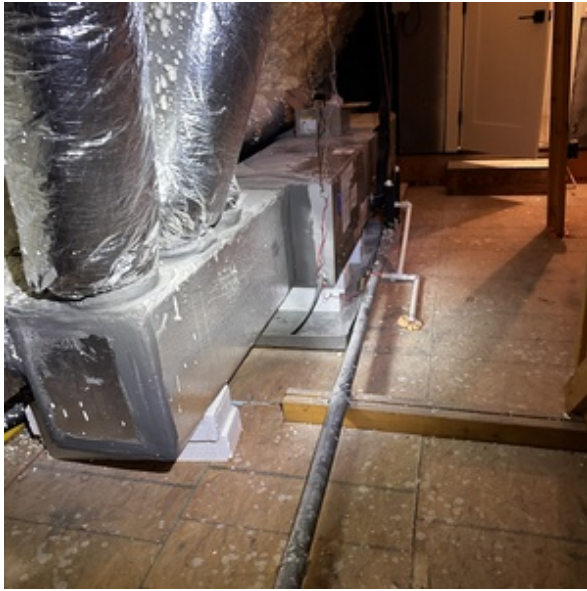
INSTALL MEETS STANDARDS

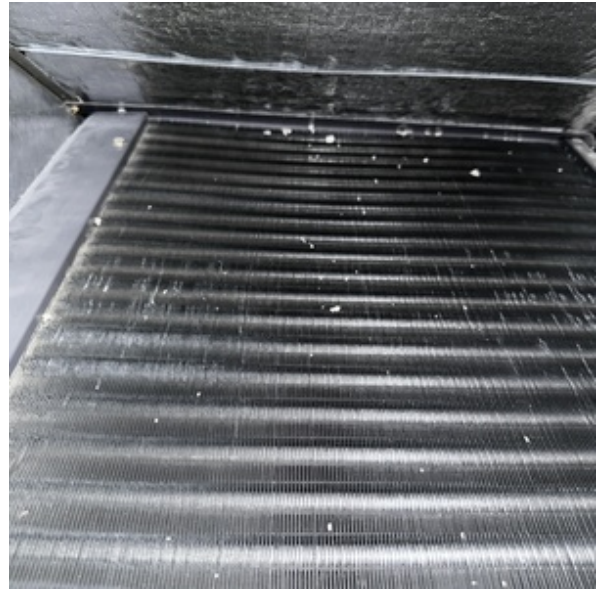
AHU: NO ISSUES DISCOVERED

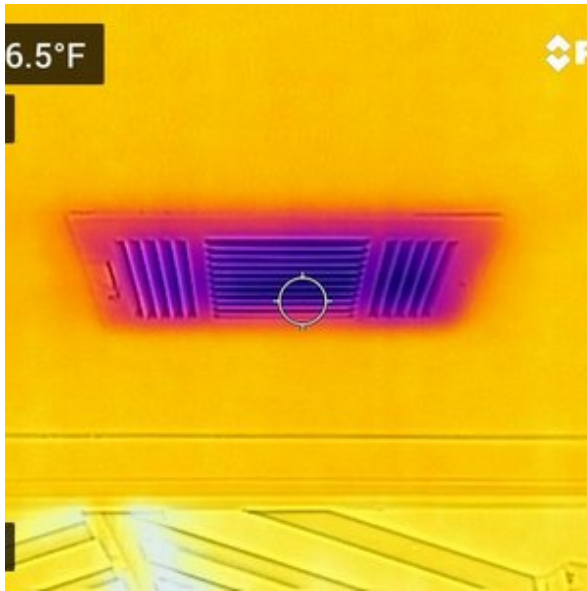
THERMAL CAMERA - NORMAL READINGS

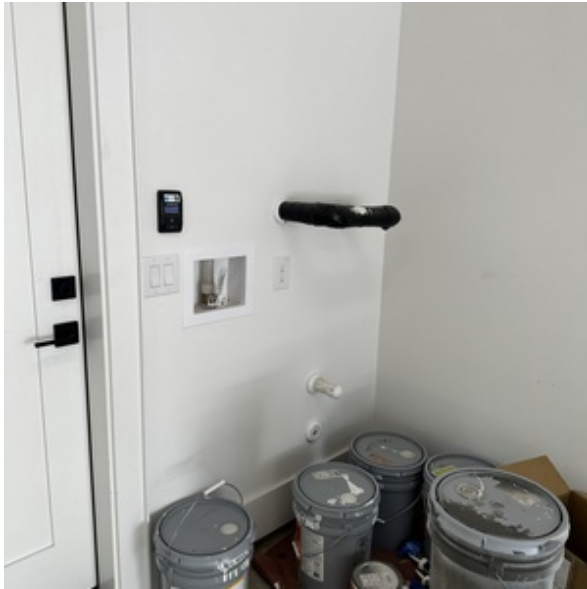
WATER SOFTENER STAGING AREA

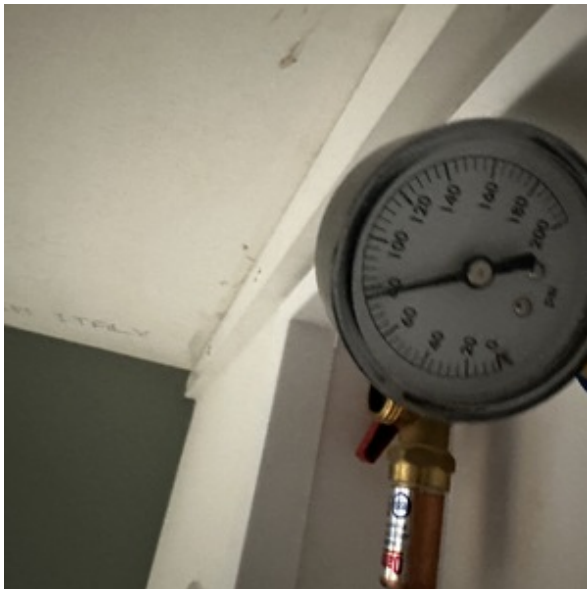
The supply side plumbing was pressurized and isolated (cut off at main meter). The water pressure was monitored for approximately 30 minutes. Minor pressure loss was noted. Minor loss is typically caused by running commodes, dripping faucets, normal system fluctuations, or a combination of common, minor issues. No significant pressure drop occurred during this test. This partial analysis indicates no major supply side leakage was present at the time of inspection. Eliminating any minor supply water loss (as needed) is recommended to improve system efficiency and prevent any possible damage. Unless otherwise stated in this report, the exact point of pressure loss could not be verified during the limited inspection process.

SUPPLY PRESSURE TEST FAILED

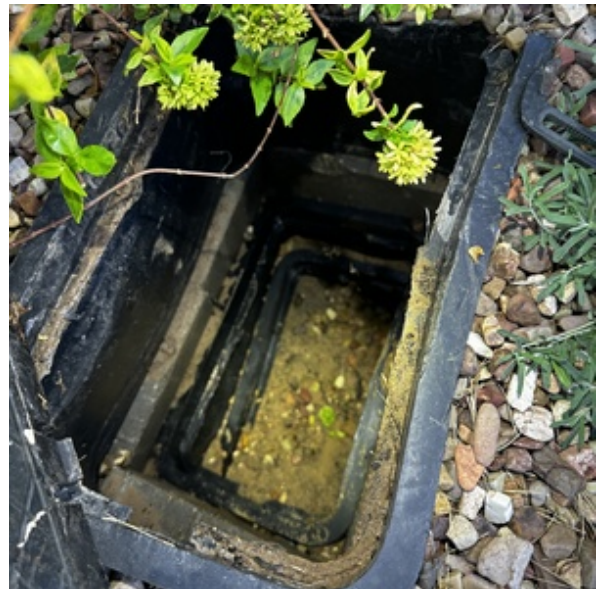
BOX NEAR CLEANOUT - PURPOSE UNKNOWN

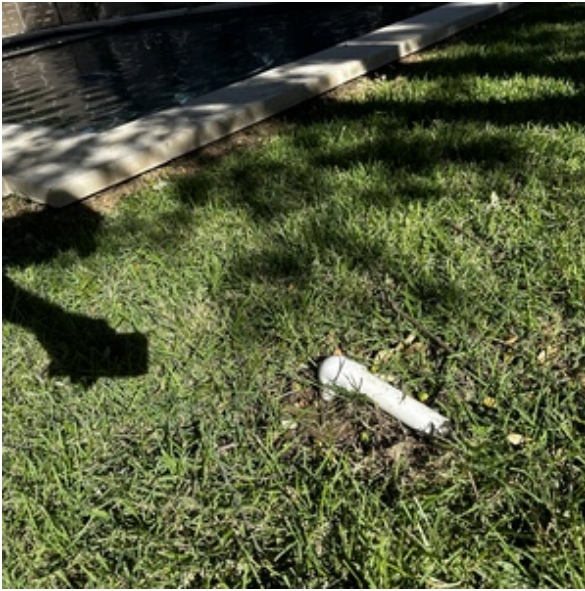
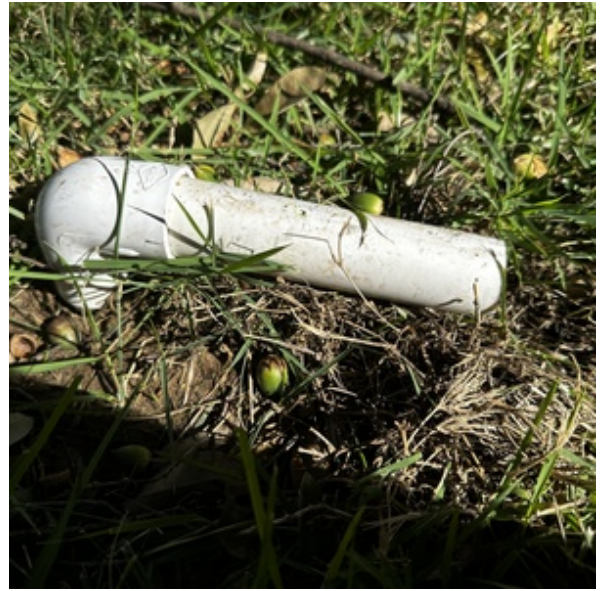
-NOTE: Ensure minimum safety standards are met. If young children occupy or visit the home, safety features should be increased.
NOTE: A 3/4" PVC pipe was protruding from the ground near the pool. We were unable to determine what the purpose of this pipe was. Recommend further inquiry with builder.

PIPE NEAR POOL: PURPOSE UNKNOWN

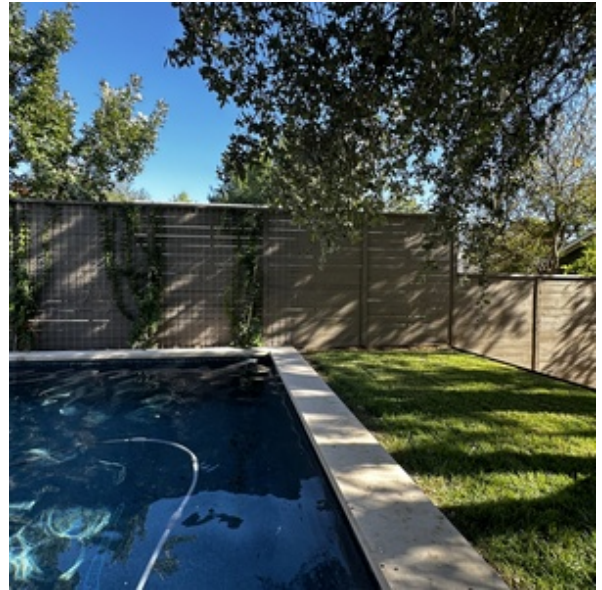
NO SURROUNDING DECKING
