**GREENBELT STRUCTURAL SERVICES**  
A DIVISION OF TAHI LLC

Property: 123 Sample Rd.  
Austin , TX 78736  
Client: Sample Report - Existing Building  
Inspector: Andy Jordan #9458  
Date: September 8, 2023

# PROPERTY INSPECTION REPORT

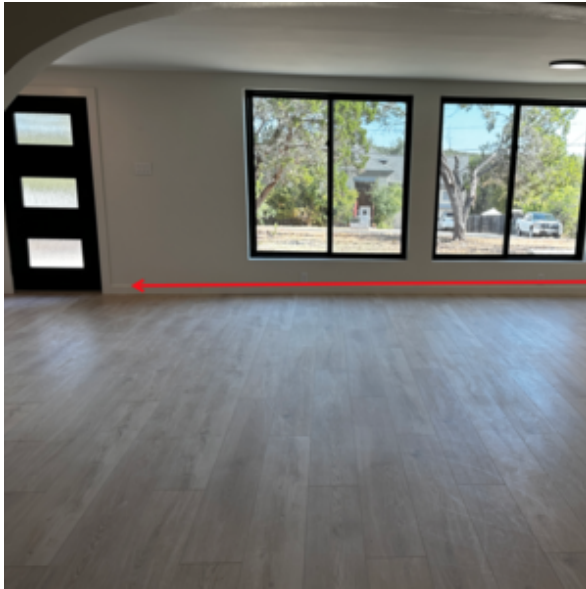
VISIBLE UNEVEN FLOOR SURFACE

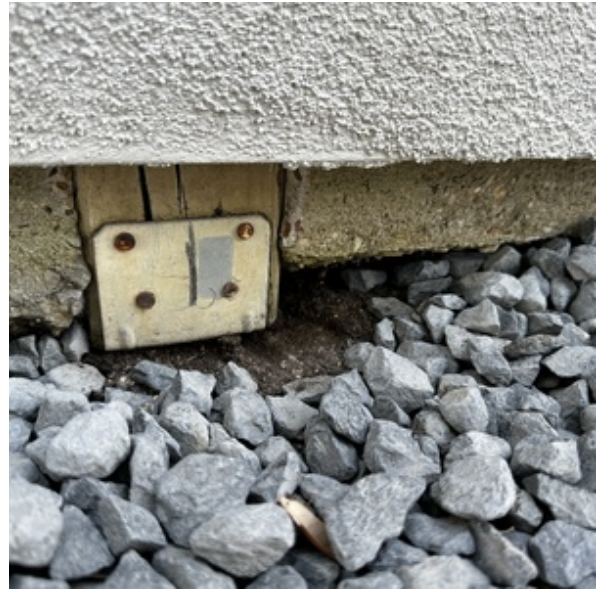
4X4" POST AT GARAGE SLAB

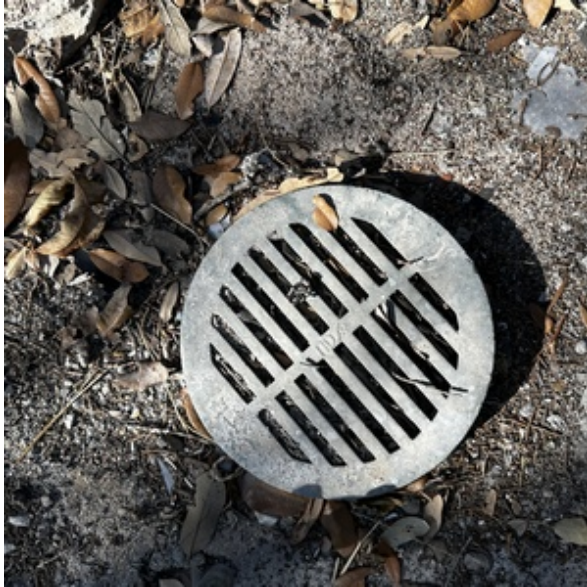
SUB-GRADE DRAINS PRESENT

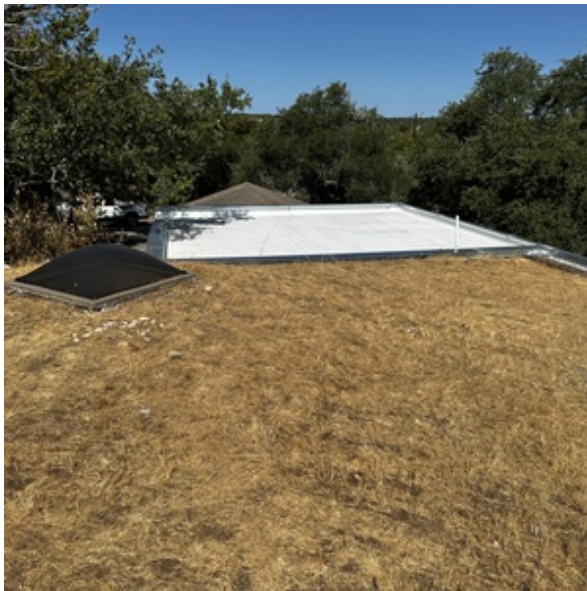
UNIQUE DRAINAGE NEEDS AT ROOF

stones/material remain secured and well sealed, future update/repair needs may require non-typical solutions  
-Ensure stones over/around left side bedroom walls and windows are properly secured (erosion over time may cause failure, hazards)  
-Ensure run-off at the roof level (berm area) has a proper path to drain away from the building (pooling water was observed at front facing berm corners (leak discovered at/near corner over main entry)  
-Request additional information regarding recent repairs at the left retaining wall (contact current owner to request repair details)

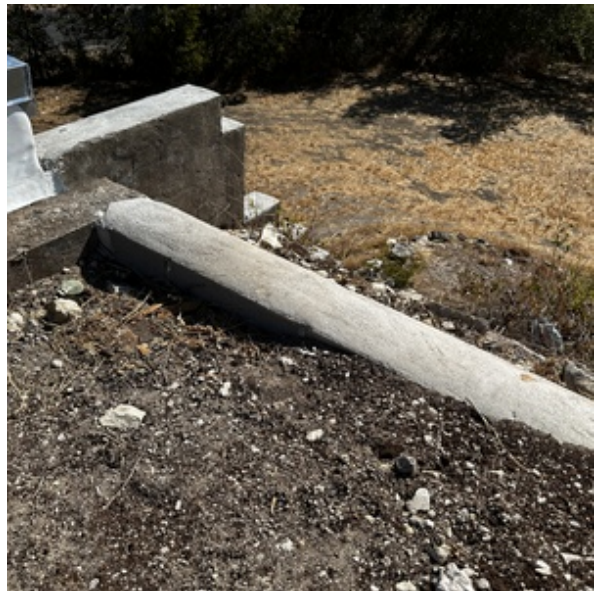
DRAINAGE PATH CONCERNS

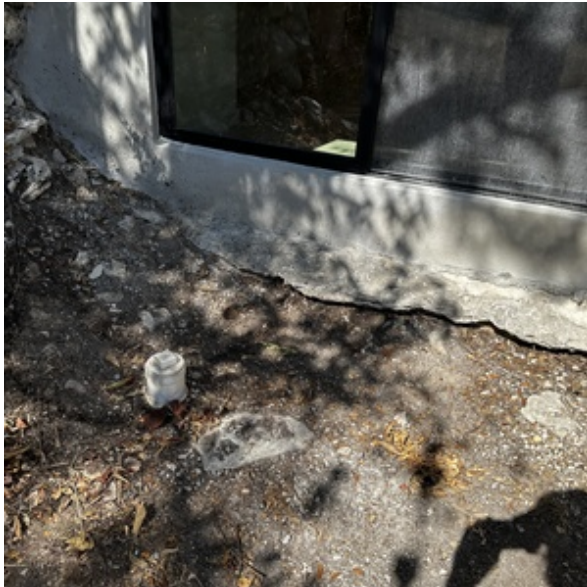
DRAINAGE ISSUE NEAR LEFT WALL

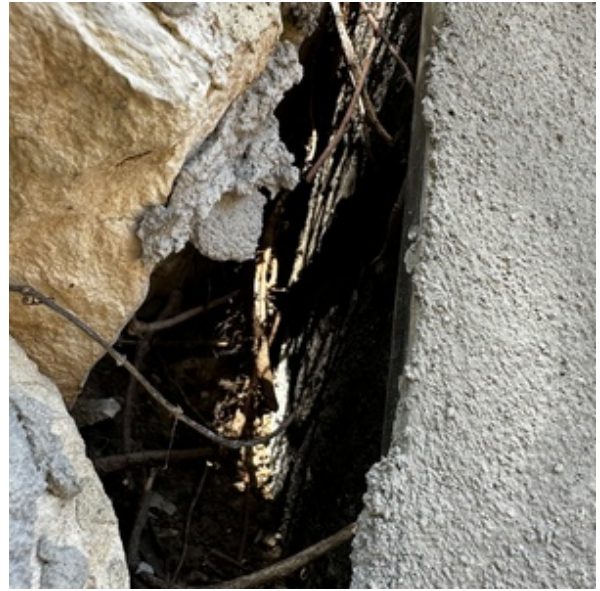
ATYPICAL DRAINAGE POINT AT STONE/CLADDING

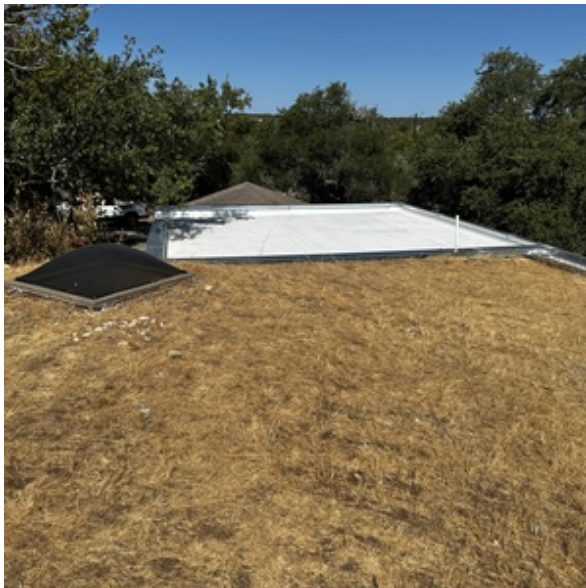
MULTIPLE ROOF COVERING TYPES

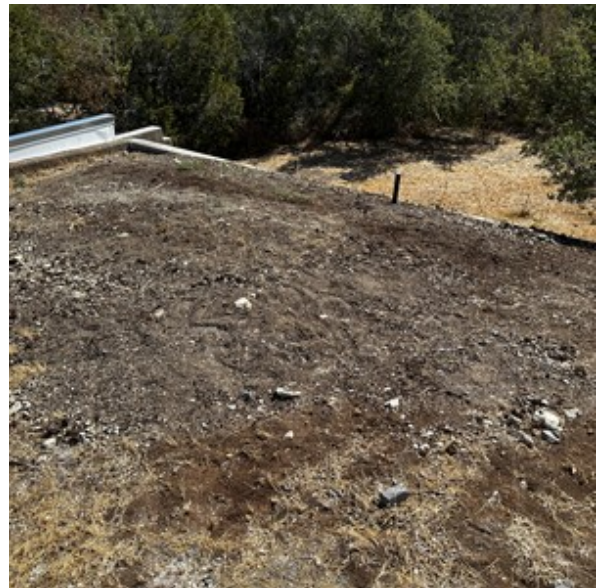
INDICATORS OF PREVIOUS EXCAVATION

NOTE: Roof repair needs may require removal of berm soils (plan and budget accordingly).

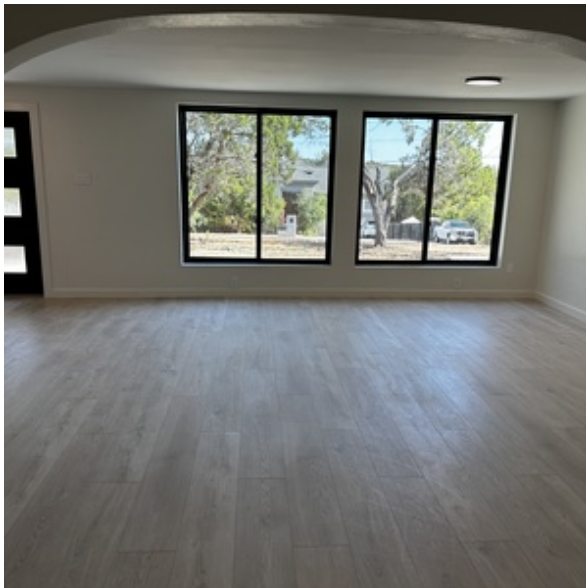
CONCRETE STRUCTURE - NO ATTIC

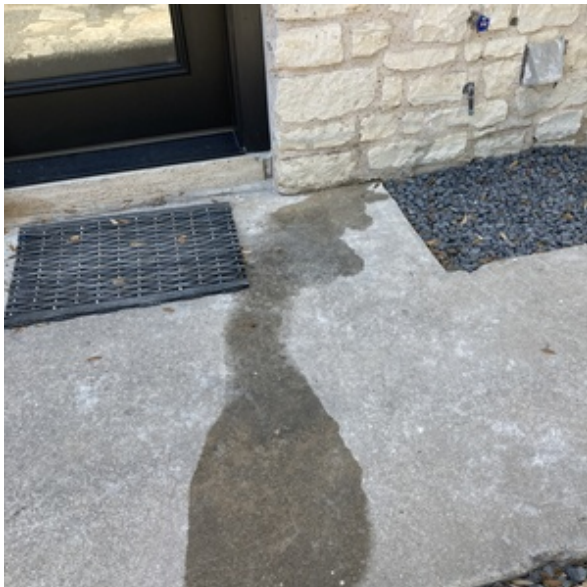
- Leak discovered at skylight
- Leak discovered at area over laundry/main entry
- Potential leak (high moisture readings) identified at the ceiling near dining area/bonus room entry
- Roof run-off water entered into interior window sash/slider (primary suite)
- NOTE: Leaks discovered through a limited/partial moisture intrusion test (hose placed at portions of roof berm and water allowed to run/naturally drain for appx. 3-5 minutes per location). Please note that high pressure water or insertion of hoses below soil line was not employed. Additional leak points may be present are non-tested locations.

LEAK OVER LAUNDRY/NEAR MAIN ENTRY

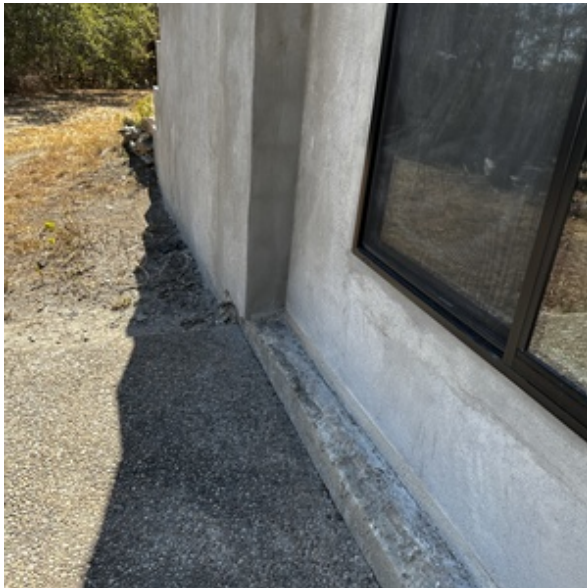
UNEVEN CMU WALL

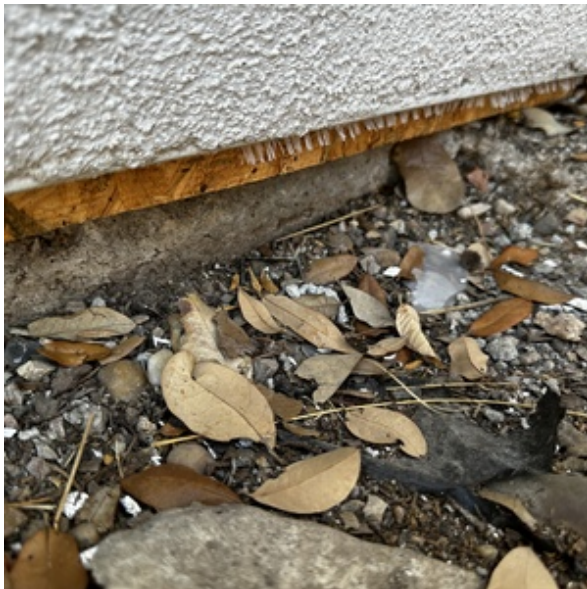
EXPOSED PLYWOOD UNDER STUCCO

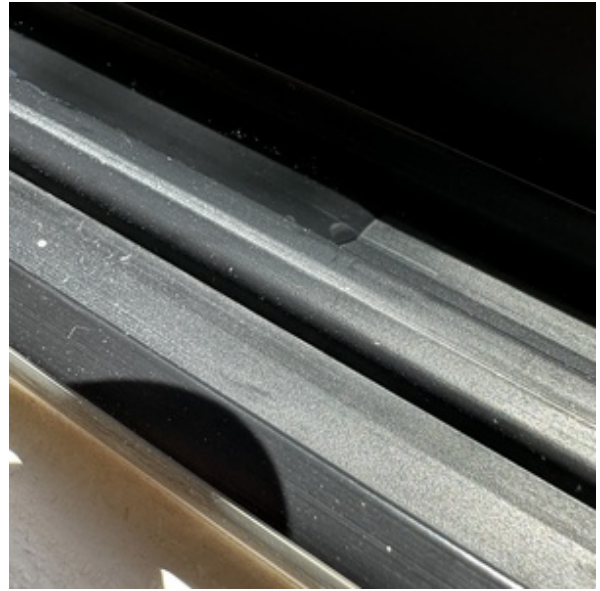
WATER FILLS WINDOW SLIDE WELL

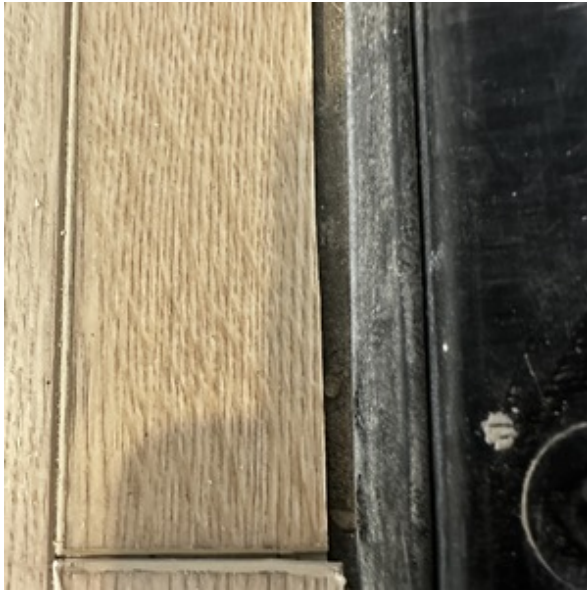
SEAL GAPS AT TRANSITIONS

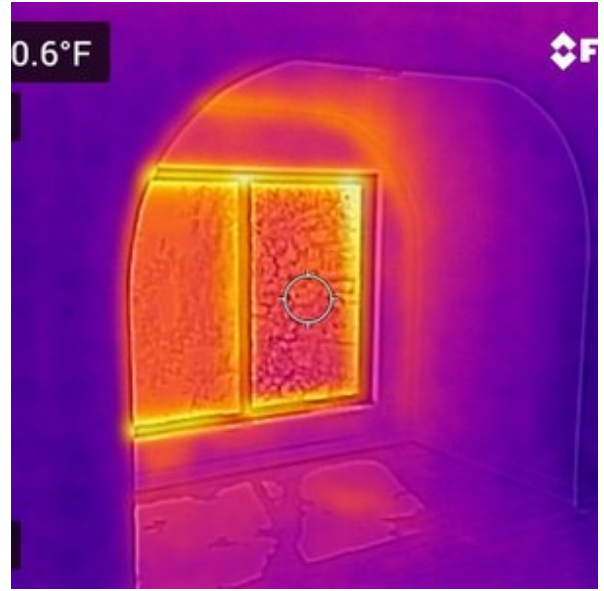
THERMAL CAMERA: NORMAL READINGS

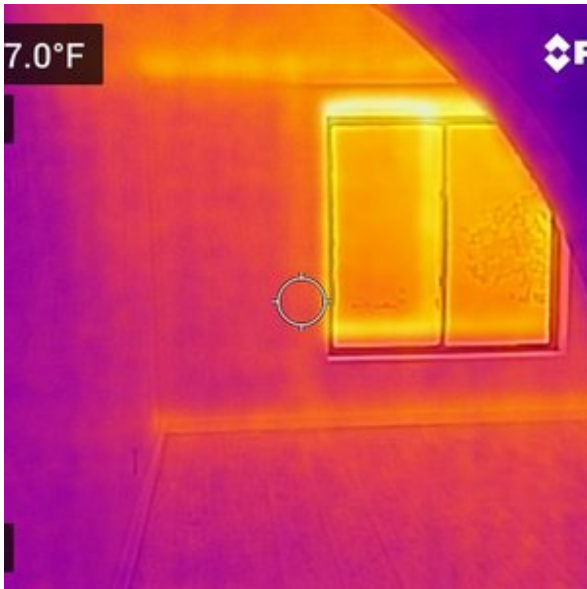
THERMAL CAMERA: NORMAL READINGS

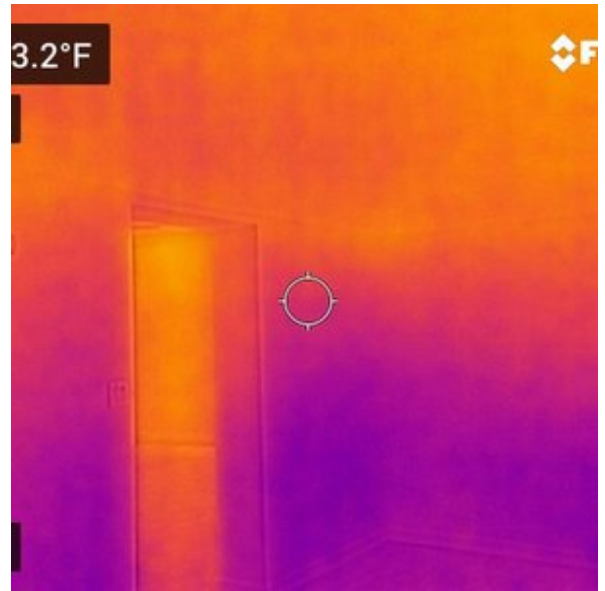
THERMAL CAMERA: NORMAL READINGS

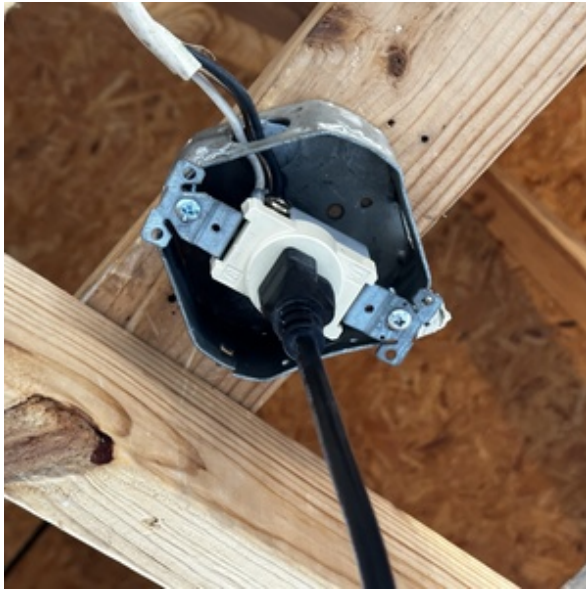
MISSING SAFETY PLATES

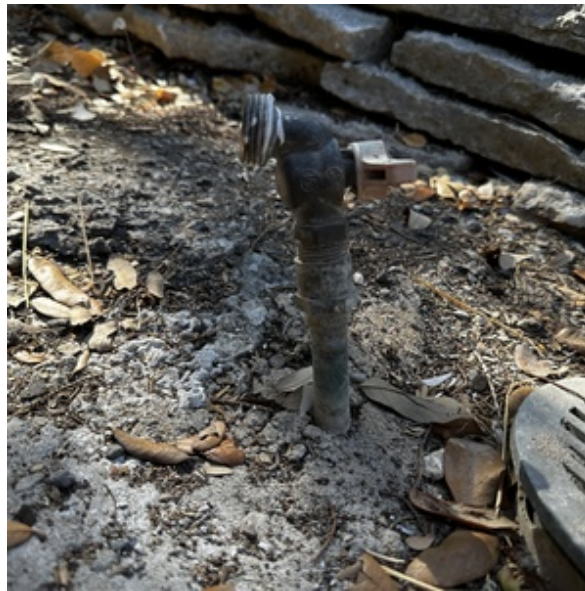
PROTECT PIPE, ADD ANTI-SIPHON

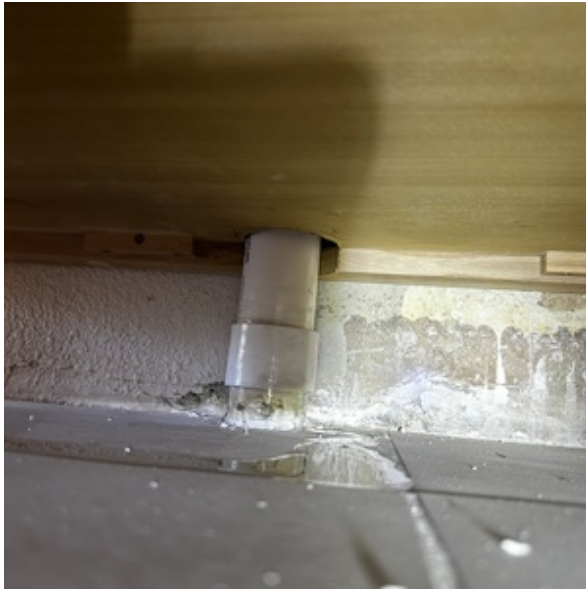
LEAK AT BEDROOM SINK
