GREENBELT STRUCTURAL SERVICES
A DIVISION OF TAHI LLC

TAHI Services and Greenbelt Structural performed a limited assessment at the above noted property. The purpose of the site visit was to assess the condition of the structure and aspects of the parcel to determine the feasibility options for future project planning.

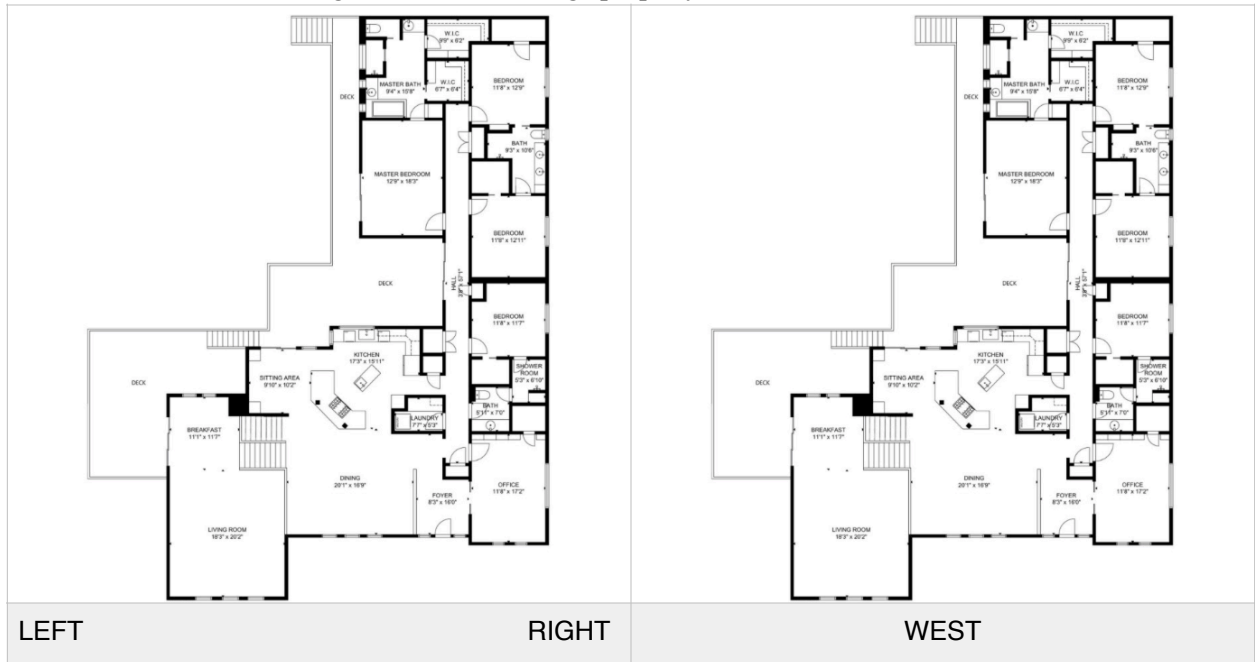
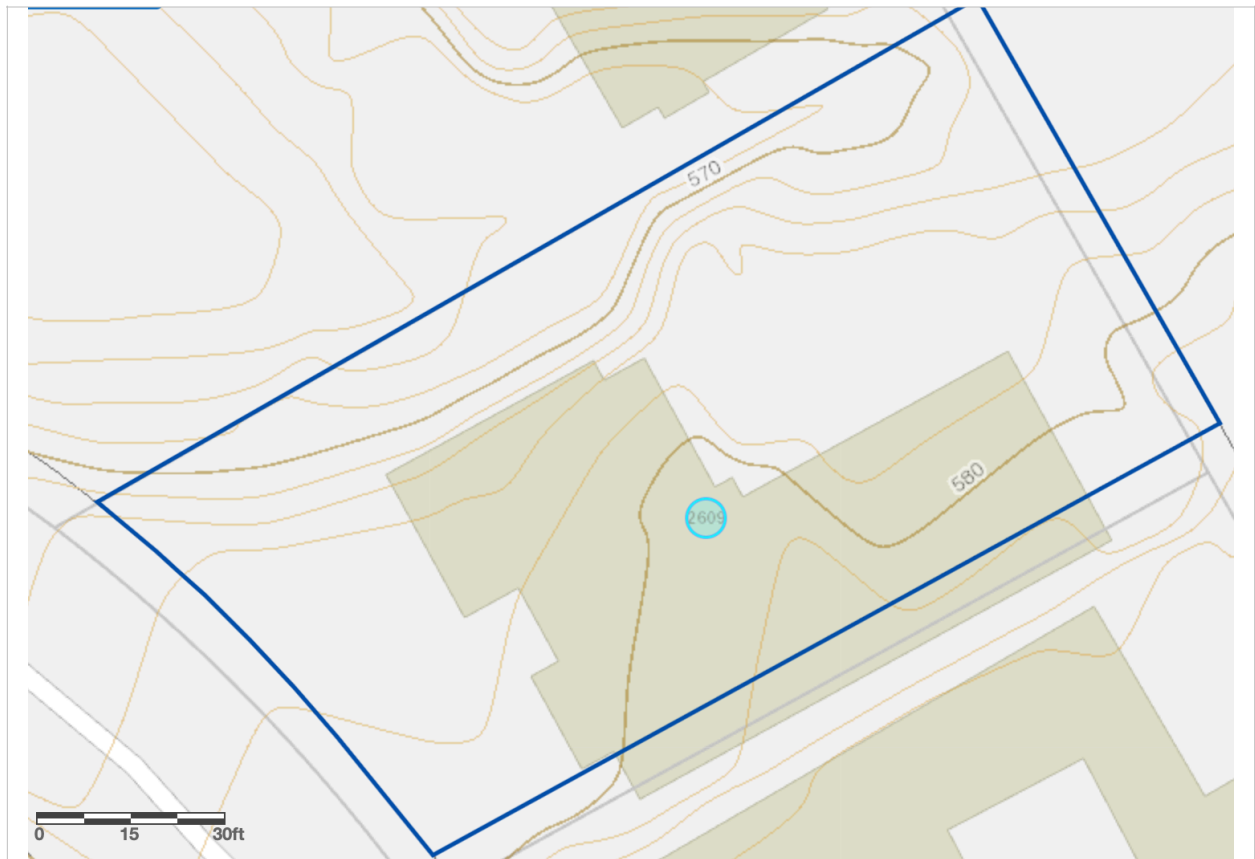
SITE ORIENTATION:

For the purposes of orientation, left and right, when referred herein this report, is always from the vantage point of an individual looking at the front door of the building main building. The front door/walls will be referred to as the west facing side of the buildings/property.
