Client: Inspector: Date: 2202 Sample Report Austin, Texas 78703 Sam Sample Andy Jordan #9458 April 9, 2019

# **PROPERTY INSPECTION REPORT**

<b>Prepared For:</b>	Sam Sample	
	(Name of Client)	
<b>Concerning:</b>	2202 Sample Report Austin, Texas 78703	
	(Address or Other Identification of Inspected	Property)
By:	Andy Jordan, Lic #9458	April 9, 2019
	(Name and License Number of Inspector)	(Date)
	(Name, License Number of Sponsoring Inspector)

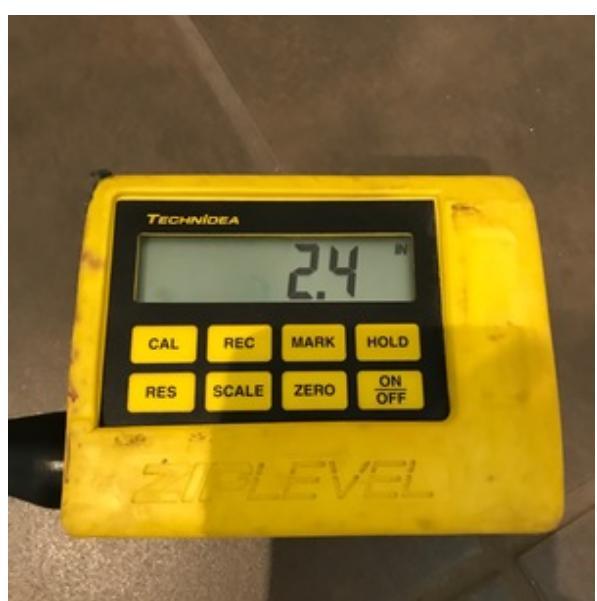
APPX. 2.4" RISE: BACK LEFT CORNER (SLAB)

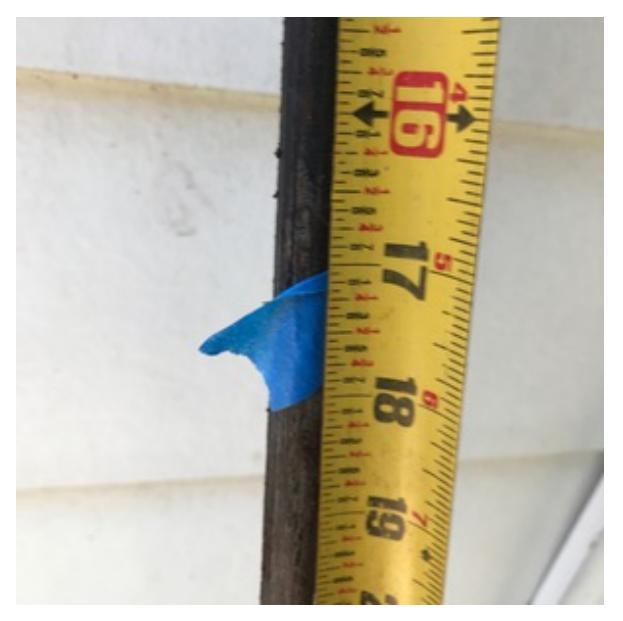
SOIL PROBE TEST: FOOTERS APPX. 17-22"

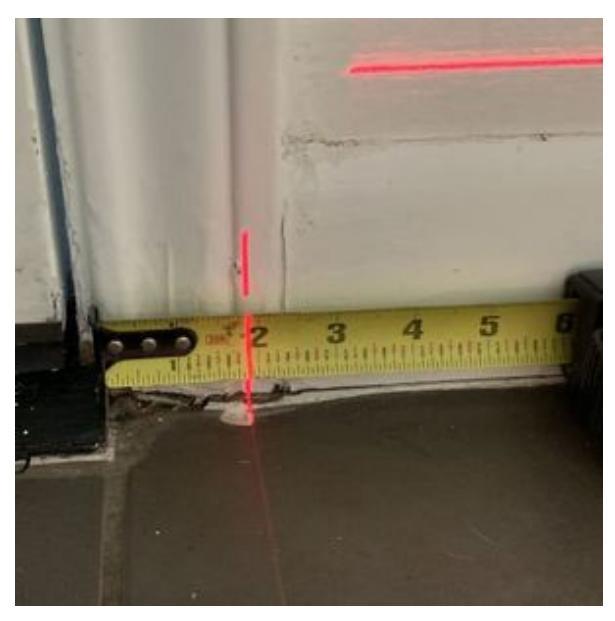
LASER LEVEL: LOWER BACK DOOR

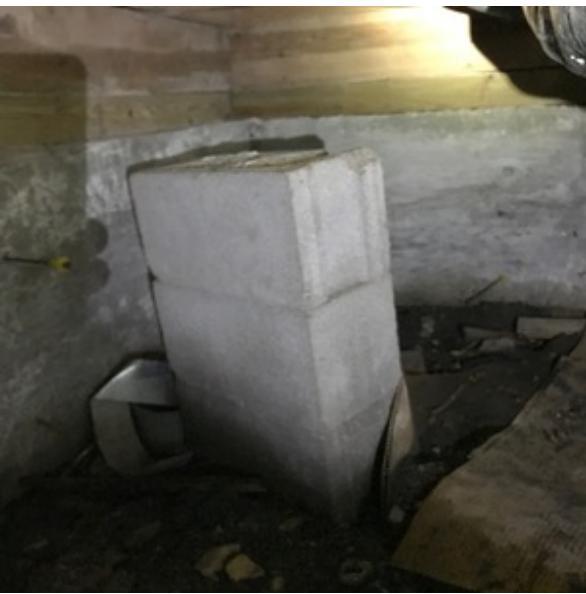
FALLEN OR DELETED BLOCK PIERS

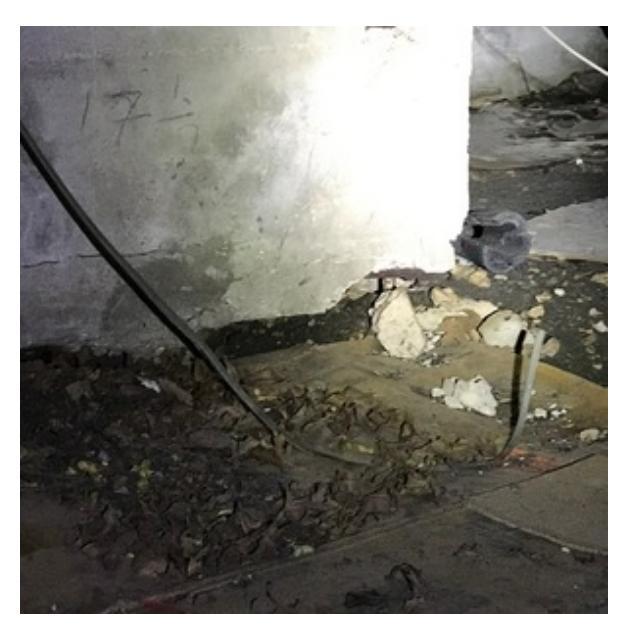
EROSION AT FRONT STEM WALL

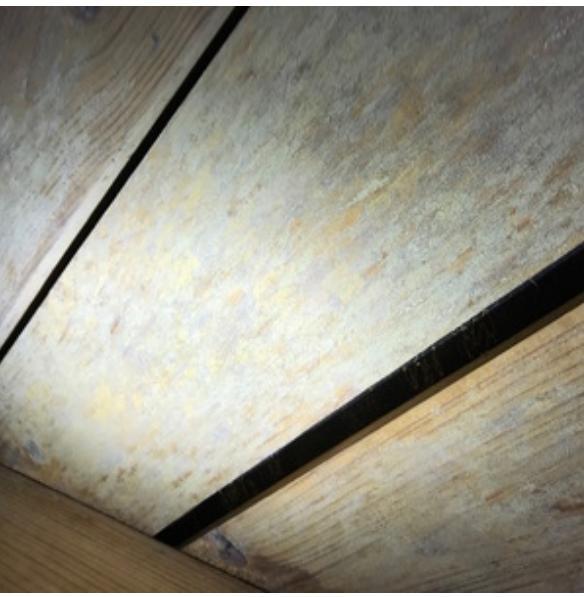
POSSIBLE SURFACE ORGANICS AT DECKING

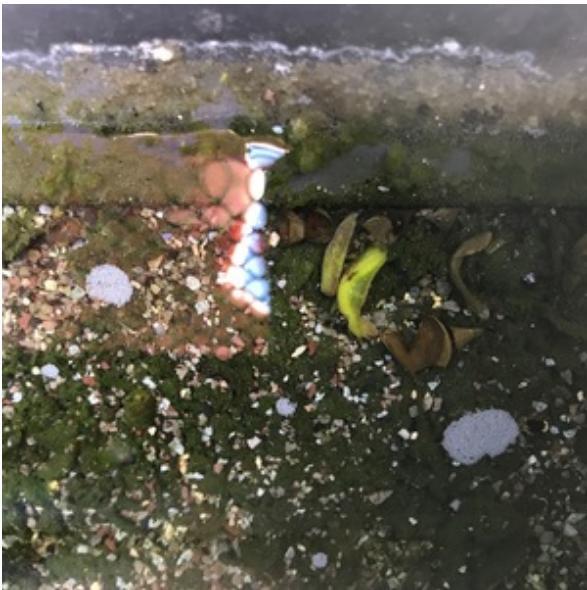
POOLING WATER: BACK GUTTER RUN

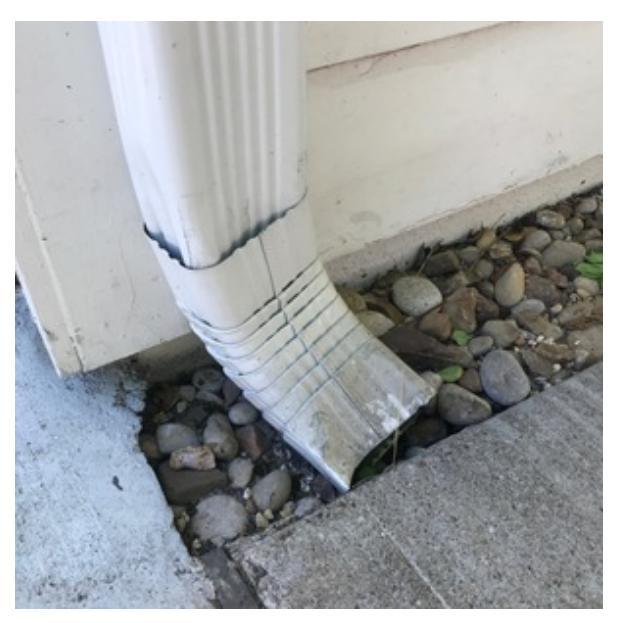
GUTTER UPDATES REQUIRED

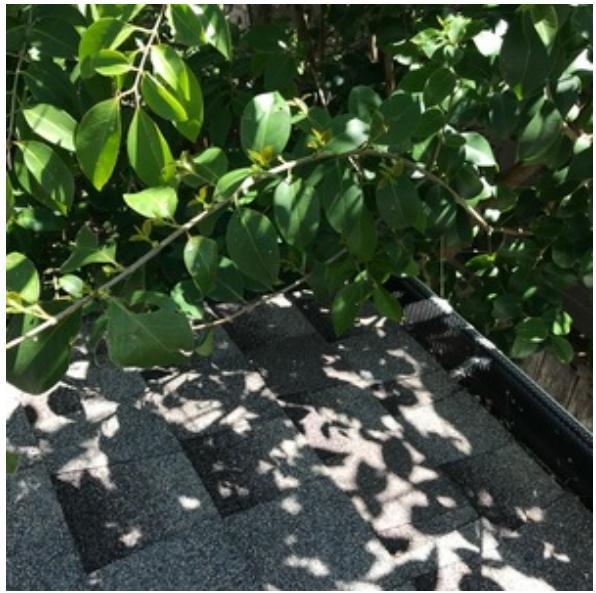
BRANCHES IN CONTACT W/ ROOF

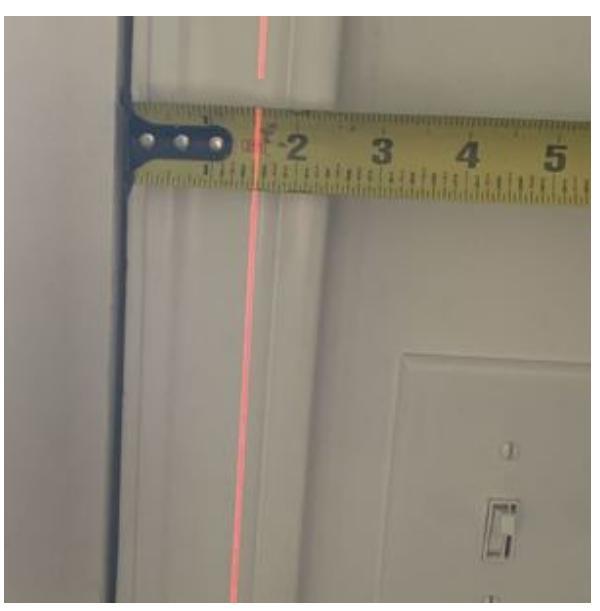
UPPER JAMB: APPX. 1/4"-1/2" OFF

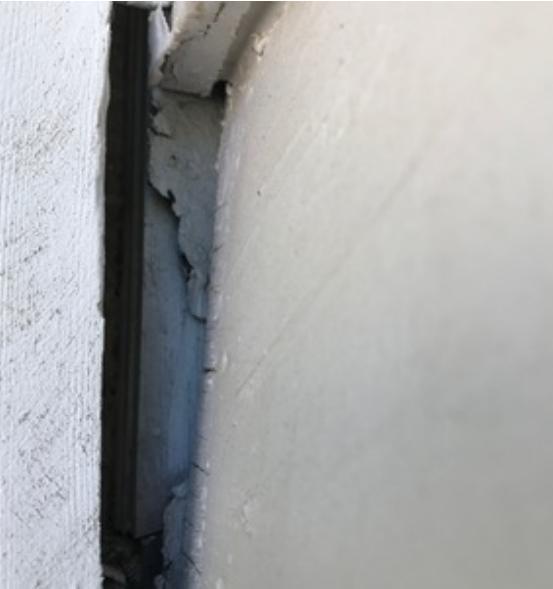
SEALING UPDATE NEEDS AT WINDOWS

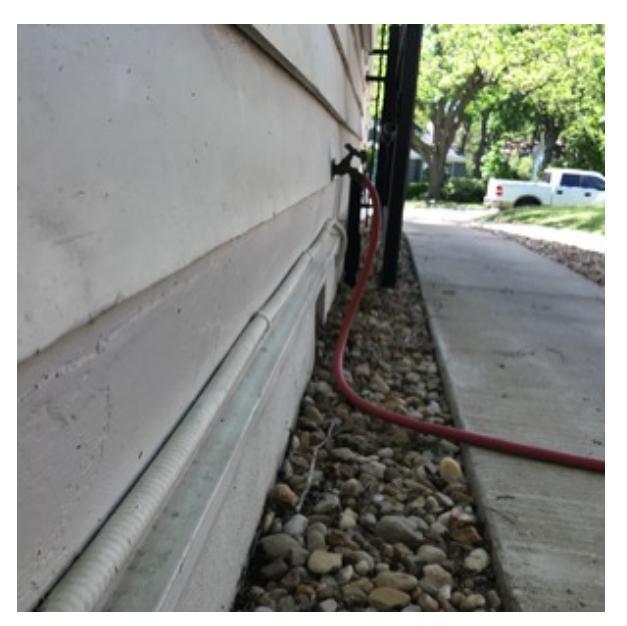
LEFT WALL STRESS/BOWING

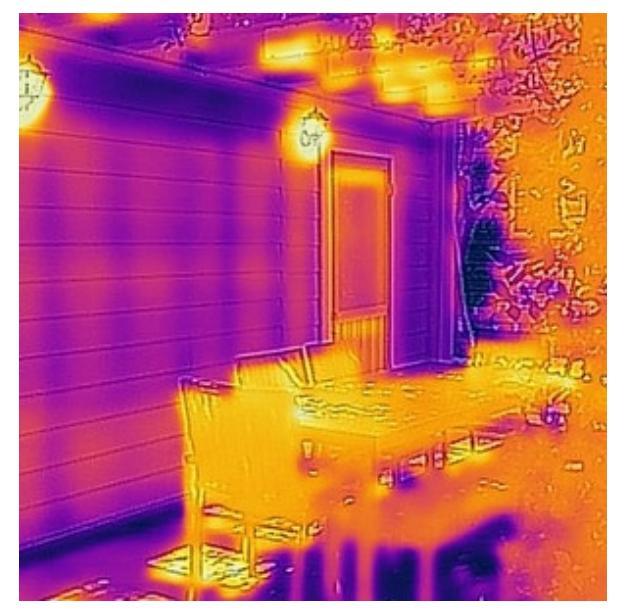
INDICATORS OF REDUCED INSULATION

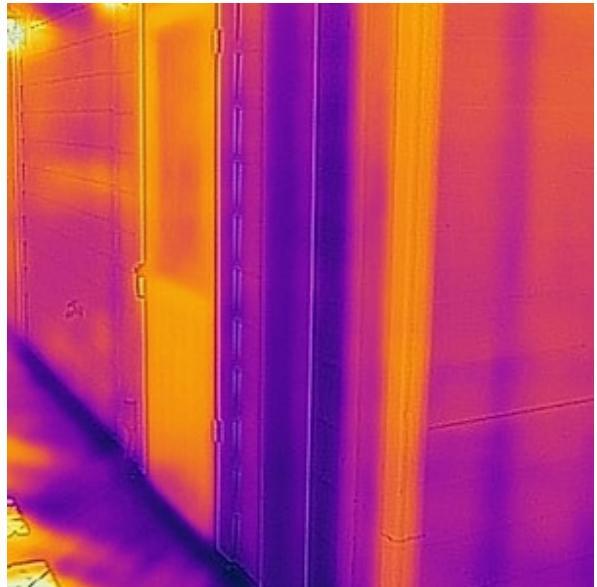
INDICATORS OF REDUCED INSULATION

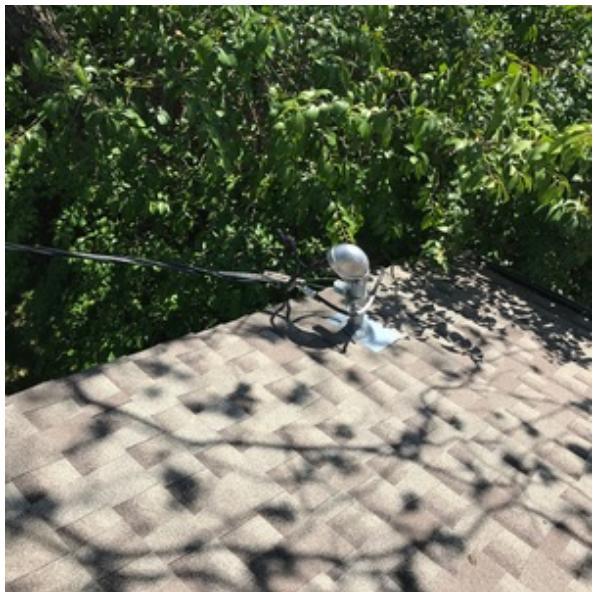
MONITOR/TRIM BRANCHES NEAR ELECTRICAL

-Ensure tree limbs are trimmed away from overhead supply wiring (back yard)
I=Inspected	NI=Not Inspected	NP=Not Present	<b>D=Deficient</b>
I NI NP D

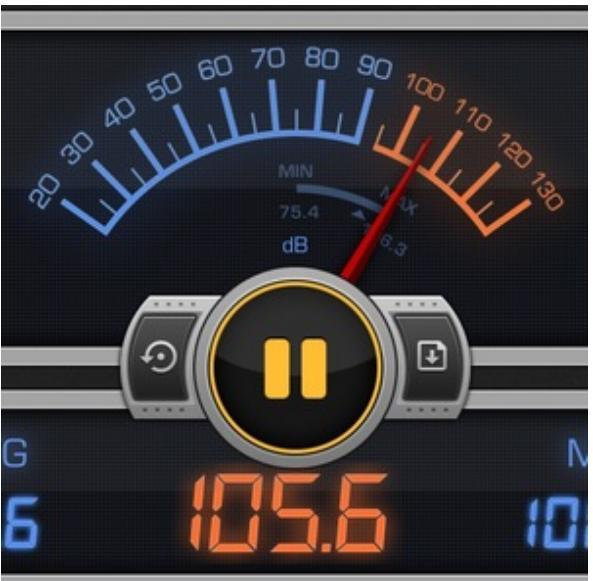
EXCESS NOISE DUE TO SYSTEM ISSUES

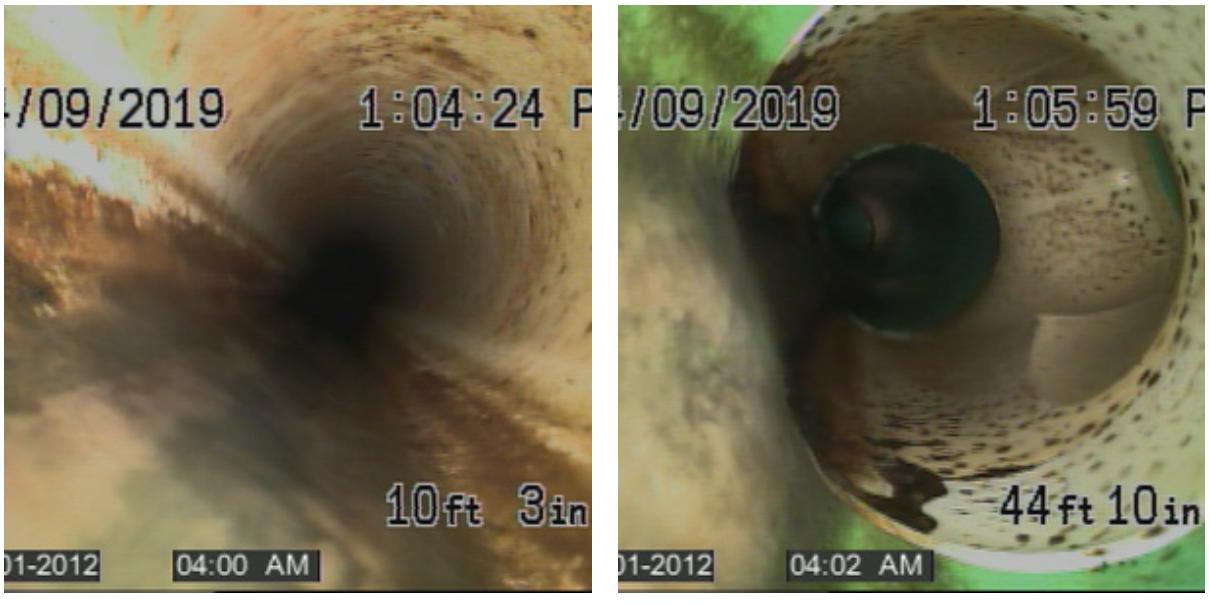
UPDATED PVC AT FRONT YARD

CITY CONNECTION NEAR STREET

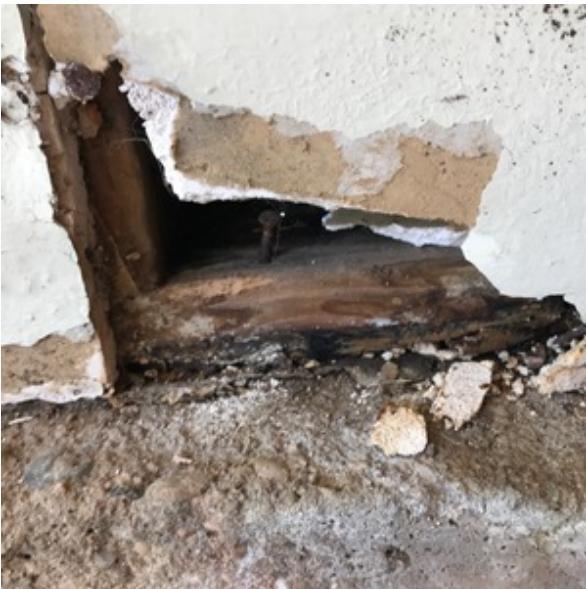
MOISTURE DAMAGE AT FRAMING
