GREENBELT STRUCTURAL SERVICES
A DIVISION OF TAHI LLC

TAHI Inspections and Greenbelt Structural, in conjunction with Capital Building Inspections, performed a limited assessment at the above noted property. The purpose of the site visit was to assess the condition of the structure and aspects of the parcel to determine the feasibility options for future project planning.

STRUCTURAL DETAILS	
BUILDING USAGE	Commercial Building - General Retail and Office
DATE OF CONSTRUCTION	1979 (CAD)
CONSTRUCTION TYPE	Tilt Wall w/ Steel Framing (I-Beams, Columns, Engineered Truss)
FOUNDATION TYPE	Concrete Slab - Segmented or Similar Design
ROOF DESIGN	Flat Roof, TPO Covering Over Steel Roof Decking
PRIMARY WALL CLADDING	Concrete w/ Aggregate Facade
ADDITIONAL STRUCTURES	Building #9 (Cleaners) of Similar Design
STRUCTURAL ADDITIONS	Concrete Foundation w/ CMU Block Walls (Suite 6A)
DATE OF ADDITION	Exact Date Unknown, Constructed After 2003
DRAWINGS/PLANS REVIEWED	No - No Drawings/Plans Provided or Discovered

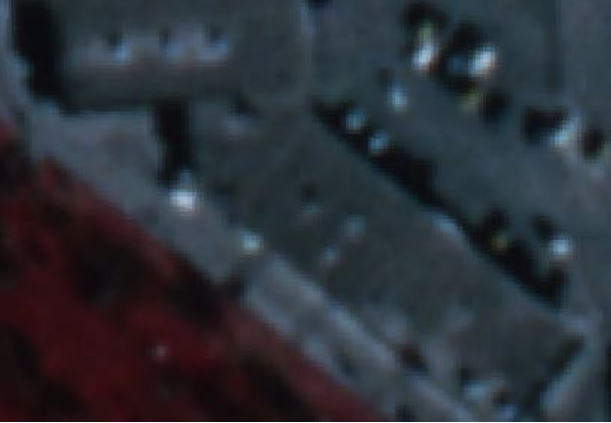
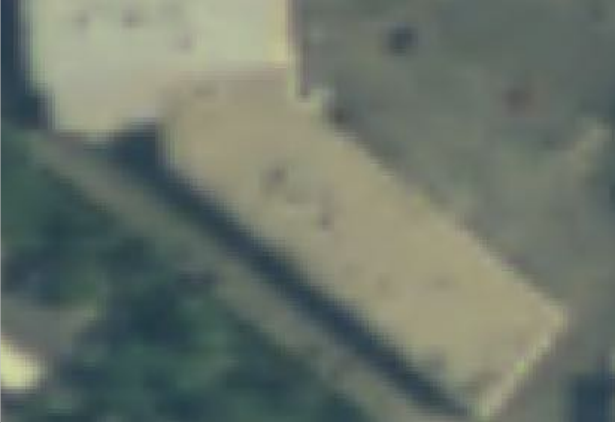
1995 - NO STRUCTURAL ADDITION		2005 - STRUCTURAL ADDITION PRESENT

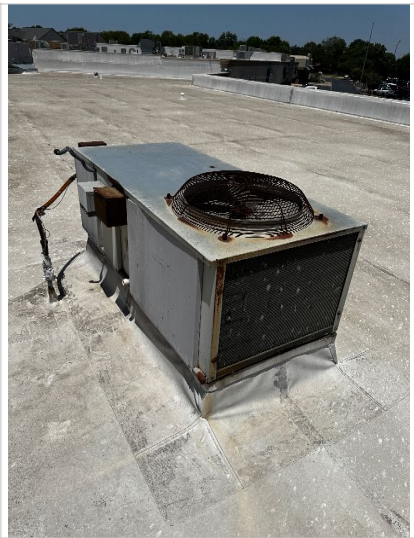
Observations of rooftop equipment indicate that the majority of HVAC units are at or exceeding a general life expectancy (12-15 years in service). Functionality was confirmed at most units, however, isolated start-up failures occurred and have been detailed in the Action Items section of this report. Equipment age and deferred maintenance issues are present throughout. Multiple rooftop units (HVAC, refrigeration, and fan equipment) have been deleted and discarded in place. Budgets to properly remove and seal roof penetrations at discarded equipment should be included in future planning.

DELETED EQUIPMENT

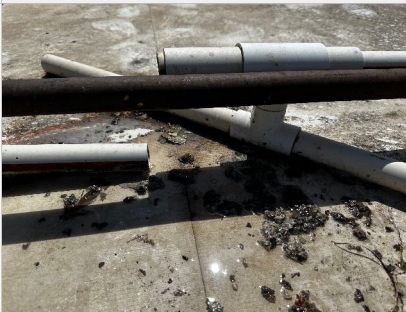
The rooftop condensate drain system is considered to be in a state of failure and will require full replacement. Additionally, condensation build up within several RTUs (rooftop units) appear to be causing leak issues within the building.

CONDENSATION ISSUES

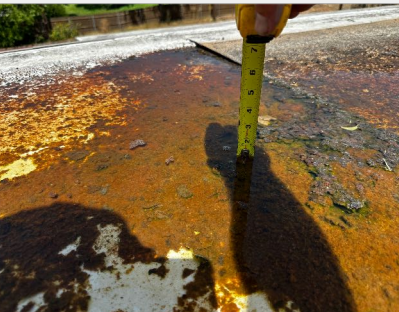
The TPO roof covering appeared to remain in serviceable condition. Most TPO seams appeared to remain sealed. No substantial membrane tears or active points of failure was identified. The back (west side of the roof structure serves as the point of drainage (roof has an appx. slope of 1.5-2.0%). Active standing/pooling water was observed at NW portions of the roof and evidence of intermittent pooling was observed throughout the west roof edge. Areas of active pooling appeared to be the result of improperly plumbed roof level HVAC equipment condensate drainage collected at areas of deflected roof surfaces. Portions of pooling water at the NW side of the building were measured at a depth of appx. 1/2". Evidence of previous leak issues was observed at interior areas below the pooling water.

POOLING ISSUES

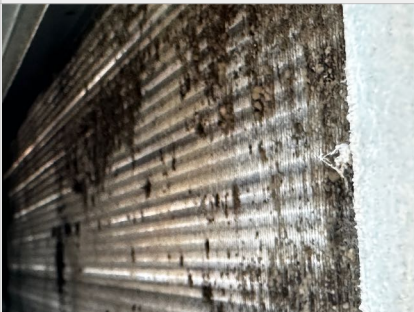
Observations of ductwork and airflow testing indicates that the duct system remains in functional, serviceable condition. Air balance, air flow, and air quality issues/concerns were identified at isolated portions of the building and will require updating based on owner/tenant needs.

AIR QUALITY ISSUES

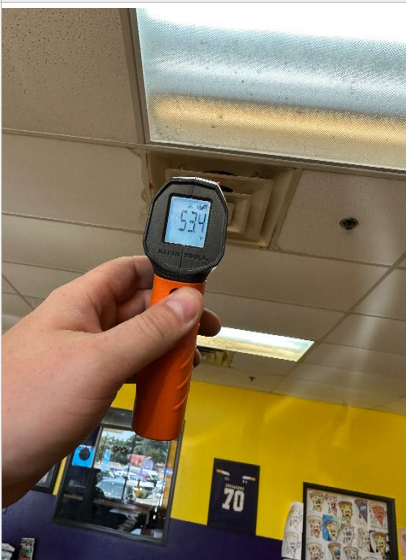
Set-point demand testing and indoor climate readings were recorded throughout the buildings. System capability issues were identified at multiple locations, however, it should be noted that outdoor temperatures exceeded 100F during testing operations.

SYSTEM CAPABILITIES VARY

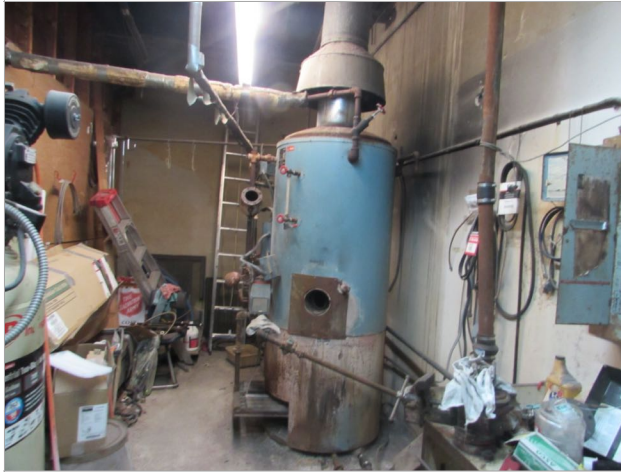
DATED/DELETED EQUIPMENT

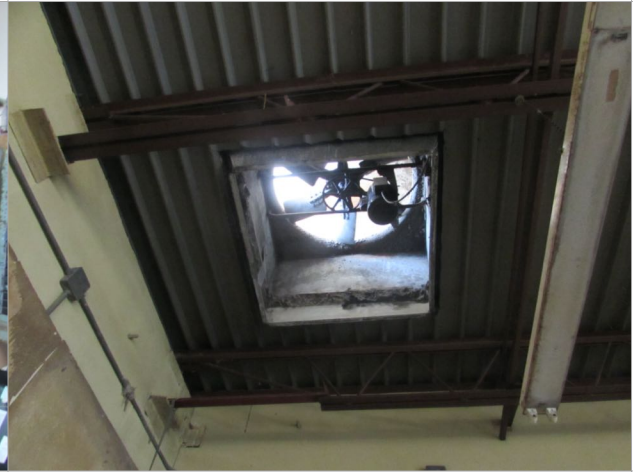
DATED/DELETED EQUIPMENT

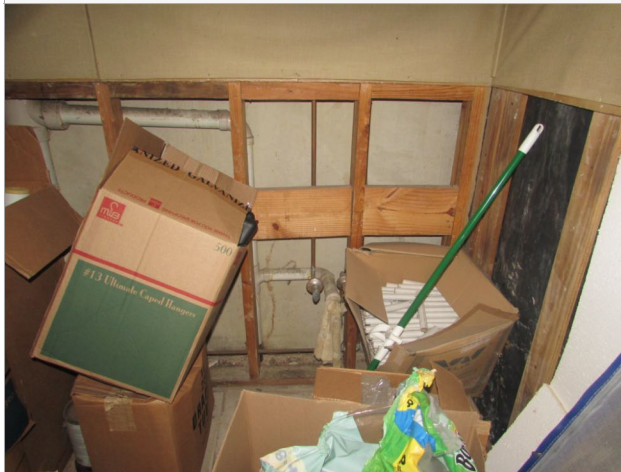
CLUTTER/DEBRIS THROUGHOUT

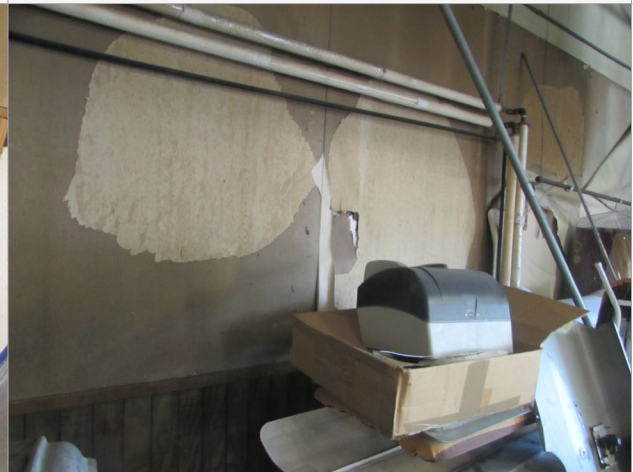
CLUTTER/DEBRIS THROUGHOUT

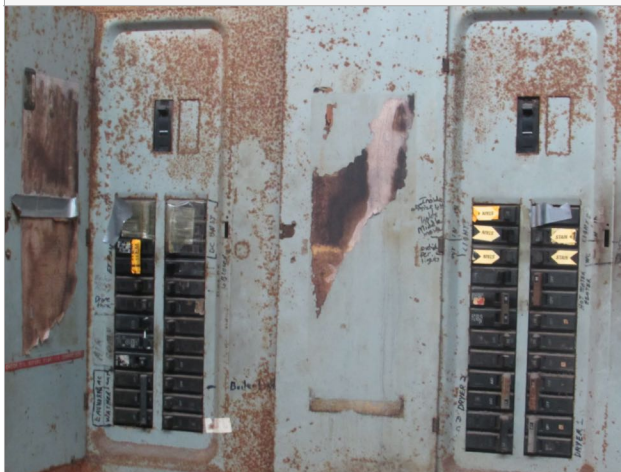
DATED ELECTRICAL

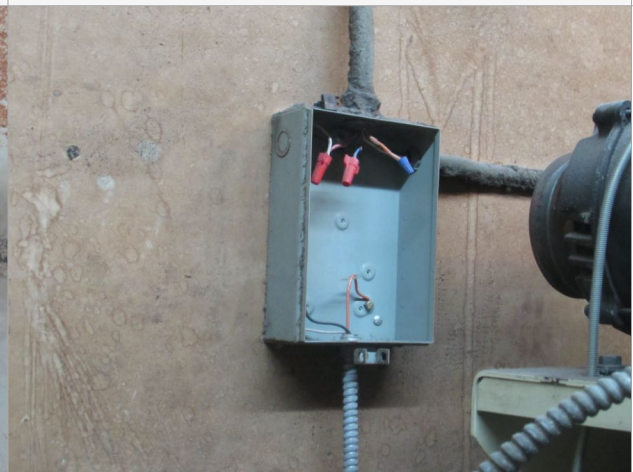
ELECTRICAL UPDATE NEEDS

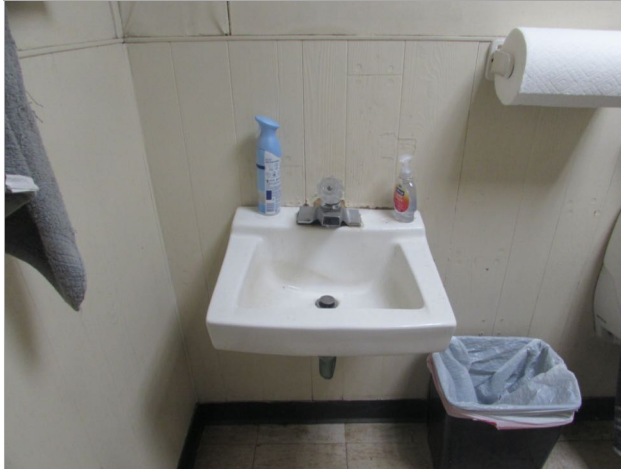
PLUMBING IN NEED OF SERVICE

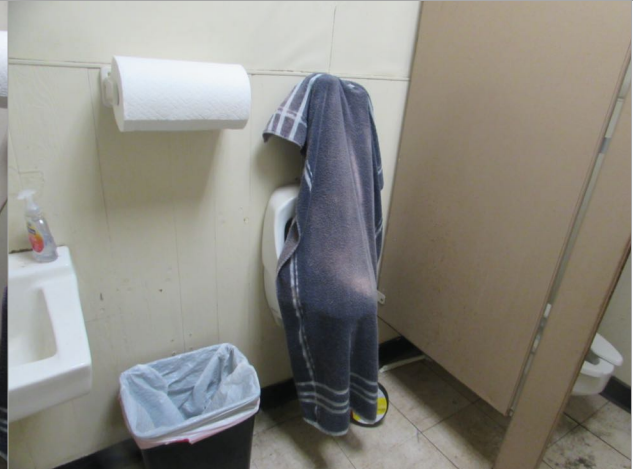
PLUMBING IN NEED OF SERVICE

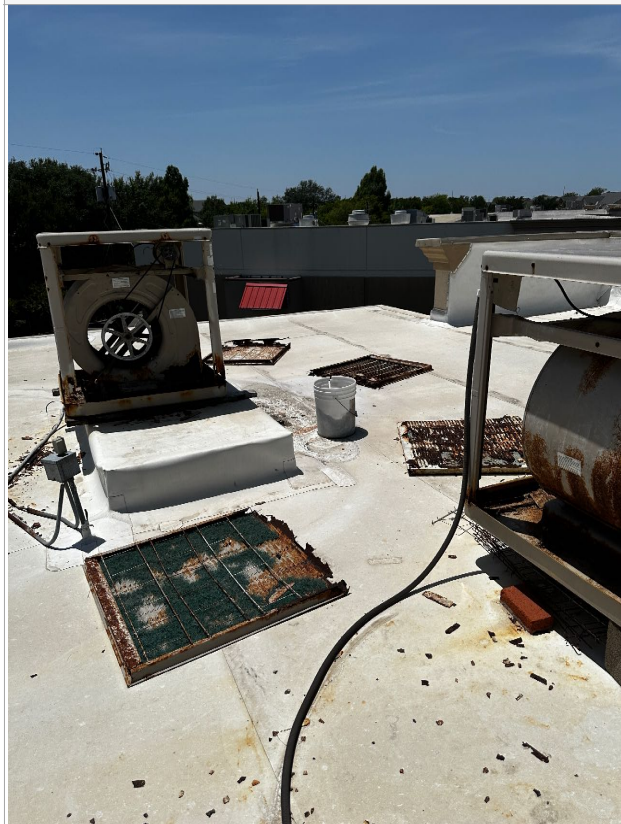
MOST ROOF TOP EQUIPMENT DELETED

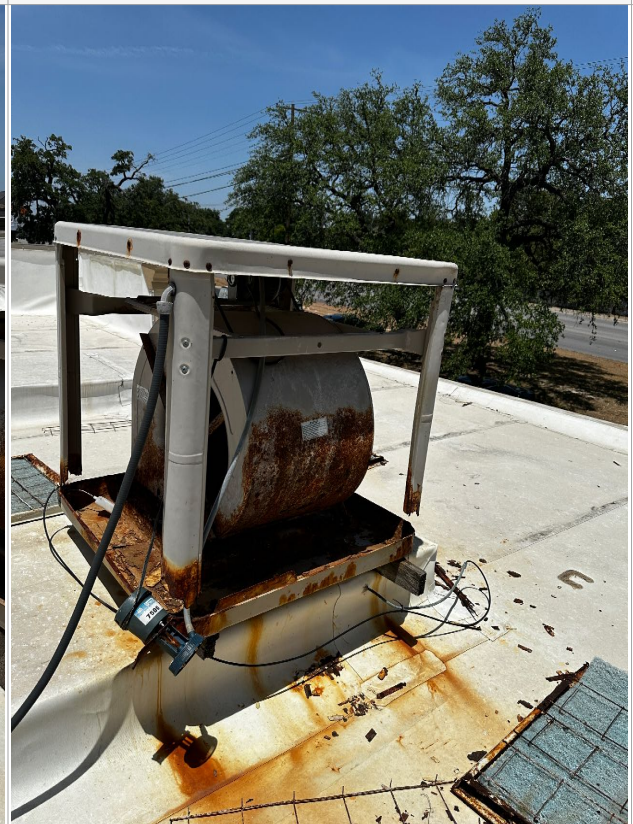
MOST ROOF TOP EQUIPMENT DELETED

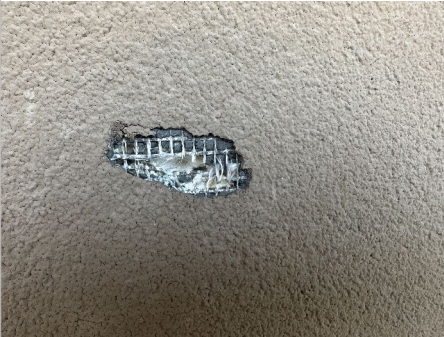
EIFS Facade	<p>Priority: Low-Mid</p> <p>Wall patches and portions of back wall covered with older generation EIFS. Product is known to retain water if not properly sealed. Ensure all gaps/flaws at EIFS material are repaired/sealed.</p>

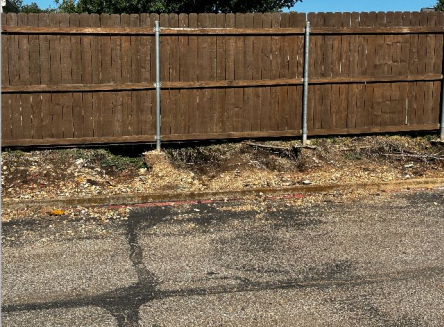
Erosion	<p>Priority: Low-Mid</p> <p>Areas of soil erosion at/around back fencing was observed. Update erosion controls to prevent failure of fencing supports.</p>

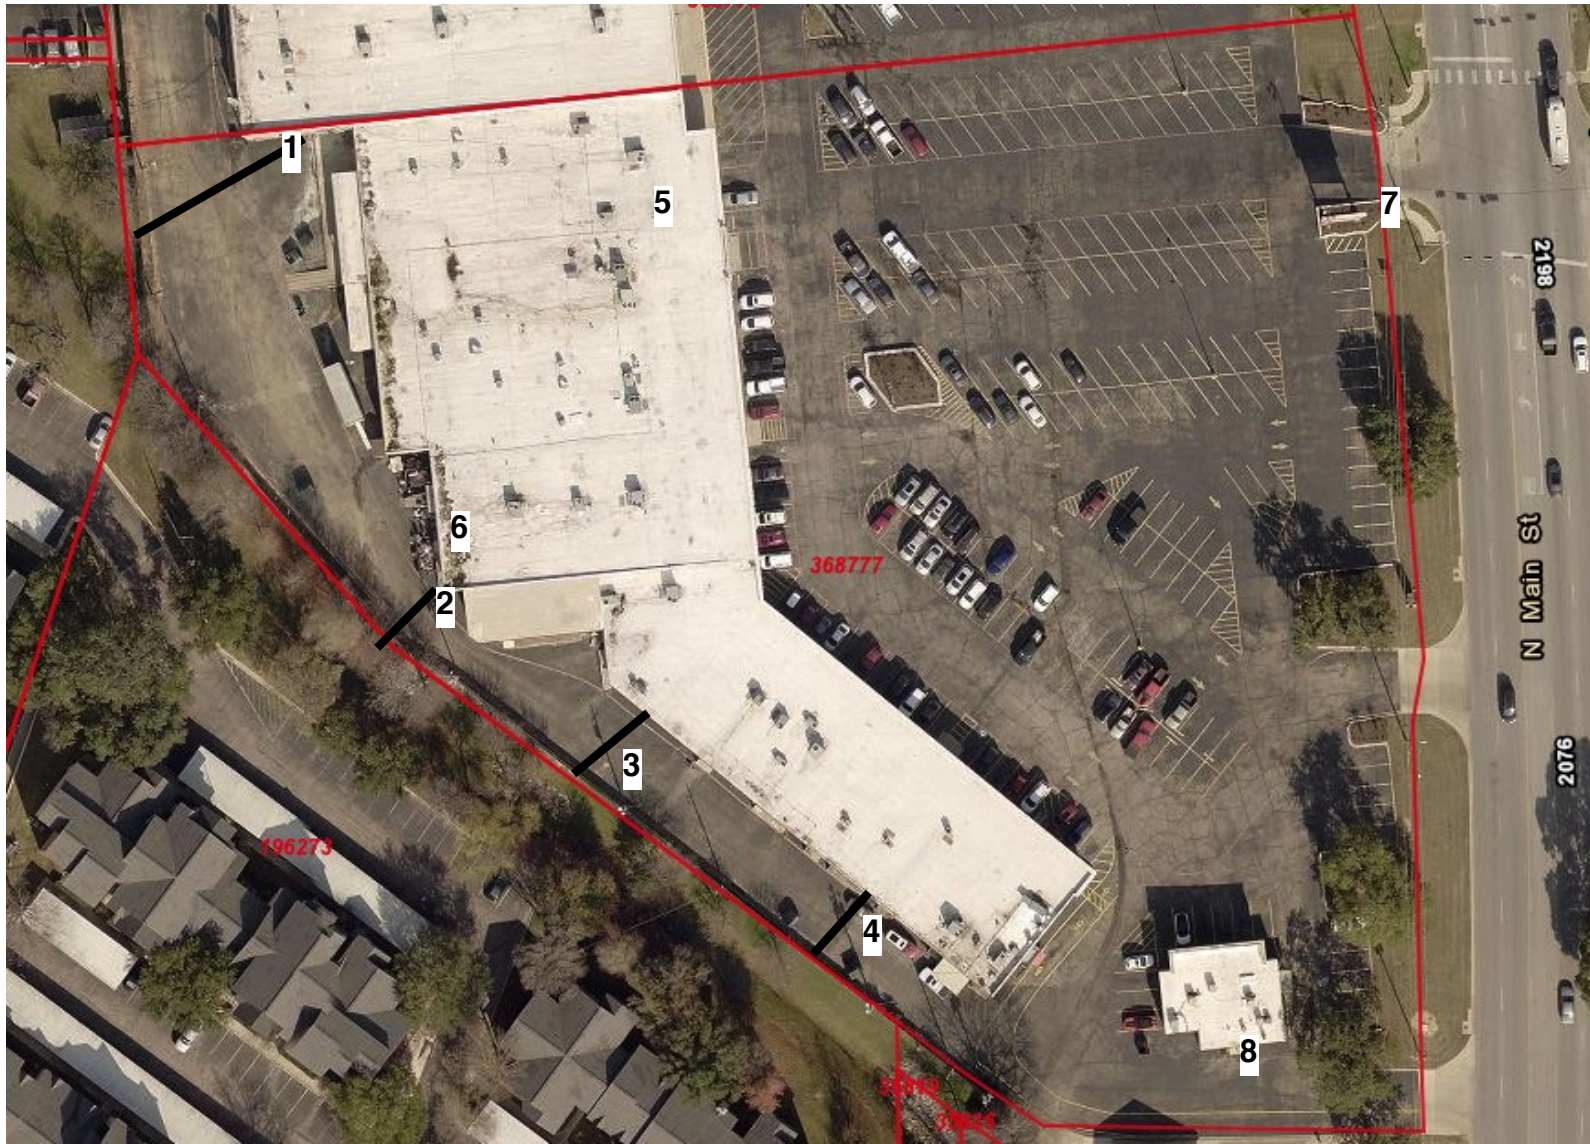
ELECTRICAL DETAILS MAP

- 1: LARGE 3-PHASE OVERHEAD SERVICE DROP AND PANEL HUB
- 2-4: ADDITIONAL SERVICE DROPS
- 5: MULTIPLE SUB-PANELS LOCATED WITHIN MAINTENANCE HALL
- 6: LARGE SUB-PANEL HUB LOCATED AT BACK INTERIOR WALL
- 7: SINGLE PHASE SERVICE DROP AT MAIN ENTRY SIGNAGE POLE
- 8: 3-PHASE SERVICE AT SECONDARY BUILDING (ORIGINAL EQUIPMENT)

- EACH SUITE PROVIDED A SERVICE METER
- PANEL/S PRESENT AT EACH UNIT/SUITE (MAP NOT COMPLETE)
- SEVERAL REMOVED METER HEADS AT BACK EXTERIOR WALL
- 3 PHASE AND SINGLE PHASE PRESENT
- ORIGINAL AND UPDATED EQUIPMENT IN USE
- MOST OBSERVED DISTRIBUTION PROPERLY INSTALLED (STEEL FLEX CONDUIT)
- MOST OBSERVED JUNCTION BOXES APPEAR TO MEET STANDARDS
- ALL TESTED OUTLETS INDICATE PROPER WIRING/GROUNDING
- AFCI/GFCI PRESENT AT ISOLATED AREAS (CURRENT STANDARDS NOT MET)

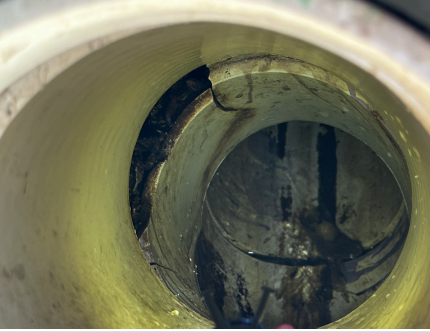
ACTION ITEM	DESCRIPTION / RECOMMENDATION	ADDITIONAL INFO
Water Heaters	<p>Priority: Low-Mid</p> <p>Several water heaters have surpassed their life expectancy. Recommend servicing and budgeting for update needs.</p>	
Riser Pipe	<p>Priority: Mid</p> <p>A cracked/damaged riser pipe was discovered during a pipe scoping camera assessment (back street riser near adjoining government building). If the cracking/damage worsens over time, replacement of the riser pipe will be required.</p>

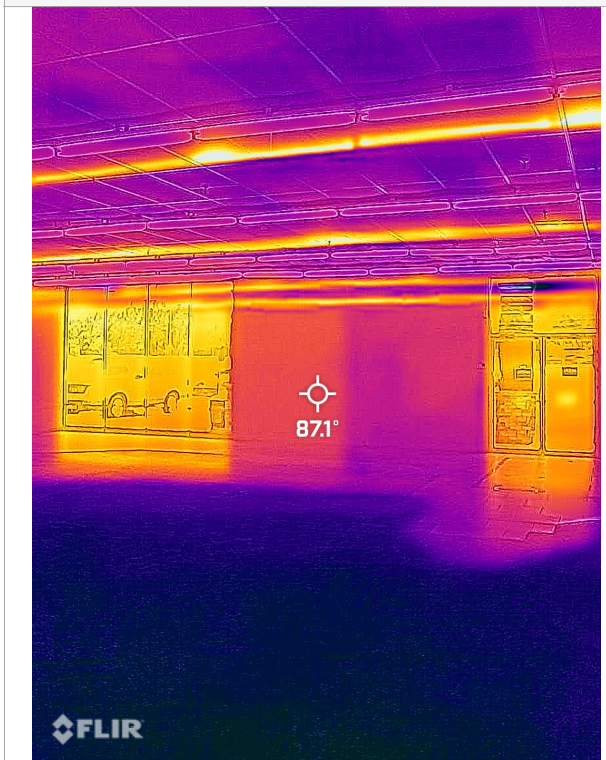
ELEVATED INDOOR TEMPERATURES
