Property: 123 Sample Rd.
Austin , TX 78703
Client: Sample Report - New Construction
Inspector: Andy Jordan #9458
Date: October 18, 2023

PROPERTY INSPECTION REPORT

Concerning: 123 Sample Rd. Austin, TX 78703
(Address or Other Identification of Inspected Property)

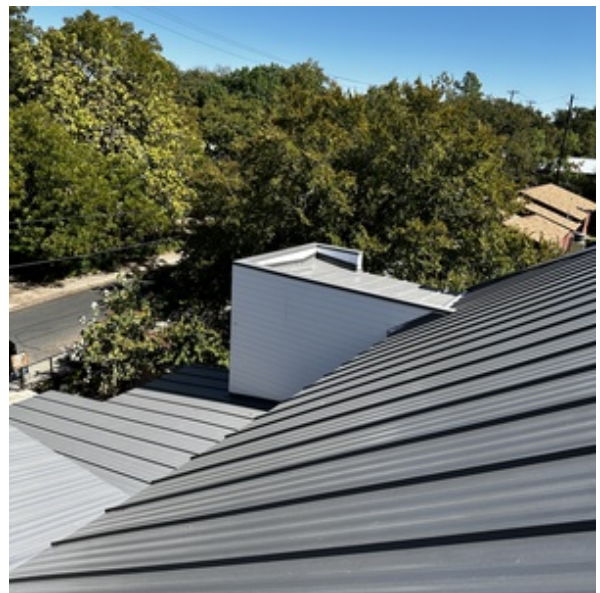
- Area of improper drain slope at flash pan of lower roof near front dormer (pooling water observed in valley flash pan)
- Recommend roofer further inspect pitch transitions at dormer areas: Pitch break/transition flashing not installed (panels bent and may be notched to make transition), further assess to ensure bending/notching does not create potential moisture entry points

VARIOUS PITCH TRANSITIONS

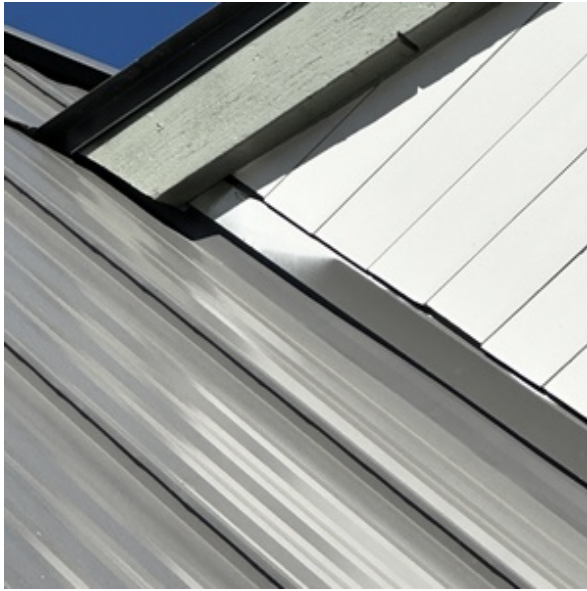
PAINT OVERSPRAY (COSMETIC)

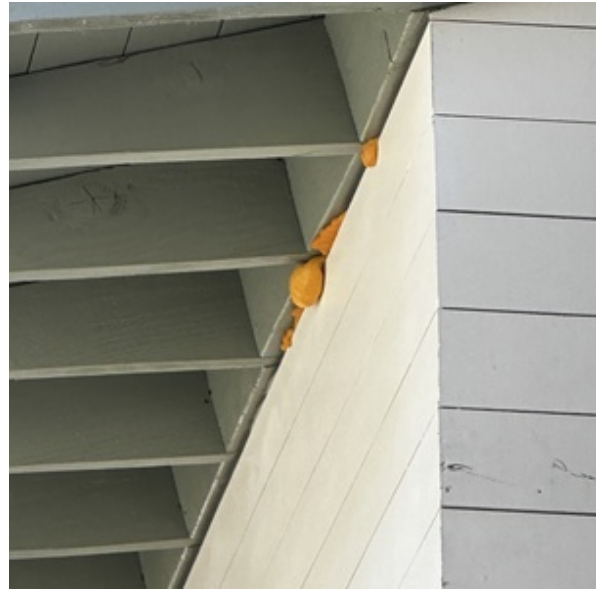
ADDRESS FOAM OVERSPRAY

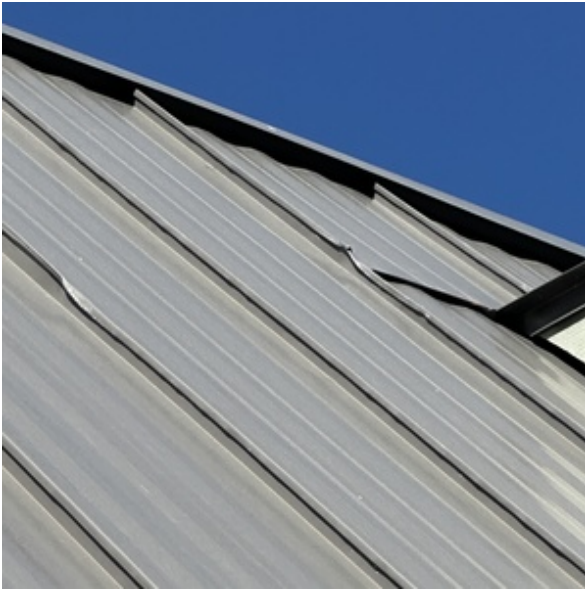
CRIMPING FLAWS OBSERVED

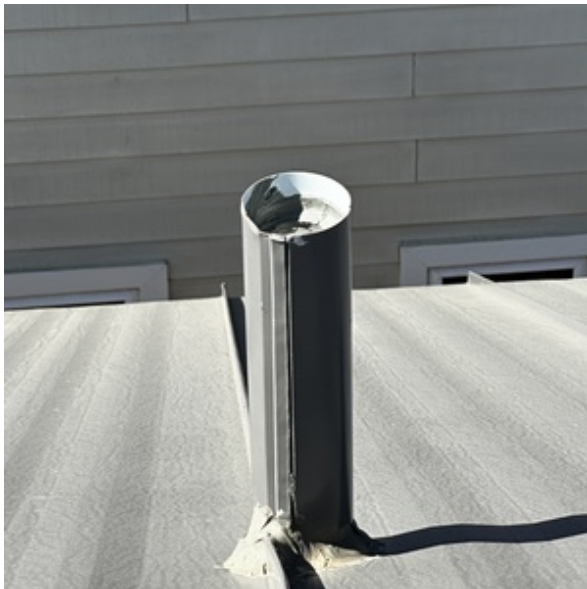
VENT BOOT/SLEEVE CONCERNS

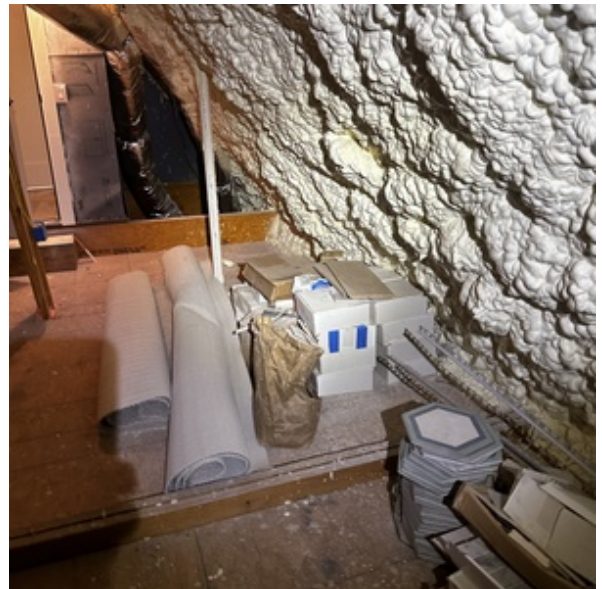
MATERIALS STORED IN BACK ATTIC

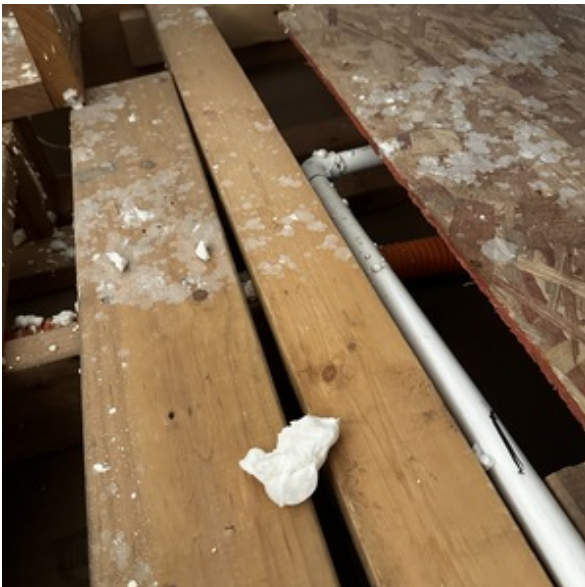
IMPROVE MAINTENANCE PLATFORM

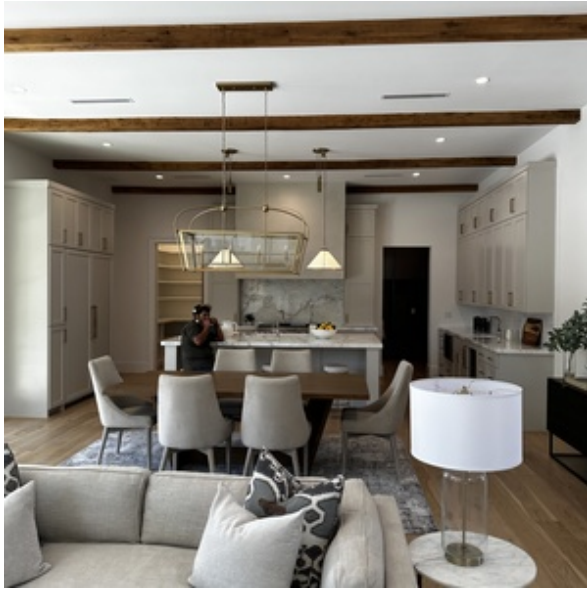
PROFESSIONAL INSTALLATION

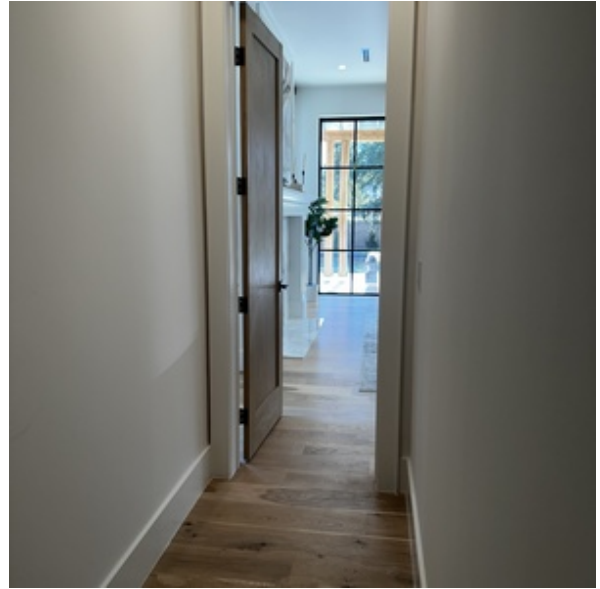
PROFESSIONAL INSTALLATION

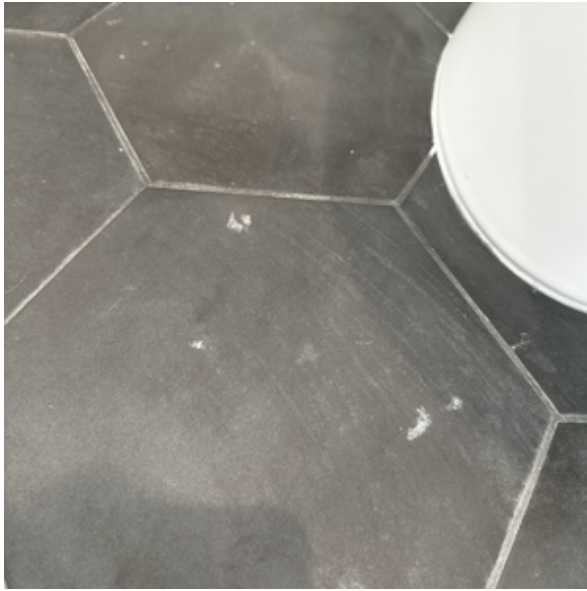
COMMON MAKE-READY NEEDS

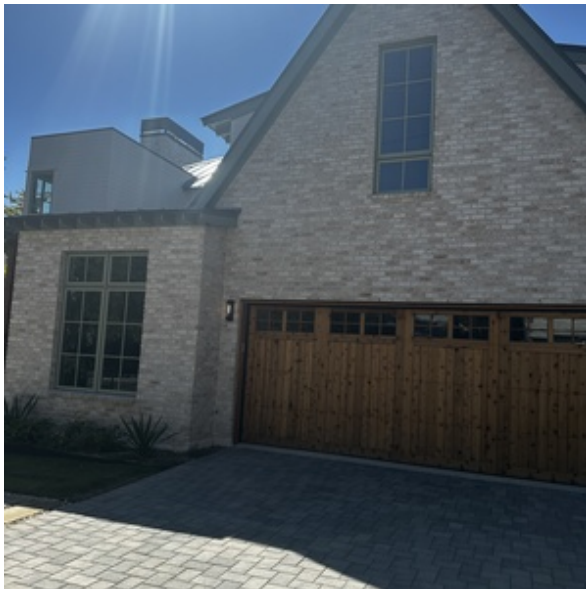
OVERALL CONDITION MEETS STANDARDS

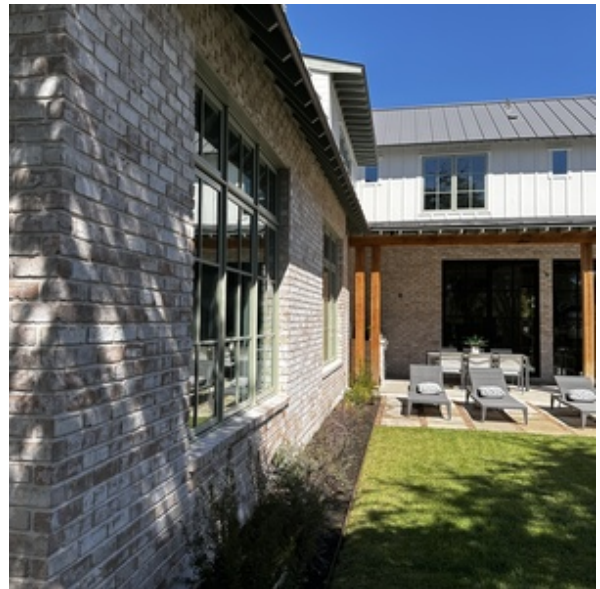
OVERALL CONDITION MEETS STANDARDS

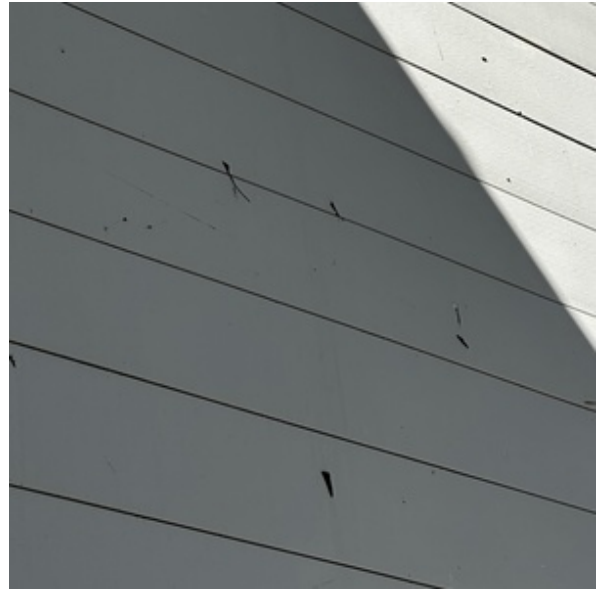
MINOR CLEANING NEEDS

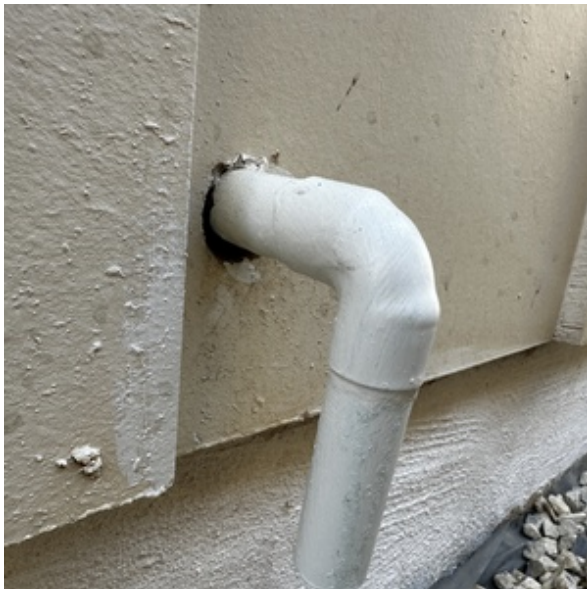
CAULK/SEAL AT PENETRATIONS

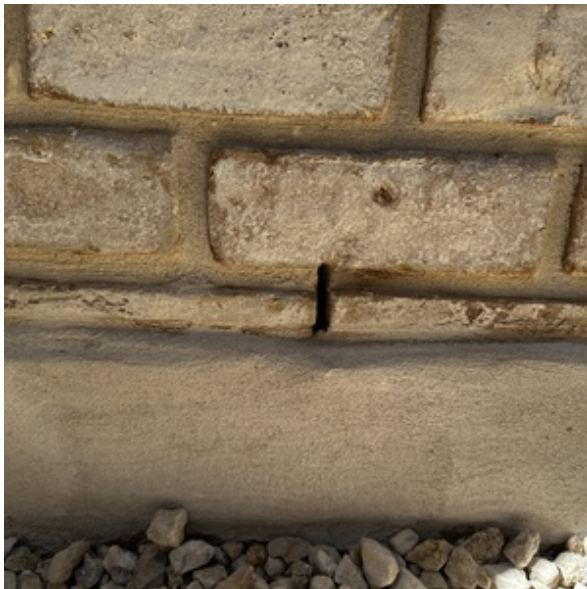
WEEP HOLES PROVIDED IN MOST AREAS

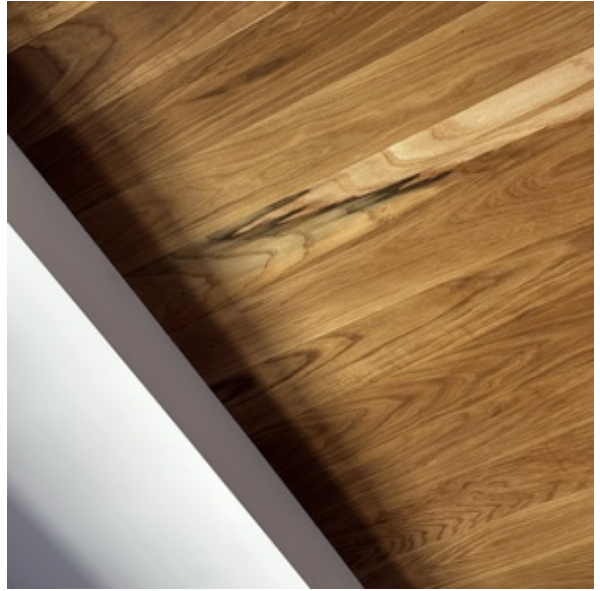
- Area of wood ceiling stain in primary suite (near windows facing pool): No evidence of moisture/leak issues (noted to make homeowner aware - monitor area)

WOOD STAINS APPEARS NON-PROBLEMATIC

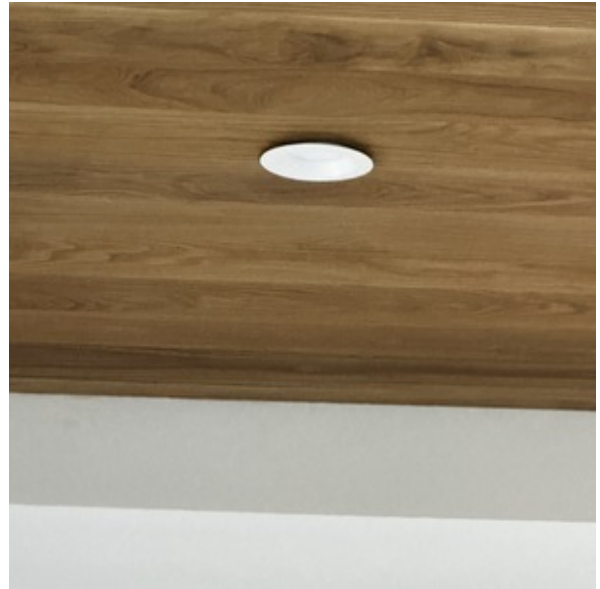
- Secure loose recessed light within primary suite (hangs out of ceiling by appx. 1/2")

IMPROVE LIGHT SECURING

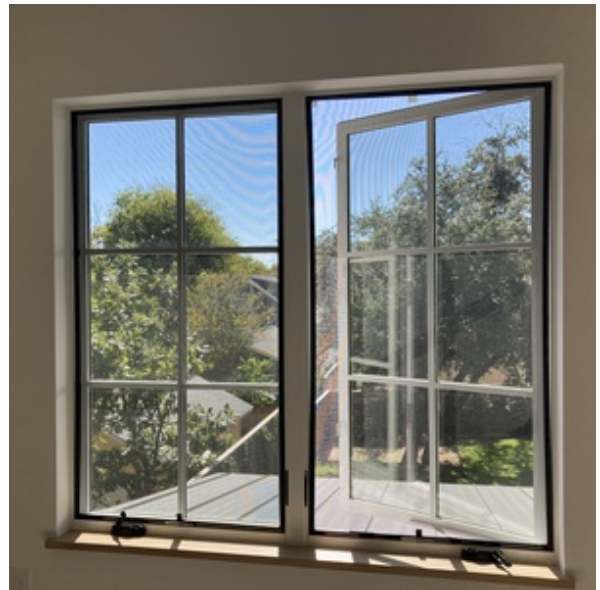
WINDOWS TESTED

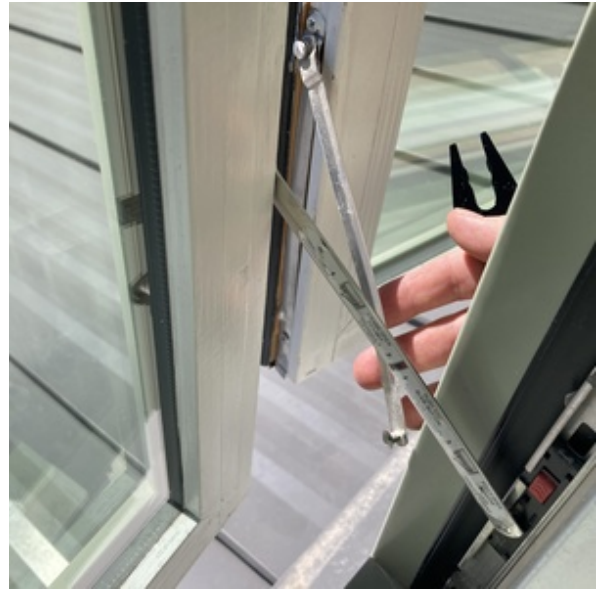
RECHECK/ADJUST HARDWARE

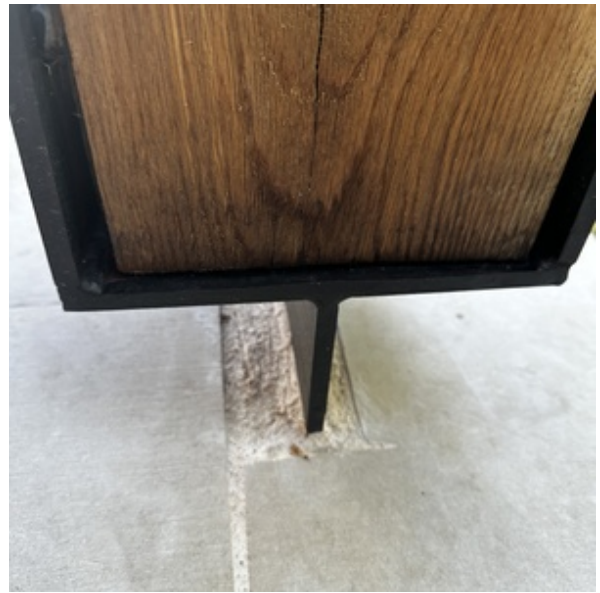
HIGH END POST BASED PROVIDED

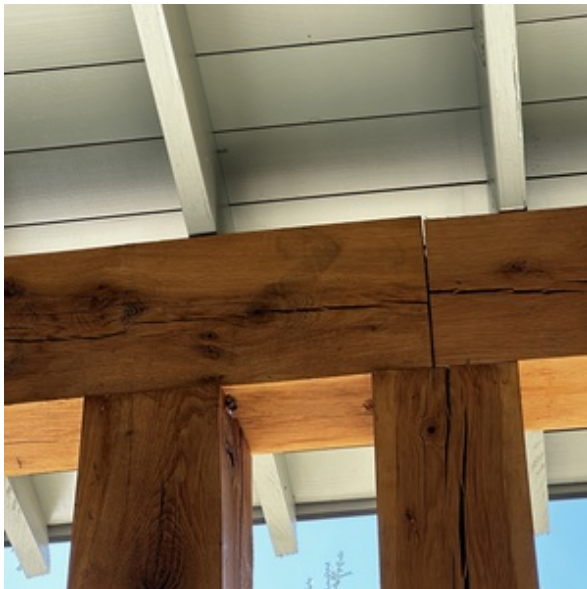
CONSIDER IMPROVED CONNECTIONS

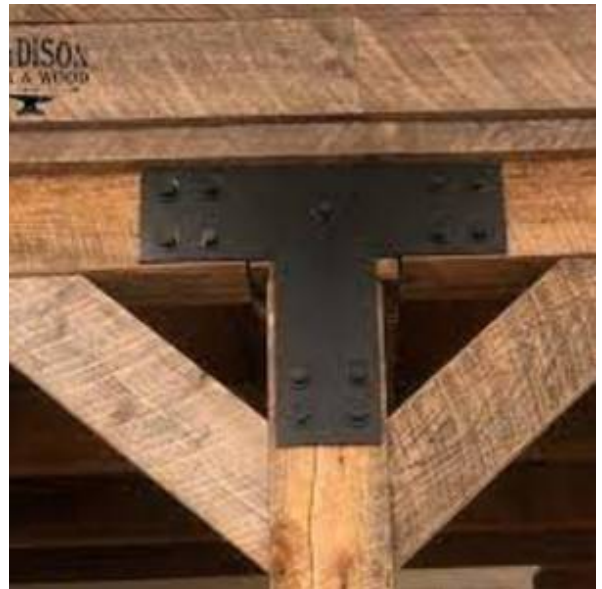
EXAMPLE: POSSIBLE STRAP IMPROVEMENT

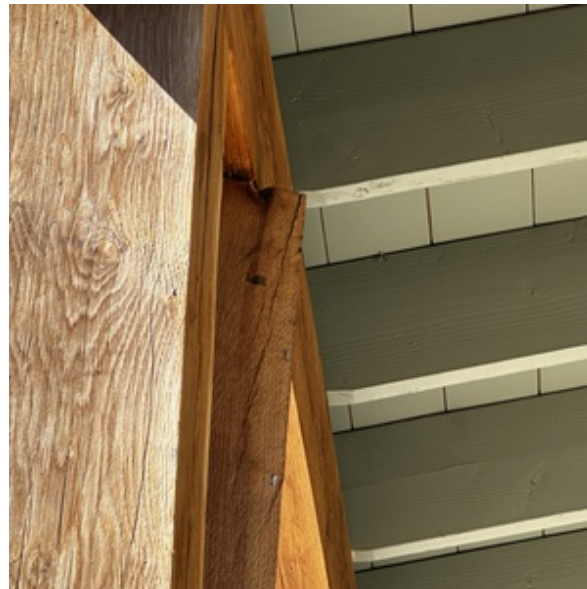
BOWED/TWISTED COLUMN

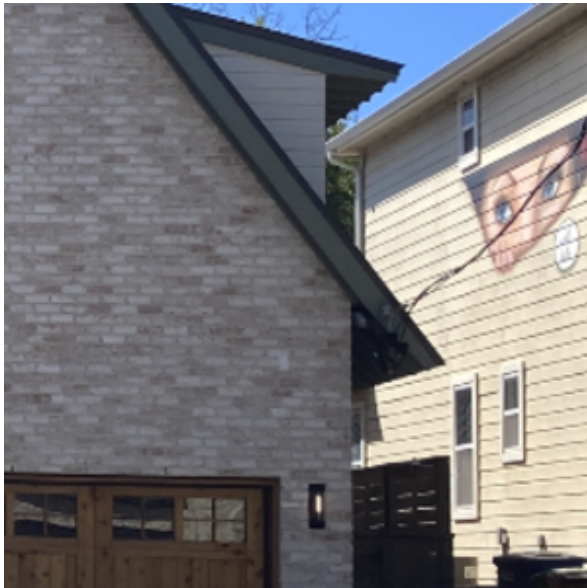
OVERHEAD MAIN SERVICE

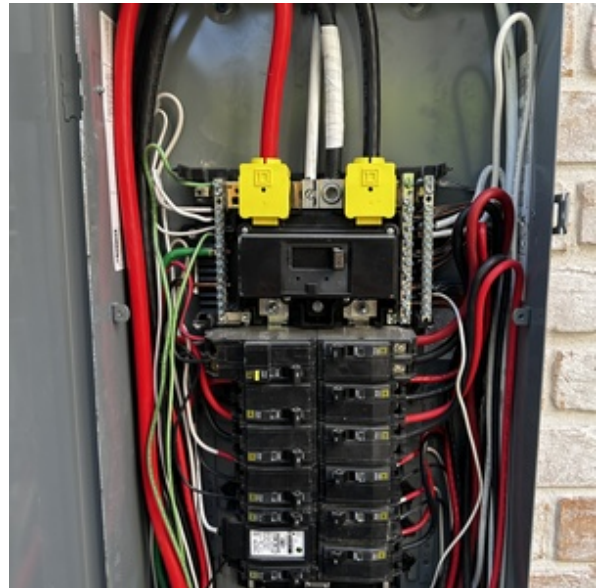
SQUARE D PANEL

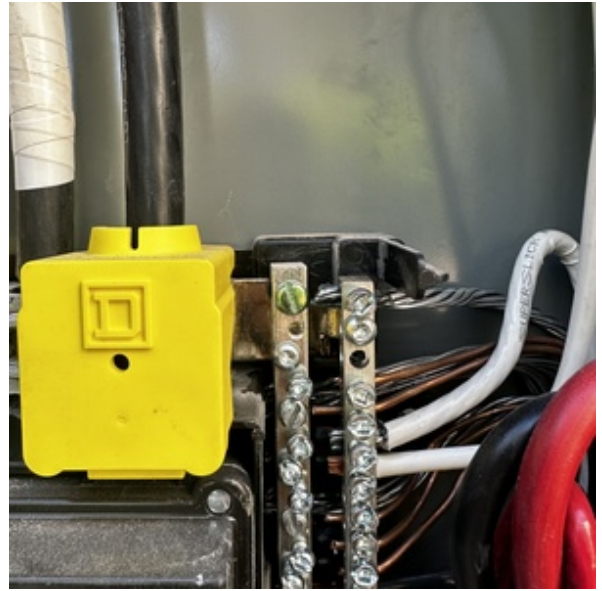
PROPER PANEL BONDING

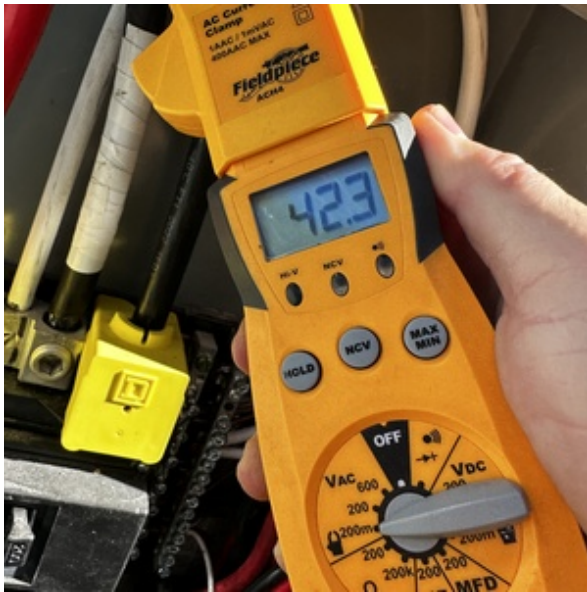
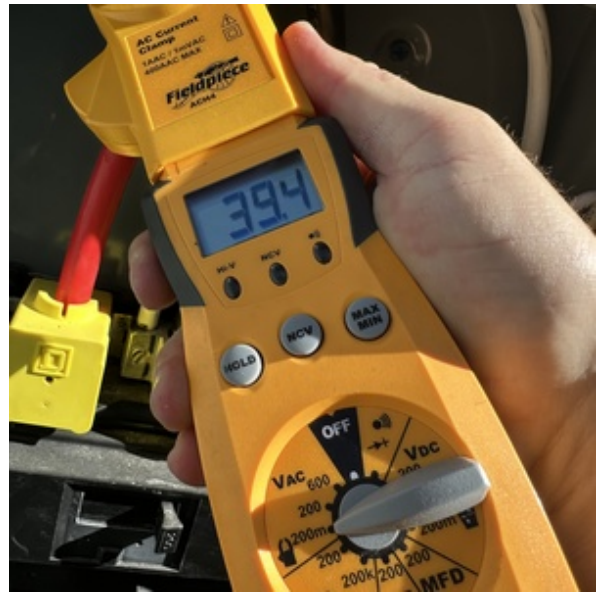
NORMAL AMP DRAW

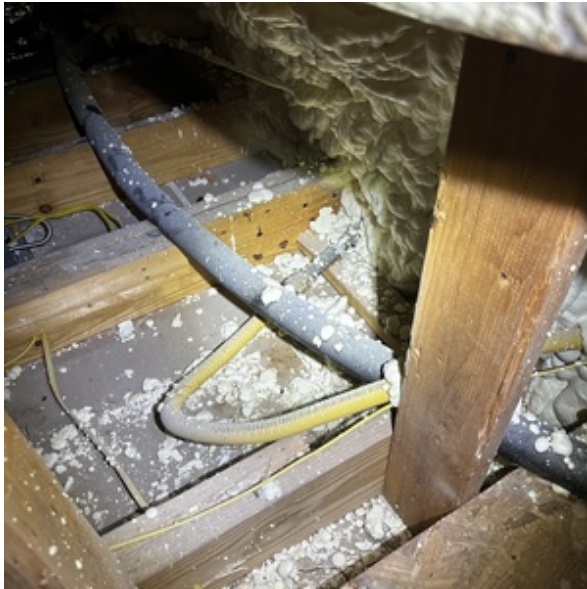
YELLOW JACKET CSST PRESENT

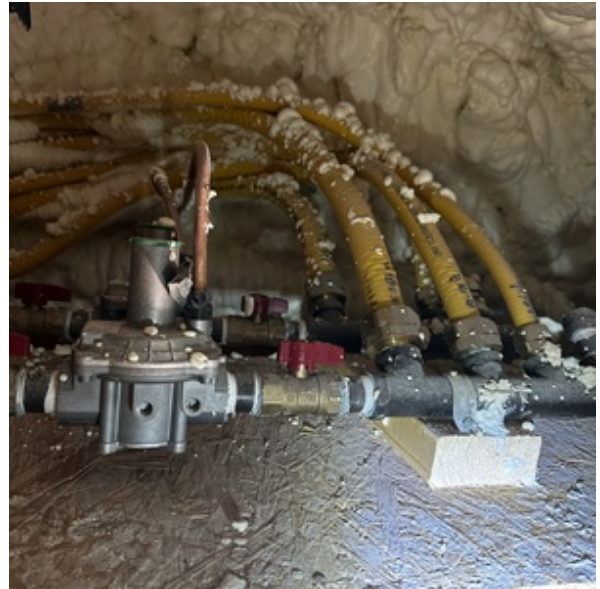
system of the structure in which the CSST is installed serves to lower the voltage build-up on the CSST caused by unintentional energizing from outside sources such as lightning strikes. The installation of an extra bonding connection is in addition to the bonding required in IFGC Section 310.1/IRC Section G2411.1 for ground fault protection. The bonding helps achieve an equipotential state between the CSST and other similarly bonded metallic systems (such as the water piping, structural steel, electrical raceways and coax cable).

NO CSST BOND DISCOVERED

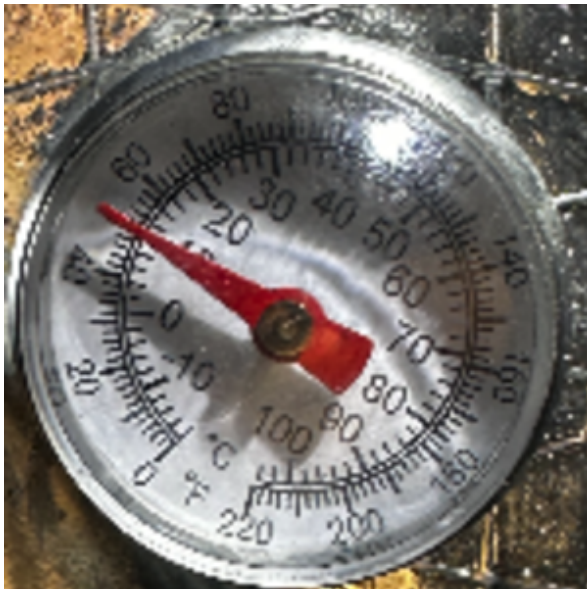
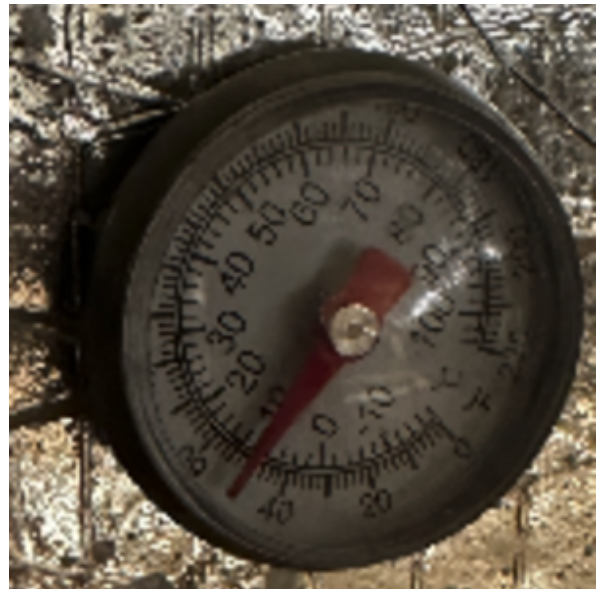
NORMAL TEMPS AT PLENUMS

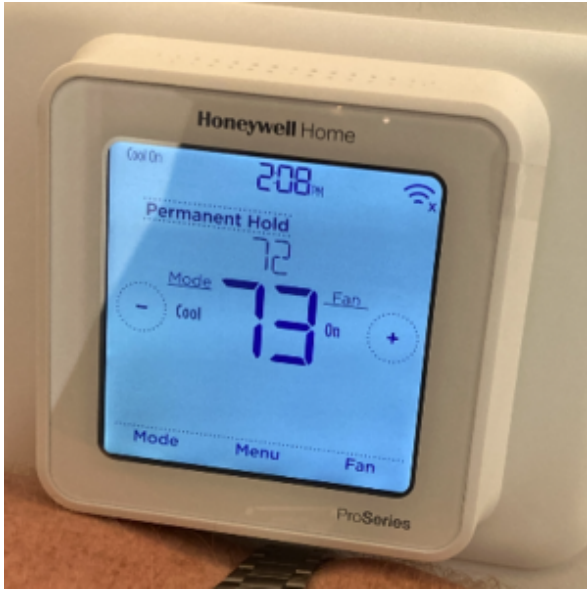
START TEMP: DEMAND TESTING

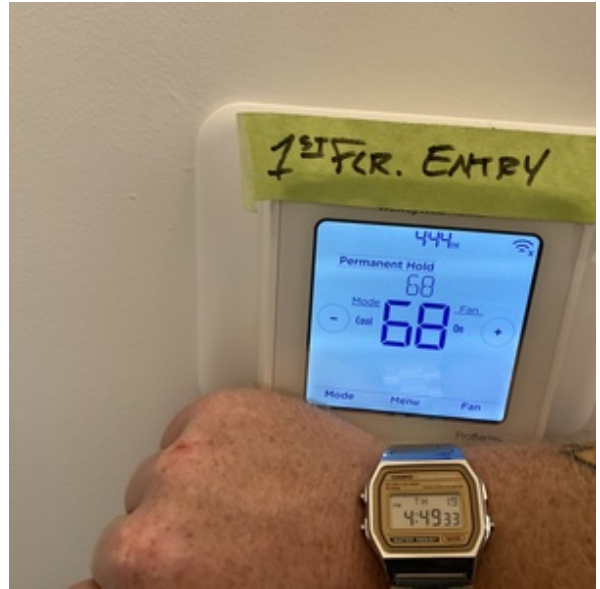
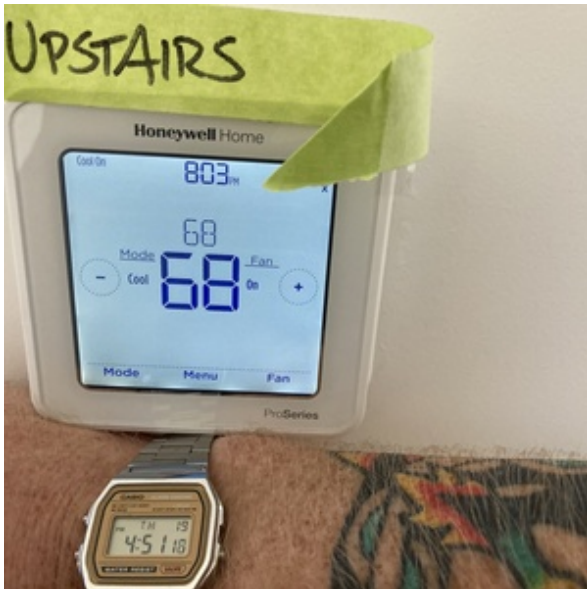
SET POINT DEMAND MET

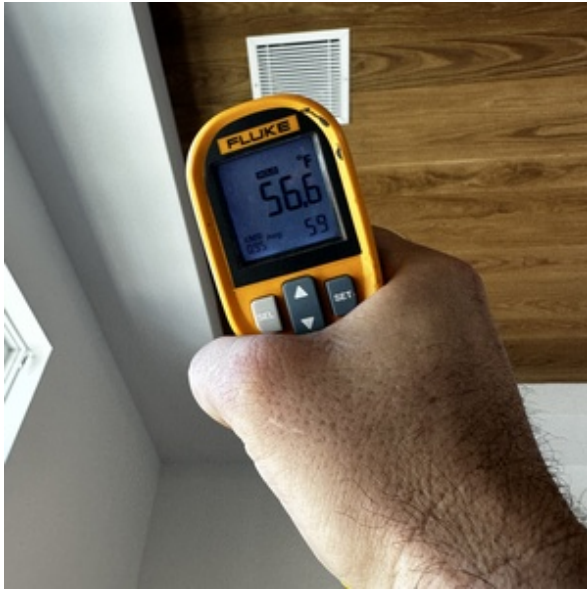
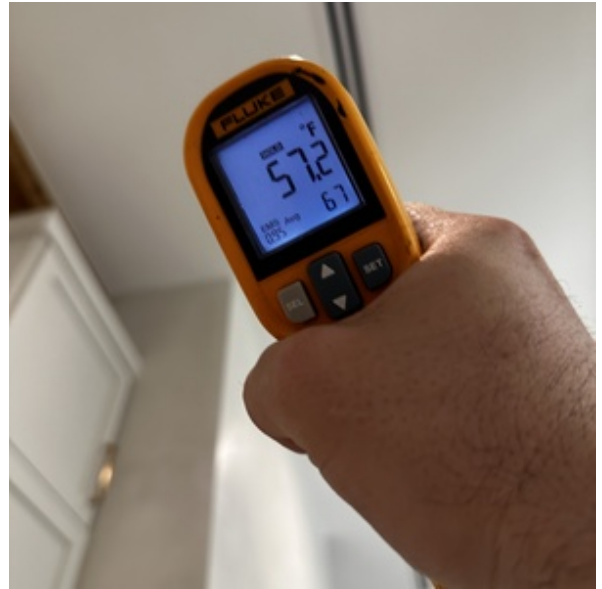
VENTS: NORMAL/UNIFORM TEMPS

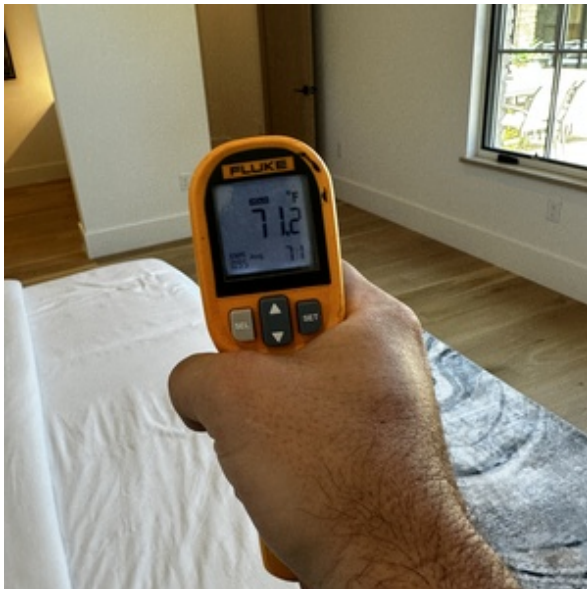
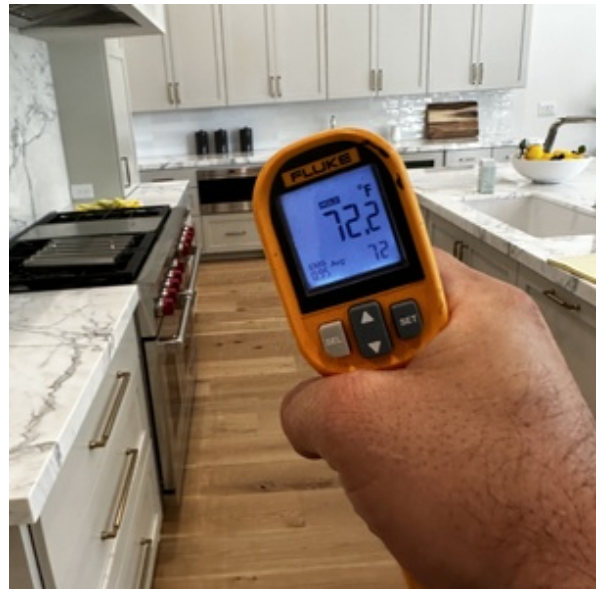
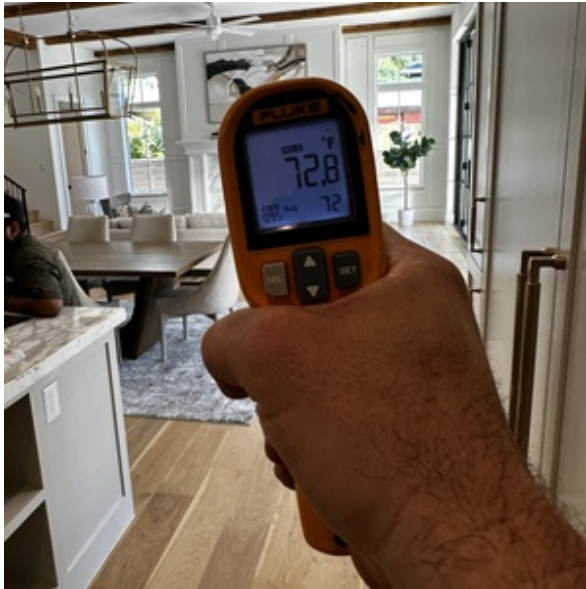
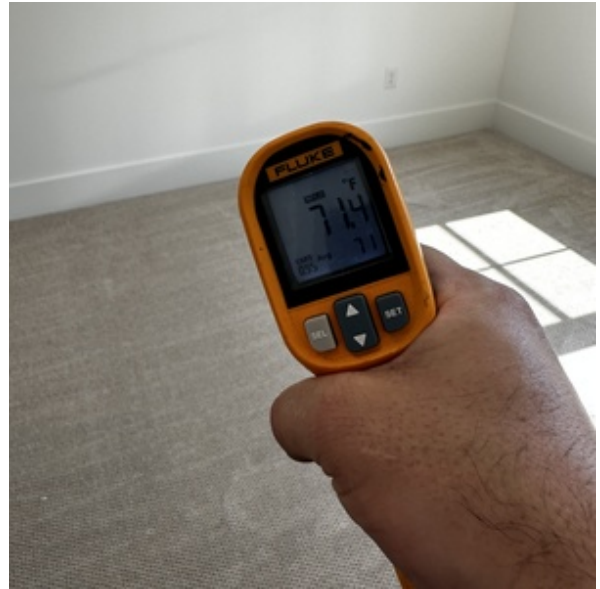
ROOMS: NORMAL/UNIFORM TEMPS

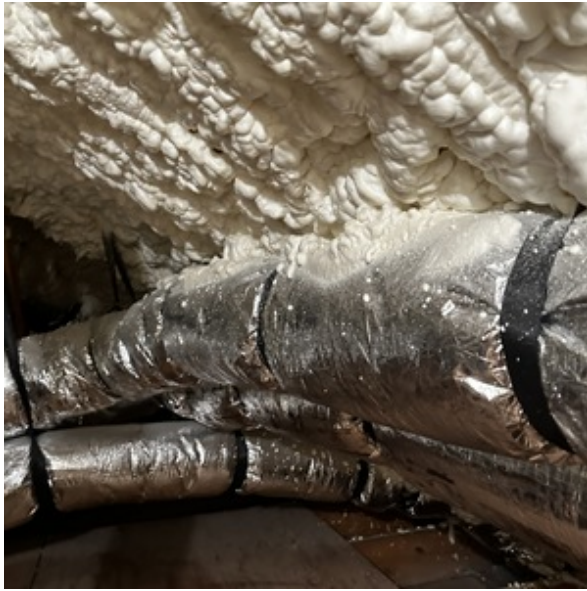
MYLAR FLEX DUCTS

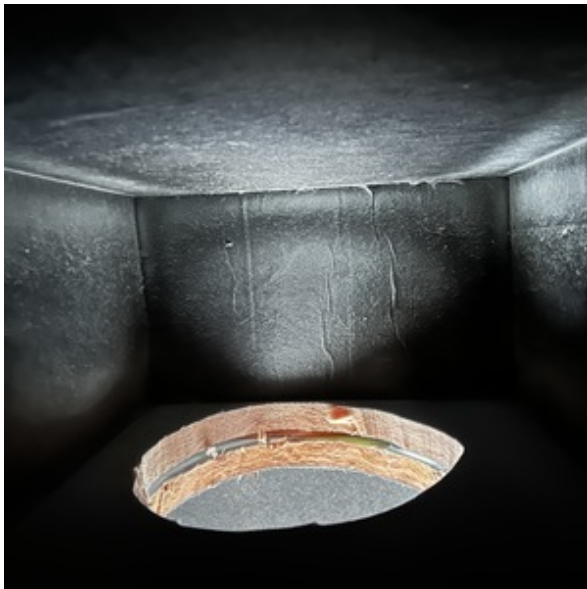
RETURNS CLEAN

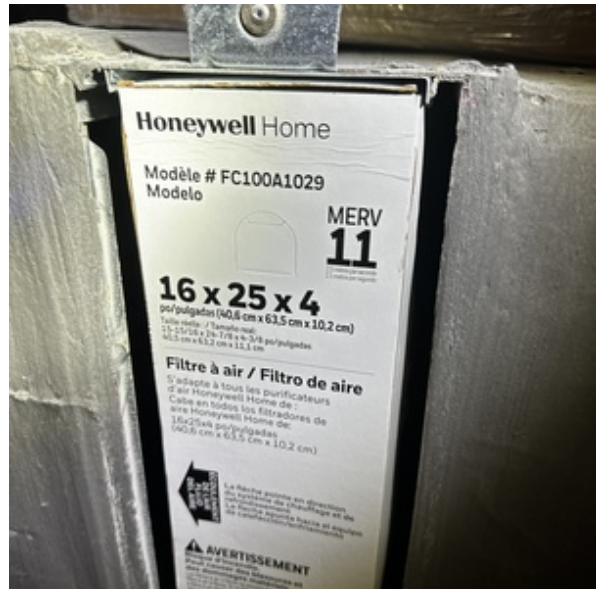
MEDIA FILTERS PROVIDED

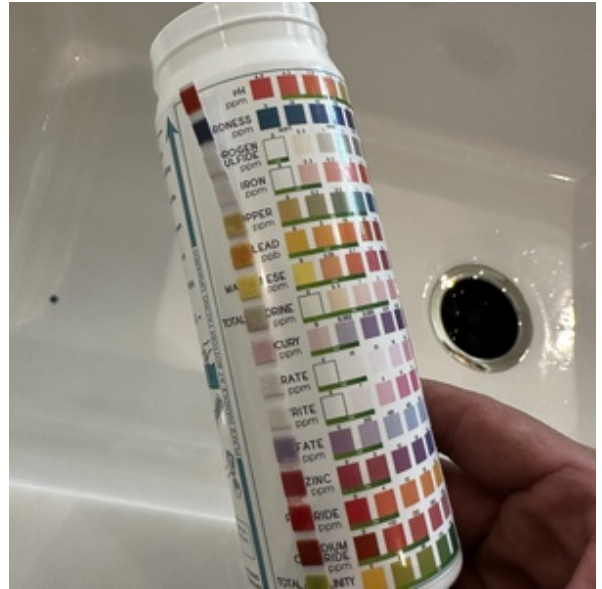
SIMPLE WATER TESTING (HARD WATER)

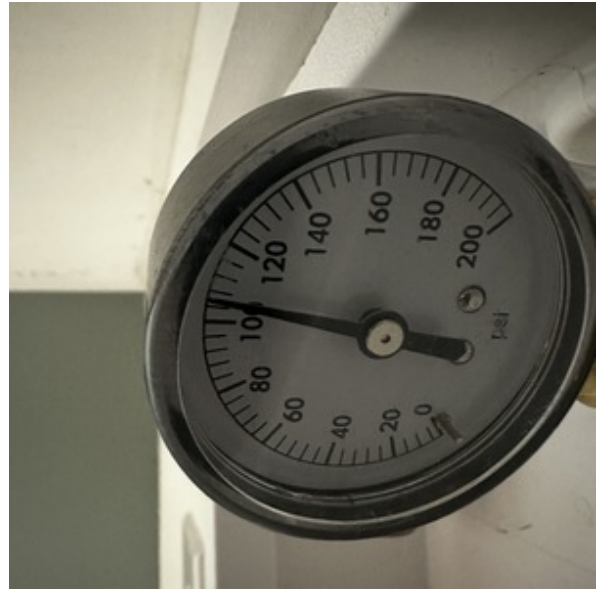
At the time of inspection, the water pressure entering the structure exceeded recommended maximum levels (PSI recommended to be with 40-80 pounds per square inch). Contacting a plumbing professional is recommended to determine if the installation of a pressure reducing valve or additional adjustments/updates are warranted.

PRESSURE EXCEEDS 80 PSI

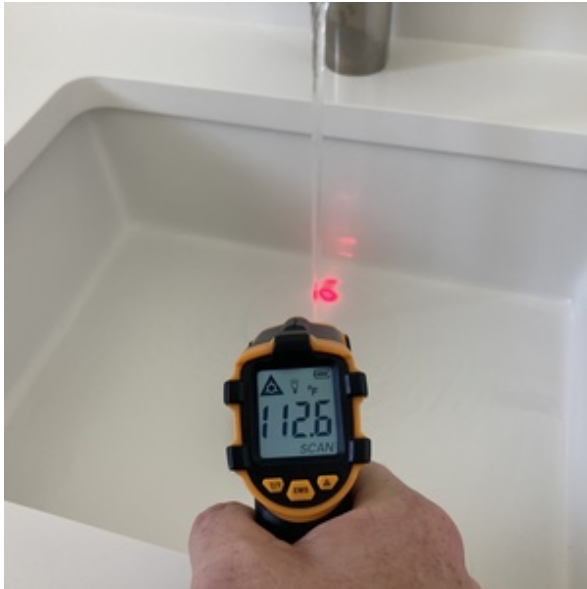
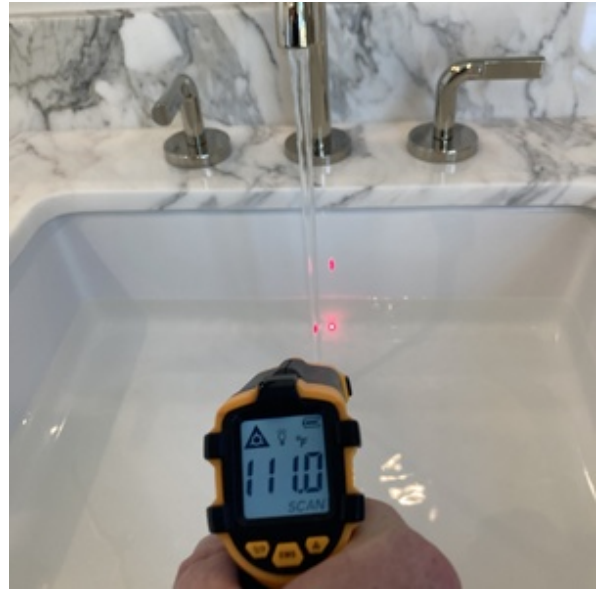
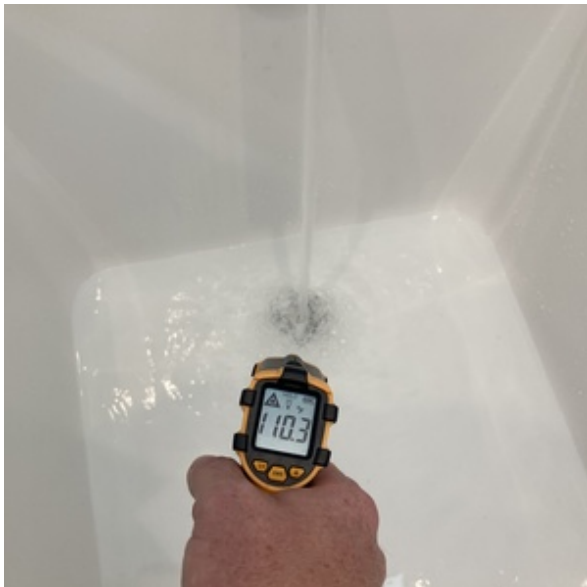
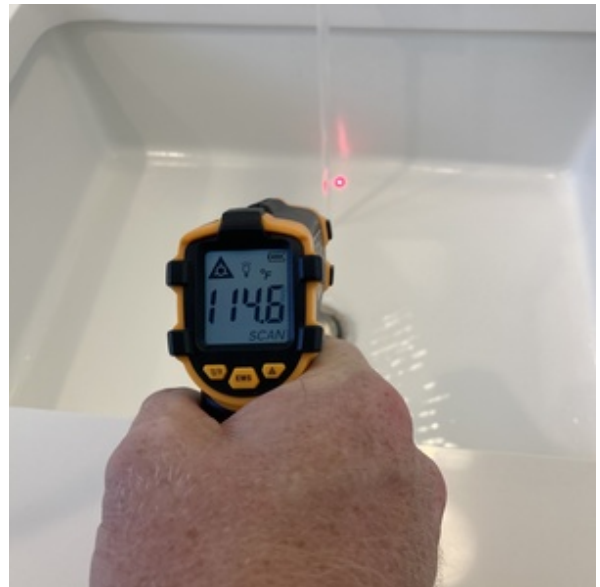
-Recorded average water temperature met minimum standards (above 110F, below 120F), Some isolated readings were recorded below 110F If hotter temperatures are desired, adjustments to mixing valves or deleting 120F max settings may be needed (deleting 120F max setting may void warranty)

AVERAGE TEMPS: 110-115F

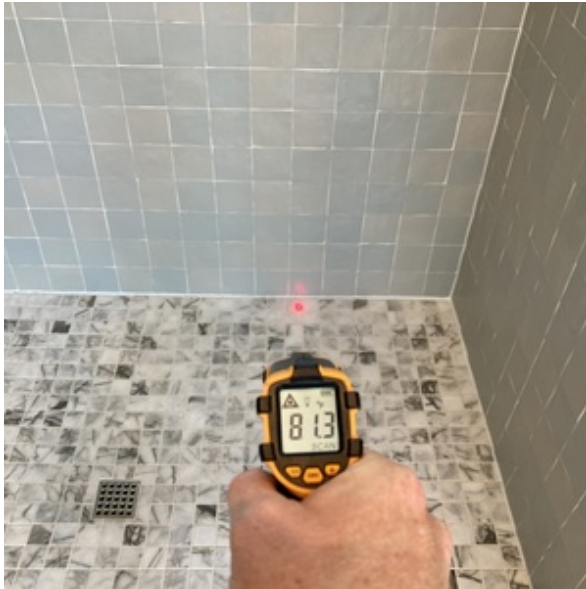
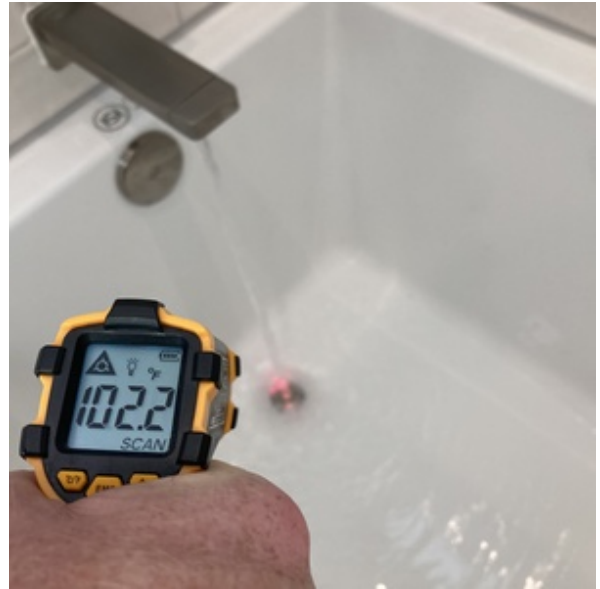
ISOLATED LOWER TEMPS

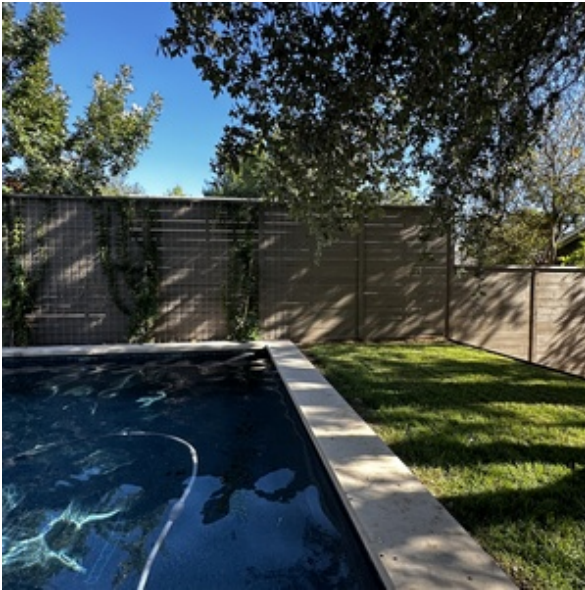
TREES NEAR POOL

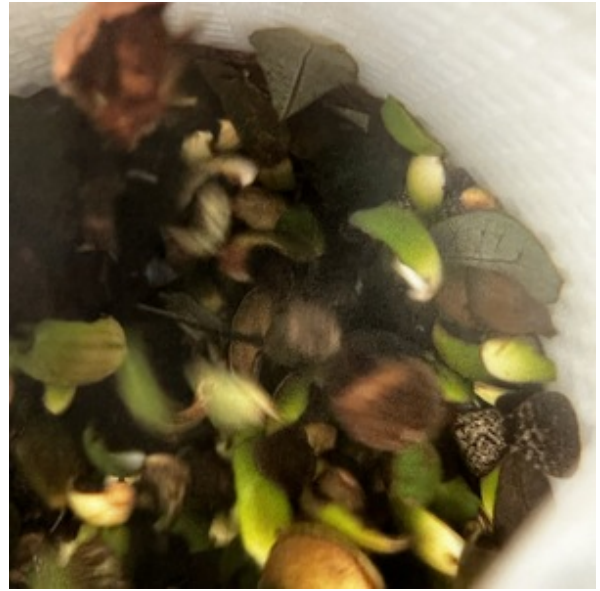
TREES NEAR POOL, SINGLE RETURN
