**GREENBELT STRUCTURAL SERVICES**  
A DIVISION OF TAHI LLC

Property: 123 Sample Rd.  
Austin , TX 78736  
Client: Sample Report - Existing Building  
Inspector: Andy Jordan #9458  
Date: September 8, 2023

# PROPERTY INSPECTION REPORT

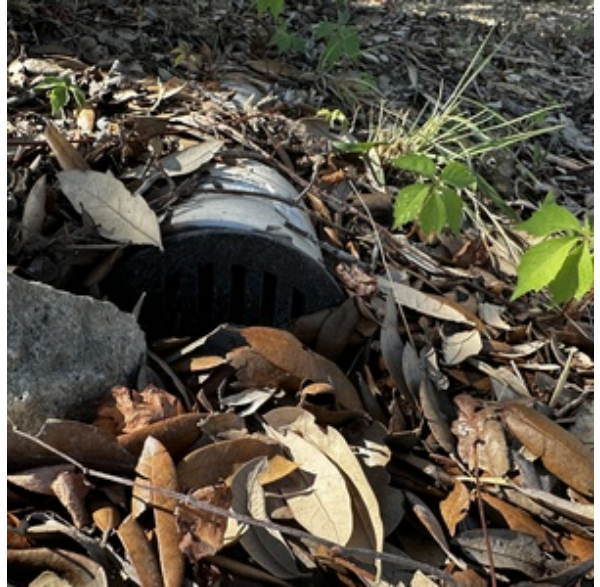
SERVICE SUB-GRADE DRAINS

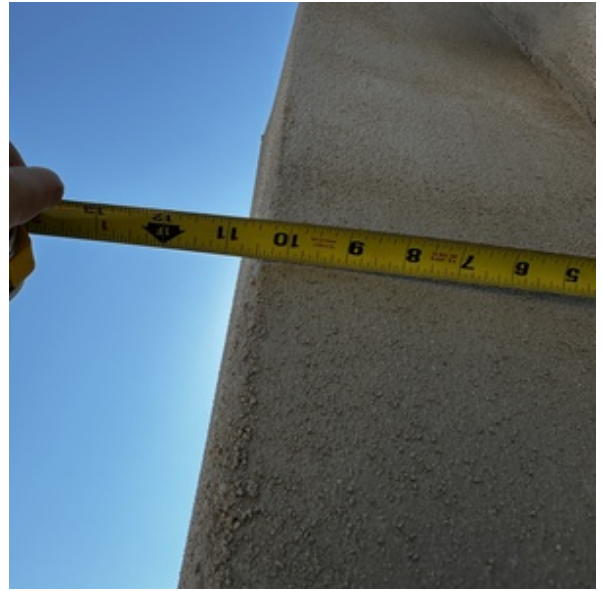
UPPER WALL: 10-11"

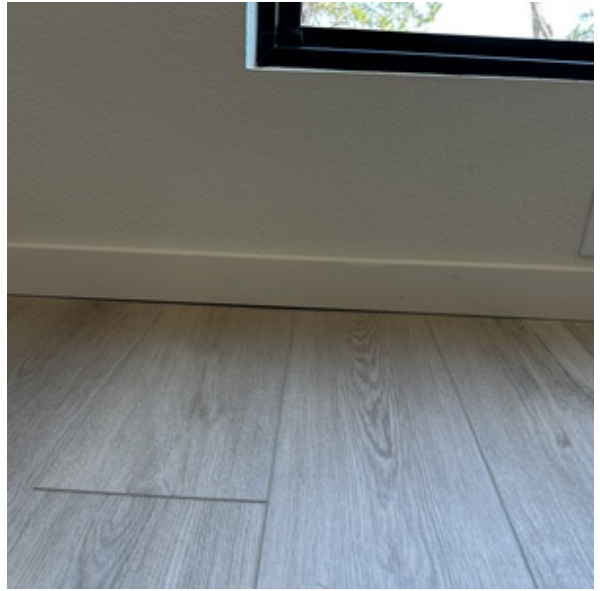
AREAS OF UNEVEN FLOOR SURFACES

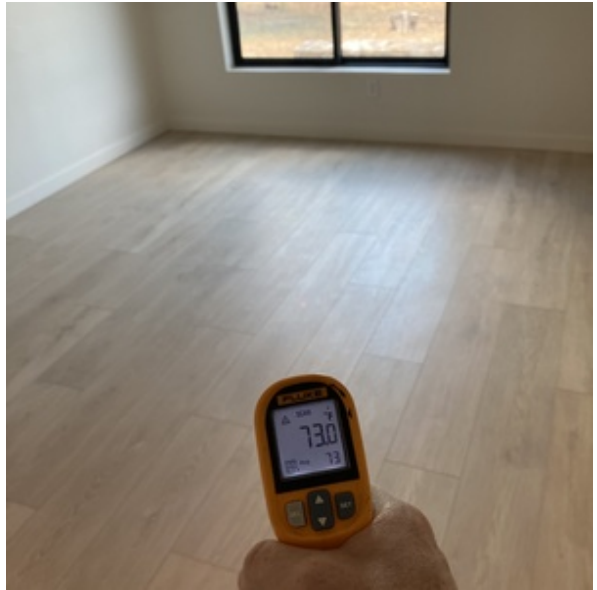
AVERAGE TEMP (BEDROOMS): 72-74F

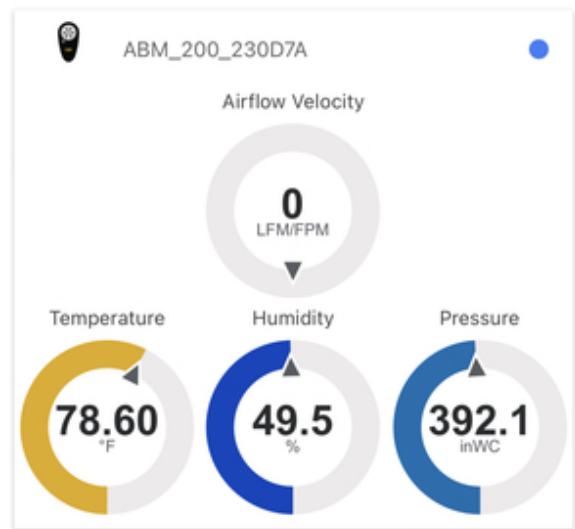
AVERAGE TEMP (COMMON AREA): 78-79F
